# Flood Investigation Report

Location: XX Stad Plas Hen, Llanddaniel Fab, Anglesey LL60 6HW

Date of Flood Incident: 22<sup>nd</sup> November, 2017

Reference: YM2017S19.31

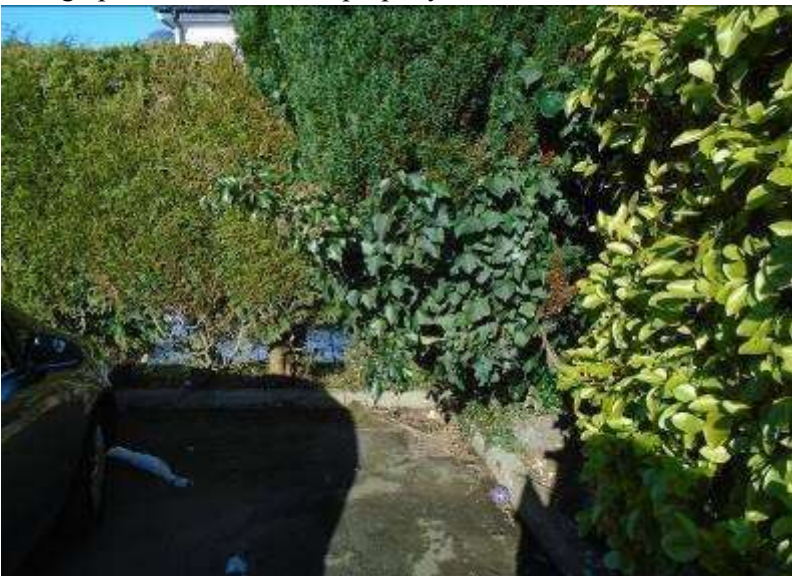
There are road gullies located in the estate road fronting the property and an initial inspection of the system, which discharges to a land drainage ditch, revealed no obvious obstruction or blockages.

Photograph 3 – Overhanging trees by the highway gully  
Isle of Anglesey County Council, Llangefni, Anglesey. LL77 7TW
