M4 Corridor around Newport

Environmental Statement Volume 3: Appendix 10.8 Otter and Water Vole Survey 2014

M4CaN-DJV-EBD-ZG_GEN-AX-EN-0028

Welsh Government M4 Corridor Around Newport Otter and Water Vole Survey 2014

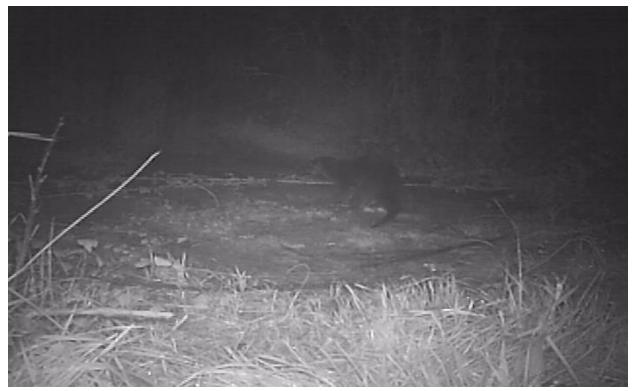
Field signs were also found on water body 1129 along with numerous mammal paths in adjacent vegetation within Tata steelworks. Much of the vegetation and water bodies in this area show heavy contamination, but interspersed there are water bodies with apparently better water quality such as 1129 with moderate flow, and also dense vegetation. There is also suitable scrub to the west and south which could be used by otters for a holt, refuge or as a corridor to move to more suitable areas. A camera trap was deployed at two locations along reen 1129.

Figure 3 - Steelworks reen bridge 15/10/2014 20:57

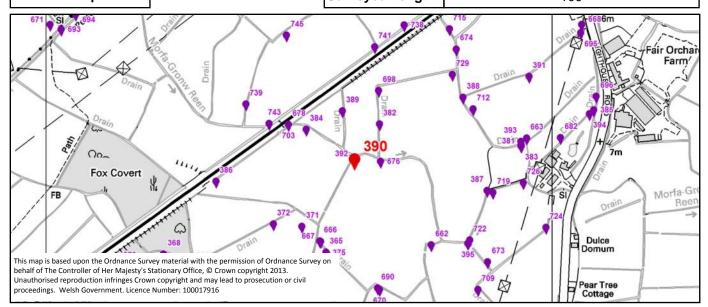
Unique Reference	390	Date:	Date: 04-07-2014 10:50		GPS:	51.547802, -3.016526	
Waterbody Number:	258	Surveyor:			TS		
Location Map:		Survey	Surveyed Length:		100

Habitat	Reen		
Bank Profile	Flat <10 degrees		
Depth of Water	1 - 2m		
Channel Width	1 - 2m		
Flow Speed	Still		
Shore Banks	Earth

Neighboring Land Use	Arable;
Bank Management	Unfenced
Suitability for Otters	Low
Otter Signs	
Suitability for Watervoles	High
Watervole Signs	Pathways; Feeding Stations;

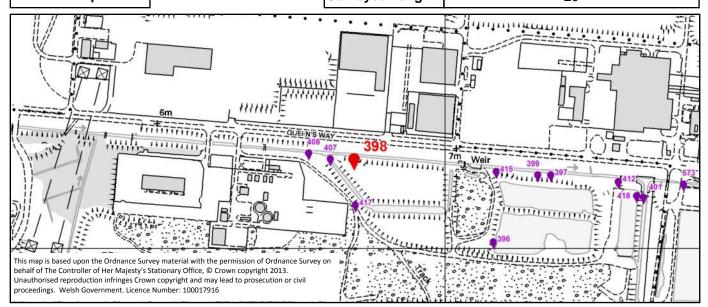
Unique Reference	398	Date:	05-	08-2014 11:31	GPS:	51.571008, -2.89856
Waterbody Number:	1243	Survey	or:		TS MN	AO TR
Location Map:		Surveyed Length:		enath:		20

Habitat	Reen			
Bank Profile	Steep >45deg			
Depth of Water	1 - 2m			
Channel Width	5 - 10m			
Flow Speed	Sluggish			
Shore Banks	Earth

Neighboring Land Use	Scrub;			
Bank Management	Unfenced			
Suitability for Otters	Low			
Otter Signs				
Suitability for Watervoles	Medium			
Watervole Signs	Latrines; Pathways; Feeding Stations;

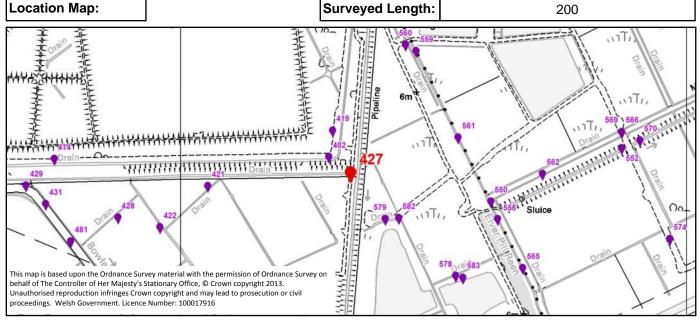
Unique Reference	427	Date:	06-	08-2014 10:21	GPS:	51.565402, -2.891022
Waterbody Number:	1152	Surveyor:		AO MM

Habitat	Reen			
Bank Profile	Steep >45deg			
Depth of Water	1 - 2m			
Channel Width	2 - 5m			
Flow Speed	Still			
Shore Banks	Earth

Neighboring Land Use	Scrub;
Bank Management	
Suitability for Otters	Low
Otter Signs	
Suitability for Watervoles	Medium
Watervole Signs	Pathways; Feeding Stations;

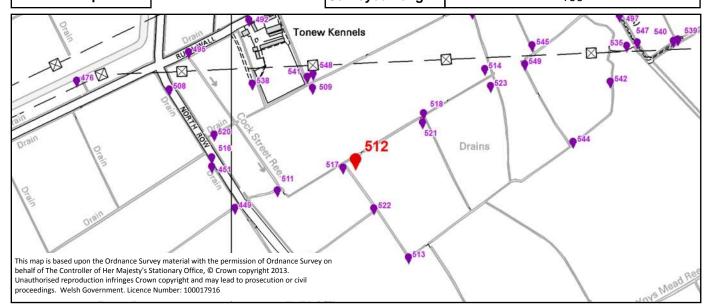
Unique Reference	512	Date:	Date: 12-08-2014 1		GPS:	51.564763, -2.863465
Waterbody Number:	978	Survey	Surveyor:		AO	& SC
Location Map:		Surveyed Length:		enath:		100

Habitat	Ditch				
Bank Profile	Steep >45deg				
Depth of Water	1 - 2m				
Channel Width	2 - 5m				
Flow Speed	Still				
Shore Banks	Earth

Neighboring Land Use	Livestock grazing;
Bank Management	Mixture
Suitability for Otters	Low
Otter Signs	
Suitability for Watervoles	Low
Watervole Signs	Burrows; Feeding Stations;

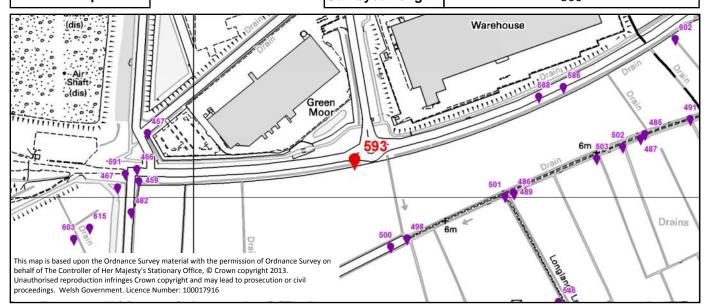
Unique Reference	593	Date:	Date: 21-08-2014 14:40		GPS:	51.570374, -2.862522	
Waterbody Number:	976	Survey	Surveyor:		AO & RE		
Location Map:		Surveyed Length:			300

Habitat	Ditch				
Bank Profile	Steep >45deg				
Depth of Water	>2m				
Channel Width	2 - 5m				
Flow Speed	Still				
Shore Banks	Man-made

Neighboring Land Use	Arable; Urban;
Bank Management	Mixture
Suitability for Otters	Low
Otter Signs	
Suitability for Watervoles	Medium
Watervole Signs	Latrines; Burrows; Pathways; Feeding Stations; Lawns;
