M4 Corridor around Newport

Environmental Statement Volume
3: Appendix 8.2

Cultural Heritage Desk Based
Assessment

M4CaN-DJV-HER-ZG_GEN-AX-EN-0008

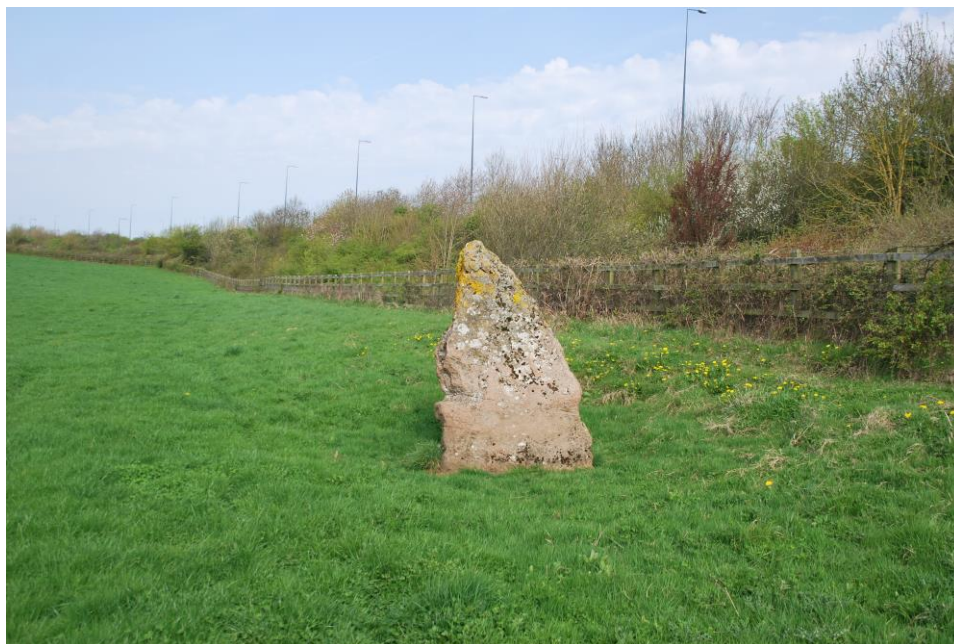
- 4.1.5** Geophysical survey undertaken in connection with the proposed new section of motorway shows a very distinct circular feature approximately 125 metres to the south of the standing stone (Figure 8). This may identify the location of a ring-ditch suggesting the former presence of a Bronze Age burial mound or a ring-gully more indicative of a former circular building. Further to the west, the same survey suggests the presence of the remains of enclosures - these features could also be contemporary with the standing stone.

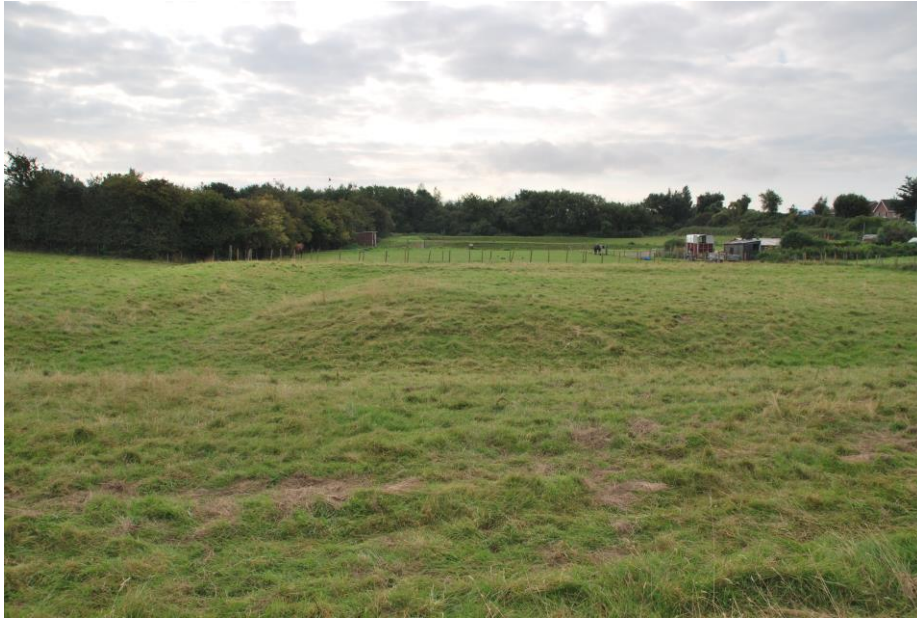
- 4.1.19** Another Scheduled Monument within the Defined Study Area is a moated site located just to the east of Undy (Figure 2f, SM001). A number of similar sites are recorded within the Gwent Levels and are possibly indicative of individual farmsteads that were subsequently abandoned. This example is well preserved despite recent residential development on adjoining land.

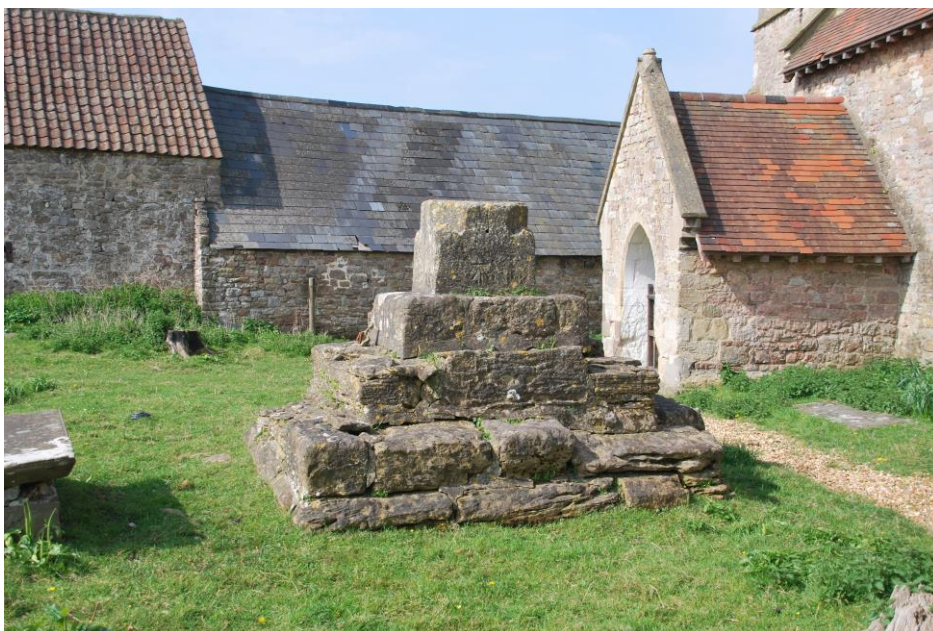
- 4.1.20** The third Scheduled Monument within the Defined Study Area is a medieval stone cross within the churchyard of the Church of St Michael and All Angels at Llanfihangel (Figure 2f, SM003). The cross has three very weathered steps with the base of the shaft above and the monument reaches a total height of 1.3 metres. It is located on the south side of the church, not far from the door and is also a Grade II listed building (LB011).

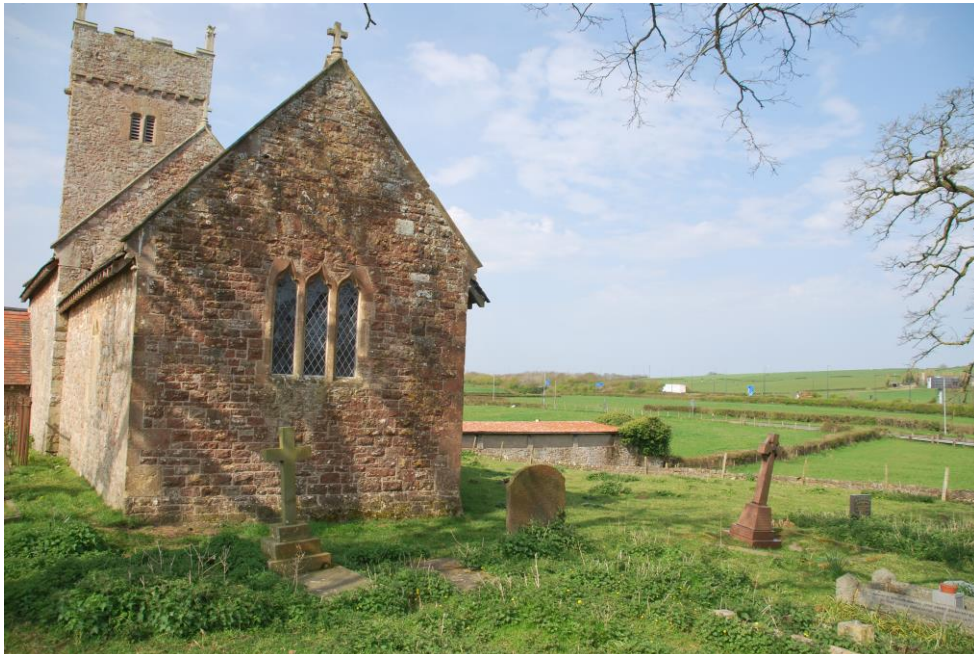
Church of St Michael and All Angels, Llanfihangel (LB002)

- 5.3.1** This church is situated between Green Farm and Old Court Farm, south of the B4245 Caldicot Road. This is a medieval church of mostly 13th century date (although a church here is mentioned in Domesday). The chancel was extended in the 14th century and the church was heavily restored in 1904. There is a tower of reasonable height at the west and a possible Norman arch around the main south door.

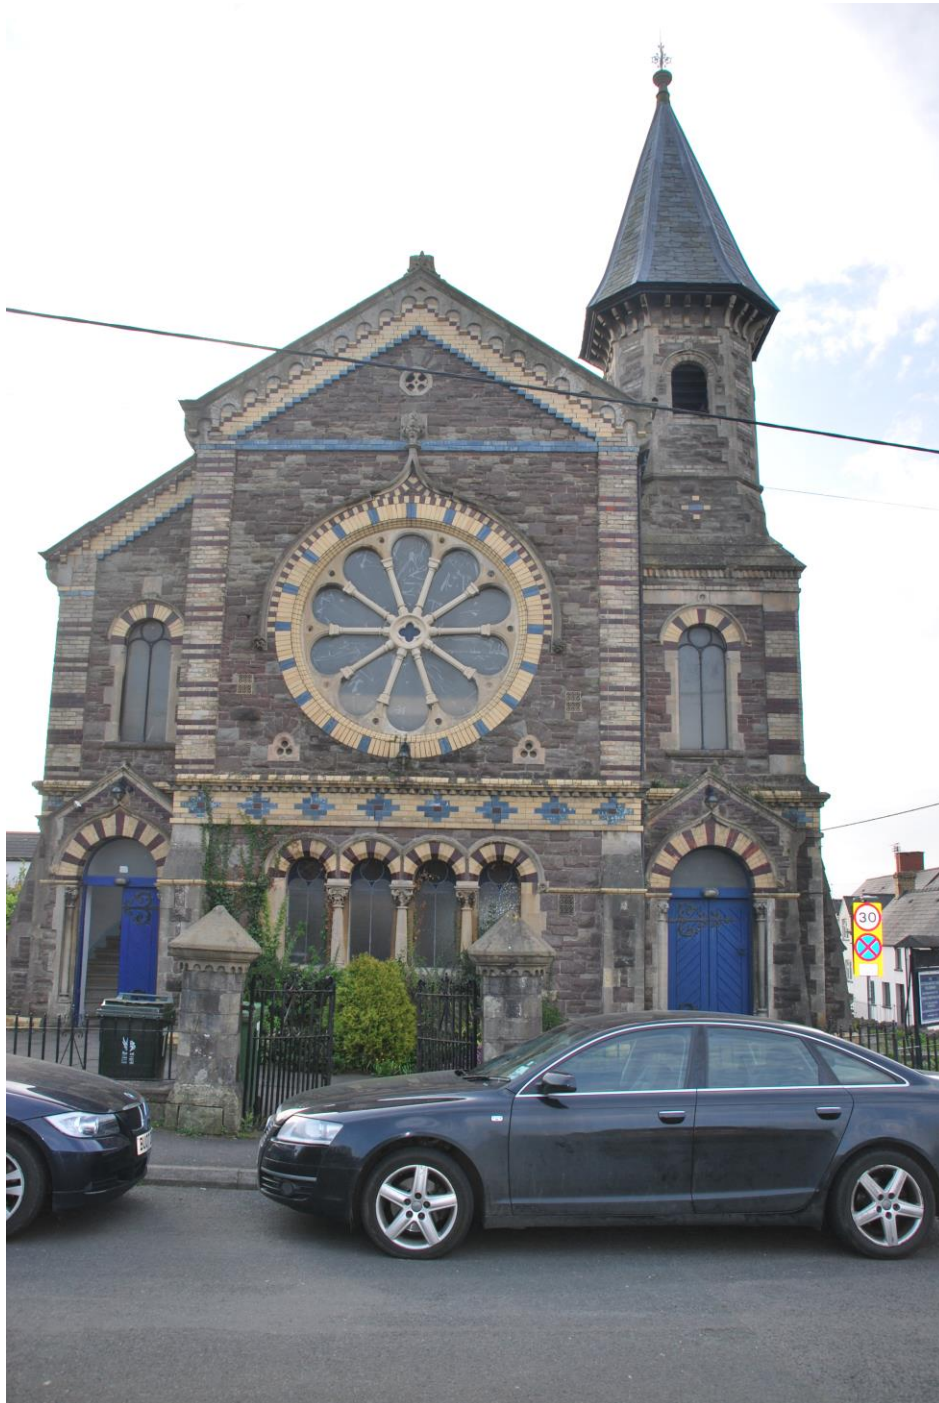
Castleton Baptist Church (LB003)

- 5.4.1** This is situated on the corner of the A48 and Marshfield Road. It was built in 1859 to the design of RG Thomas and is an early example of the Italianate-style façade chapel that later became popular in parts of south Wales. The chapel is built in limestone and red sandstone and has a bell-tower and spire.

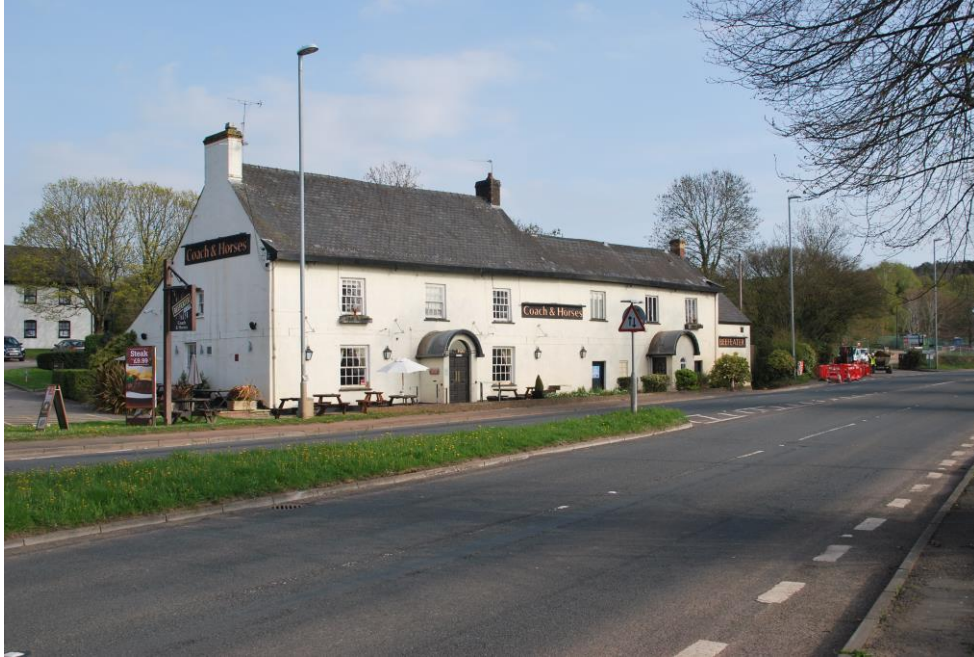
Coach & Horses Public House, Castleton (LB004)

- 5.4.2** Located on the north side of the A48, this is a roadside coaching inn of 18th century date with modern alterations. It has two storeys with rendered elevations and a steeply pitched slated roof. The gable end chimneys have been rebuilt in brick. A lower two storey extension on the east side is probably of 19th century date.

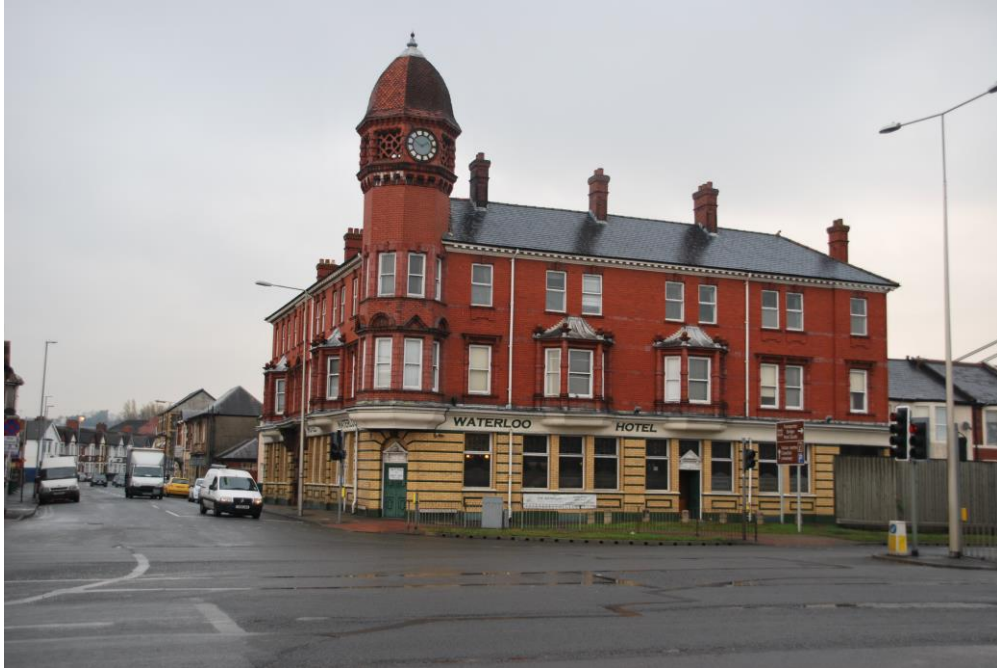
Waterloo Hotel Public House, Pillgwenlly, Newport (LB005)

- 5.4.3** This substantial public house is situated on the corner of Alexandra Road and Watch House Parade. It opened in 1904 and replaced an earlier public house on the same site. A fine contemporary interior has survived including a long L-shaped faience bar and etched glass screens between booths. It is three storeys in red brick elevations with terracotta detailing. At the corner is a tall hexagonal clock tower with an ogee roof covered in fish-scale clay tiles.

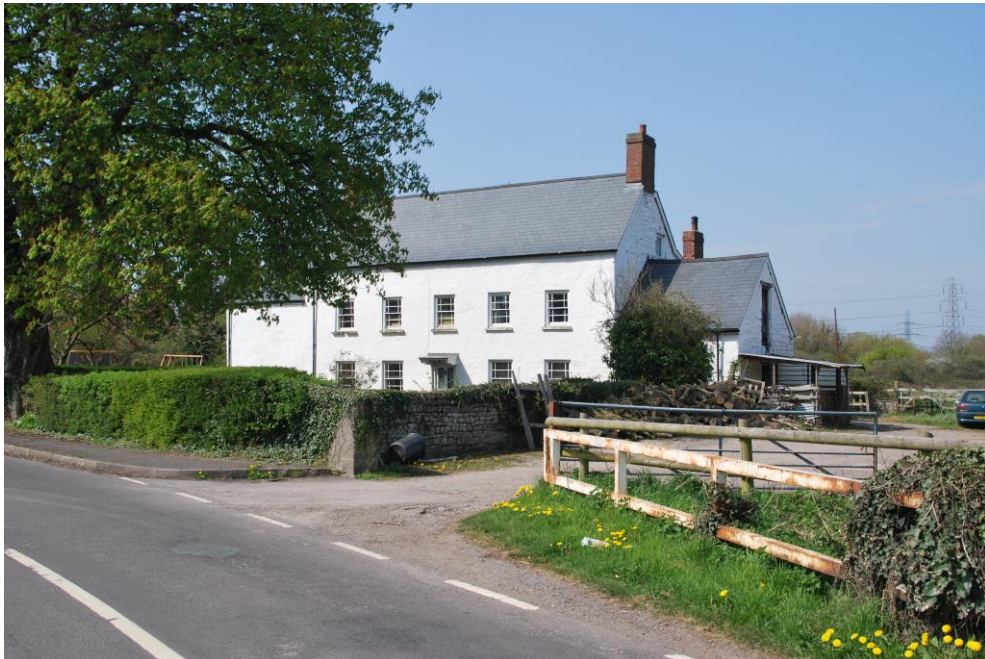
Pye Corner Farm, Nash (LB006)

This farmhouse may well have been initially constructed in the 17th century although it was substantially rebuilt in the late 18th or early 19th century and was modernised in the later 19th century. It is stone-built in two storeys with render and has a slate roof and brick end chimneys. It has recently been restored following a period of deterioration.

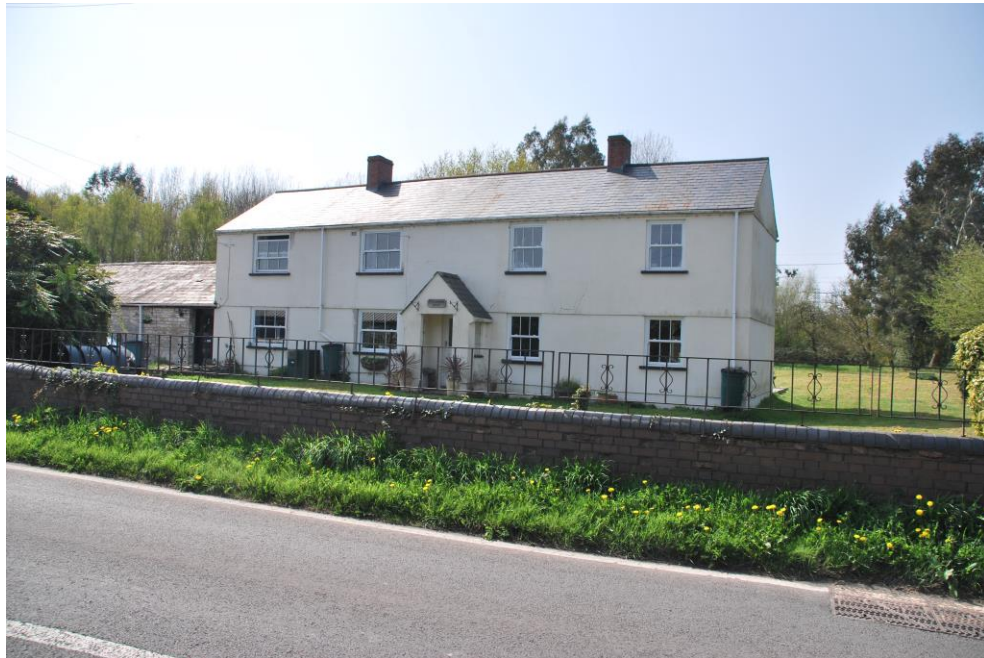
Fair Orchard, Nash (LB007)

This is located approximately 400 metres south of Pye Corner and is a former farmhouse of early 19th century date. In two storeys with a hipped slate roof and cement-rendered walls this has partially been listed due to its group value with the adjacent barn.

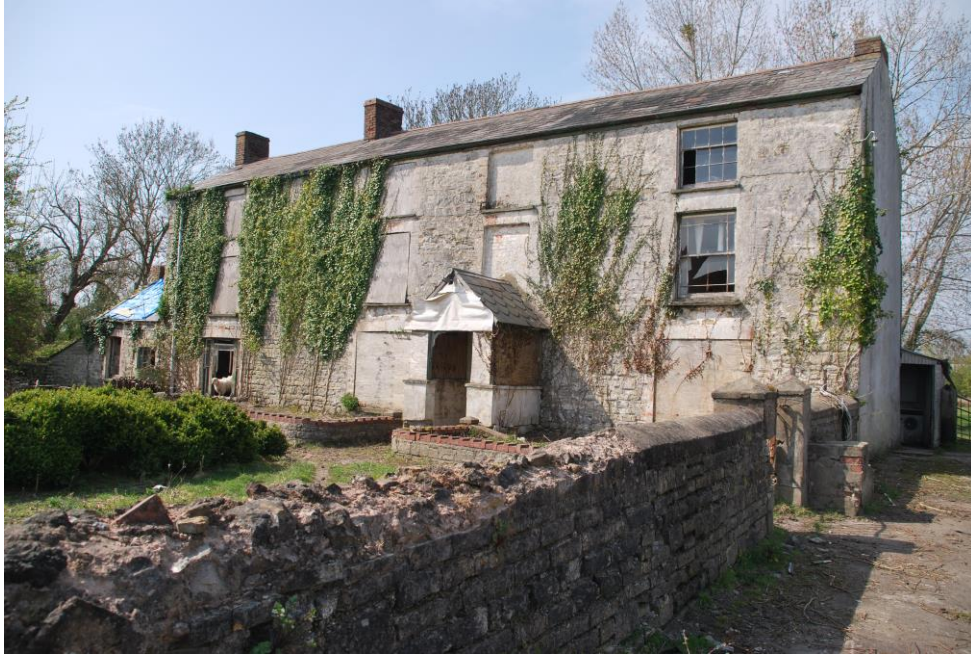
Approximately 1 km north east of Pye Corner this is a three storey asymmetrical farmhouse of early 19th century appearance but potentially with earlier origins. It is rubble-built with a slate roof and three red-brick chimneys. Currently uninhabited, this farmhouse is in a poor state of repair.

LB009	Tatton Farm	LB II	Three storey asymmetrical farmhouse of early 19th century appearance but potentially with earlier origins. It is rubble-built with a slate roof and three red-brick chimneys. Currently uninhabited this farmhouse is in a poor state of repair.	17543	Cadw	19th century	335214 185796
LB010	The Vicarage	LB II	Vicarage built 1861 to designs of John Norton. Tudor/Jacobean Revival style. Two storeys, of rock-faced stone with ashlar dressings. Steep gabled wooden porch with decorative bargeboards and cusped and pierced wooden tracery.	16068	Cadw	19th century	342042 187635
LB011	Great House Farmhouse including attached range of farm buildings	LB II	Probably originally late 17th century farmhouse of single depths extended, refurbished, refenestrated and with roof pitch altered early 19th century. Appears on OS map of 1830 as Undy Farm. Two storeys, rubble fronted with red-brick dressings. Of the primary building two rooms are retained with central hall and enclosed staircase.	16070	Cadw	Post-medieval	344343 187271

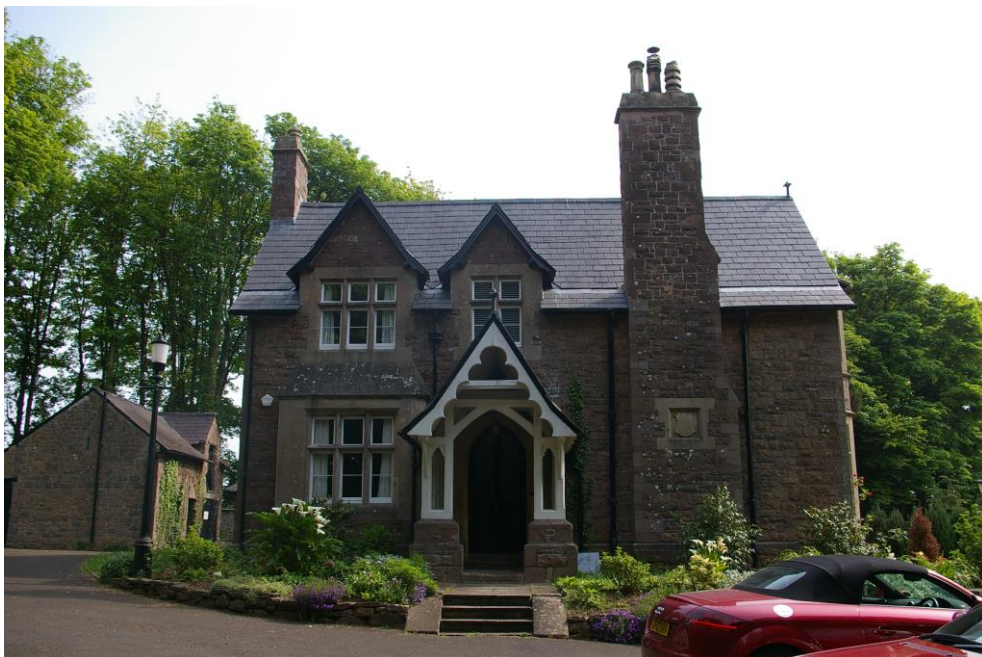
The Vicarage, Magor (LB010)

This vicarage is located on the western side of Magor, north of the B4245 Newport Road. It was built in 1861 to the designs of John Norton, an architect involved in the restoration of the Church of St Mary in Magor. The vicarage is in Tudor/Jacobean Revival style and has two storeys in rock-faced stone with ashlar dressings. There is a large external stack on the west elevation and a steeply gabled wooden porch with decorative bargeboards. The interior retains much of the original Tudor Revival material including the stone fireplaces and decoratively moulded panelled doors. To the rear of the vicarage are contemporary stables and a coach house.

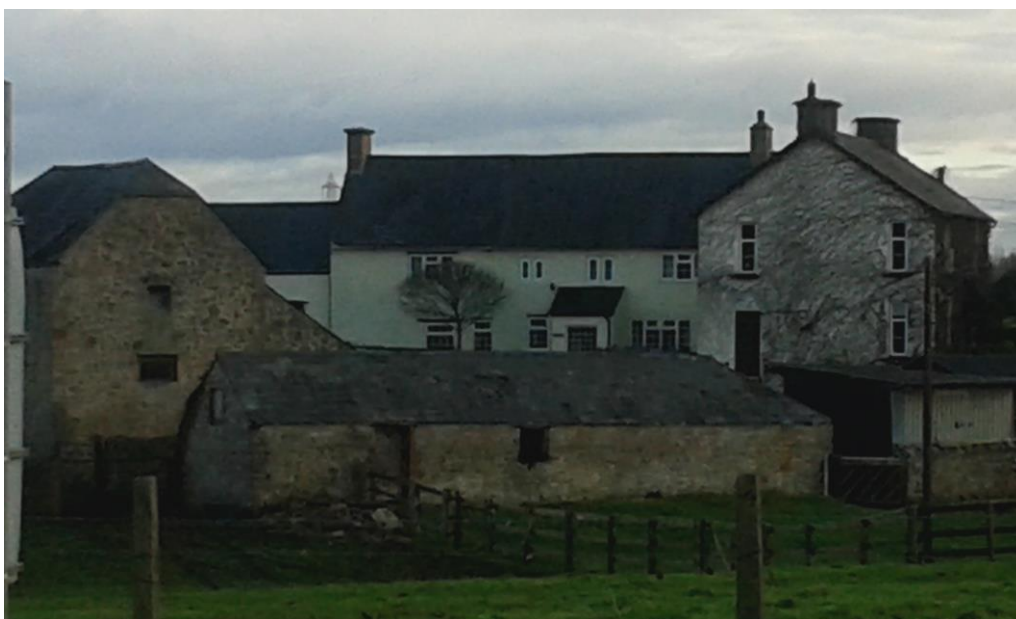
- 5.4.10** This farmhouse is located to the west of the Church of St Michael and All Angels and has a separate associated farmyard and farm buildings to the north. The house is mostly 16th century in date but the south porch and wall may be surviving elements of an earlier building, possibly a fortified house. A separate cross wing was added to the west of the farmhouse in the 19th century and a single storey former Brewhouse is adjoining to the east. The farmhouse has two storeys and is rubble-built, part whitewashed, with a slate roof.

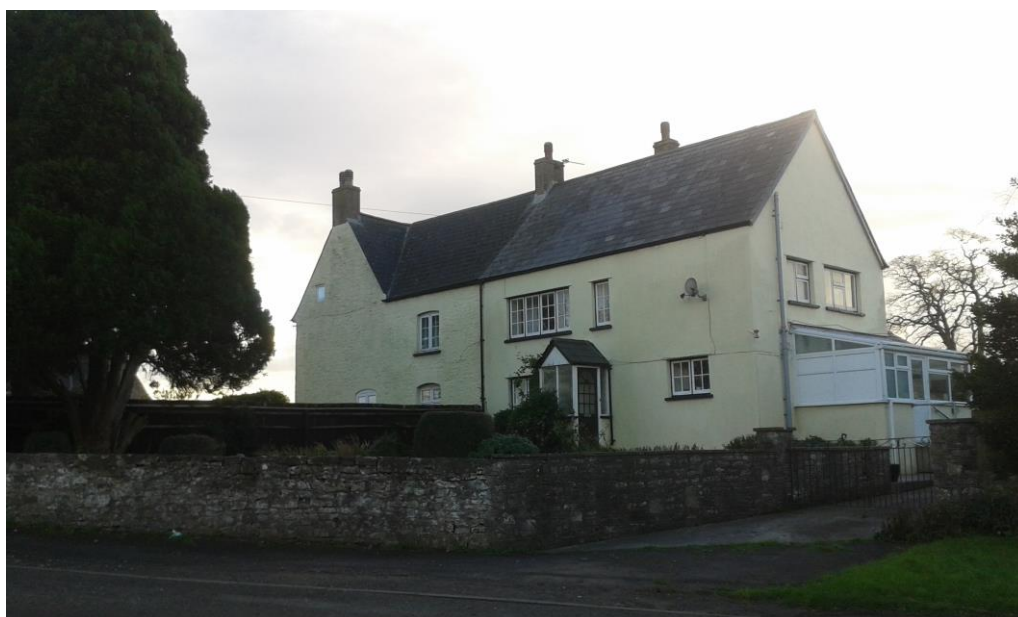
- 5.4.13** This is located to the east of the Church of St Michael and All Saints and has a separate associated farmyard and farm buildings to the south and west. The farmhouse is of 18th century date and was formerly known as New House Farm. It has two storeys and an attic and is rubble-built (now painted) with an artificial slate roof and brick end stacks. There are decorative iron railings which enclose the front garden and extend from a wall adjoining the farmhouse. Listed in part for group value with the complex of buildings here and at Old Court Farm.

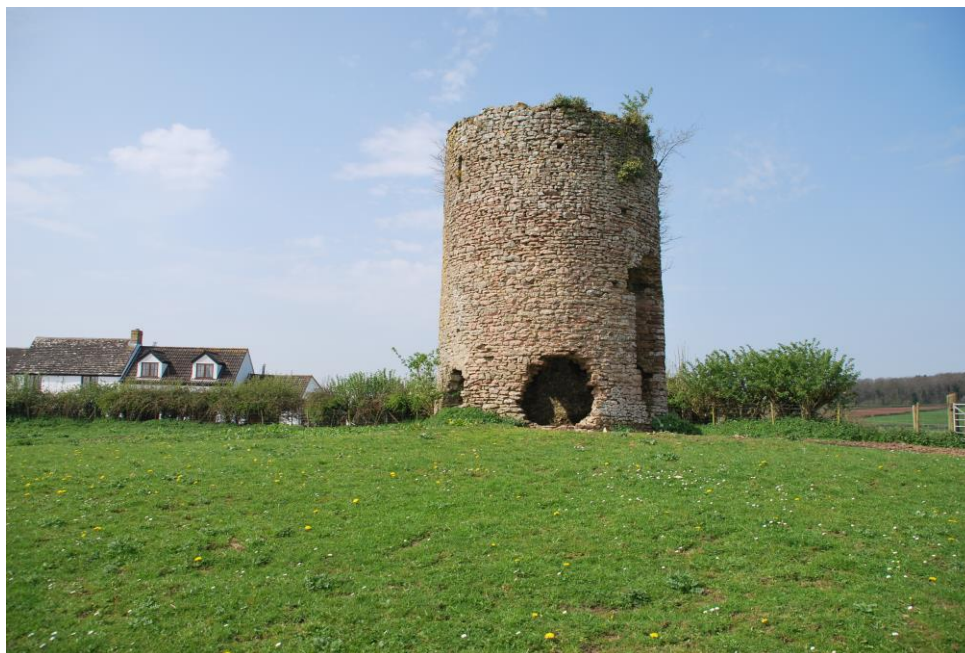
- 5.4.16** This is situated on higher ground to the north of the village, immediately north of the M48 motorway. The windmill tower was probably built around AD 1500 and is referenced in a lease dated 1526. There is no evidence as to when it went out of use although it may have operated as a watch-tower in the 18th century. The

earliest detailed mapping of the area dates from 1746 and shows a round building here; on the 1883 Ordnance Survey map it is shown as 'Old Mill'.

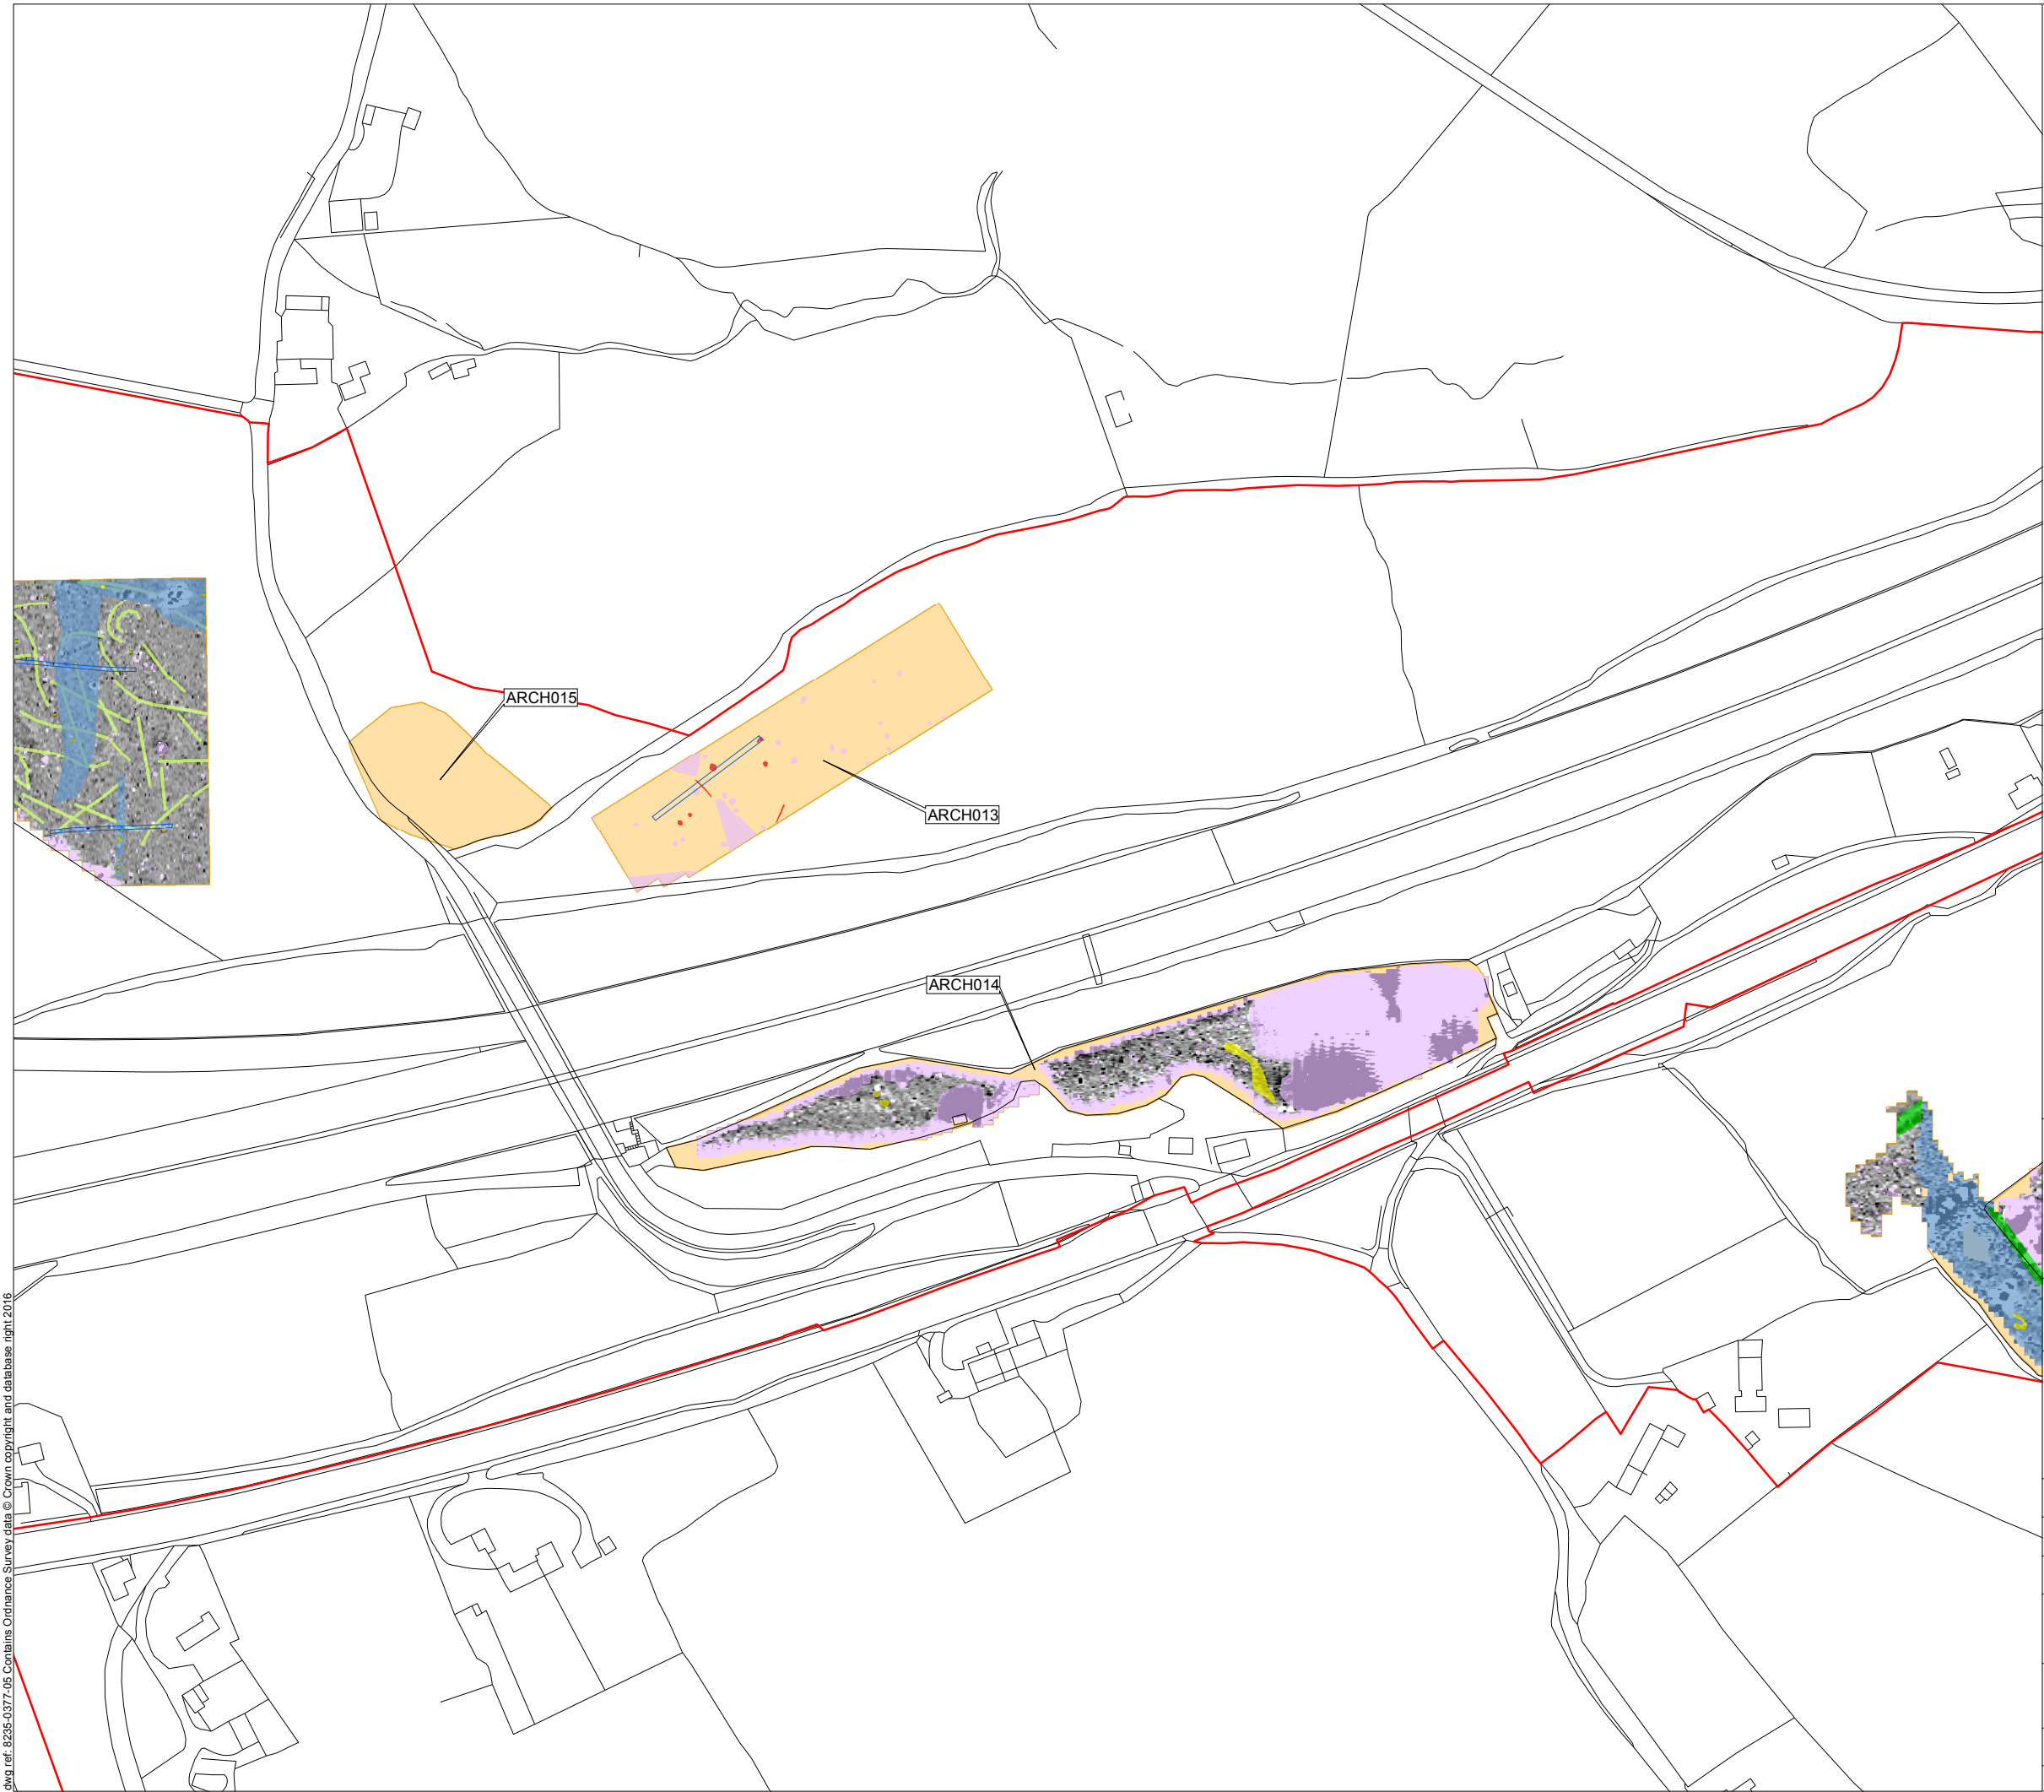
Appendix 8.2:
Cultural Heritage Desk-based Assessment
Geophysical survey and trial trenching to
the south-east of Gwaunshonbrown Farm

- 4.1.29** Earthworks of possible post-medieval date were identified just to the south of Gwaunshonbrown Farm and some features were located through geophysical survey (ARCH013, Figure 14). However, a trial trench here failed to corroborate the presence of anything of archaeological interest.
