## **Appendix C.1 – Cultural Heritage Baseline**

CAERNARFON TO			
BONTNEWYDD ROAD SCHEME			
Subject			
ABSTRACTION AND INTERPRETATION OF GRADIOMETER ANOMALIES - VIEWPORT 1-2			
VINEYARD HOUSE UPTON UPON SEVERN WR8 0SA		T: 01684 592266 E: info@stratascan.co.uk www.stratascan.co.uk	
Scale

# A487 Caernarfon to Bontnewydd Bypass

## Archaeological Evaluation - Interim Report

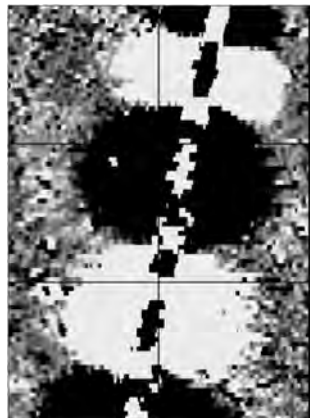
### Bipolar

A bipolar anomaly is one that is composed of both a positive response and a negative response. It can be made up of any number of positive responses and negative responses. For example a pipeline consisting of alternating positive and negative anomalies is said to be bipolar. See also dipolar which has only one area of each polarity. The interpretation of the anomaly will depend on the magnitude of the magnetic field strength. A weak response may be caused by a clay field drain while a strong response will probably be caused by a metallic service.

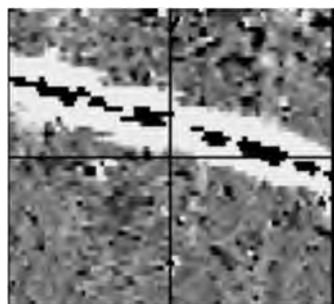
### Positive linear anomaly with associated negative response

A positive linear anomaly which has a negative anomaly located adjacently. This will be caused by a single feature. In the example shown this is likely to be a single length of wire/cable probably relating to a modern service. Magnetically weaker responses may relate to earthwork style features and field boundaries.

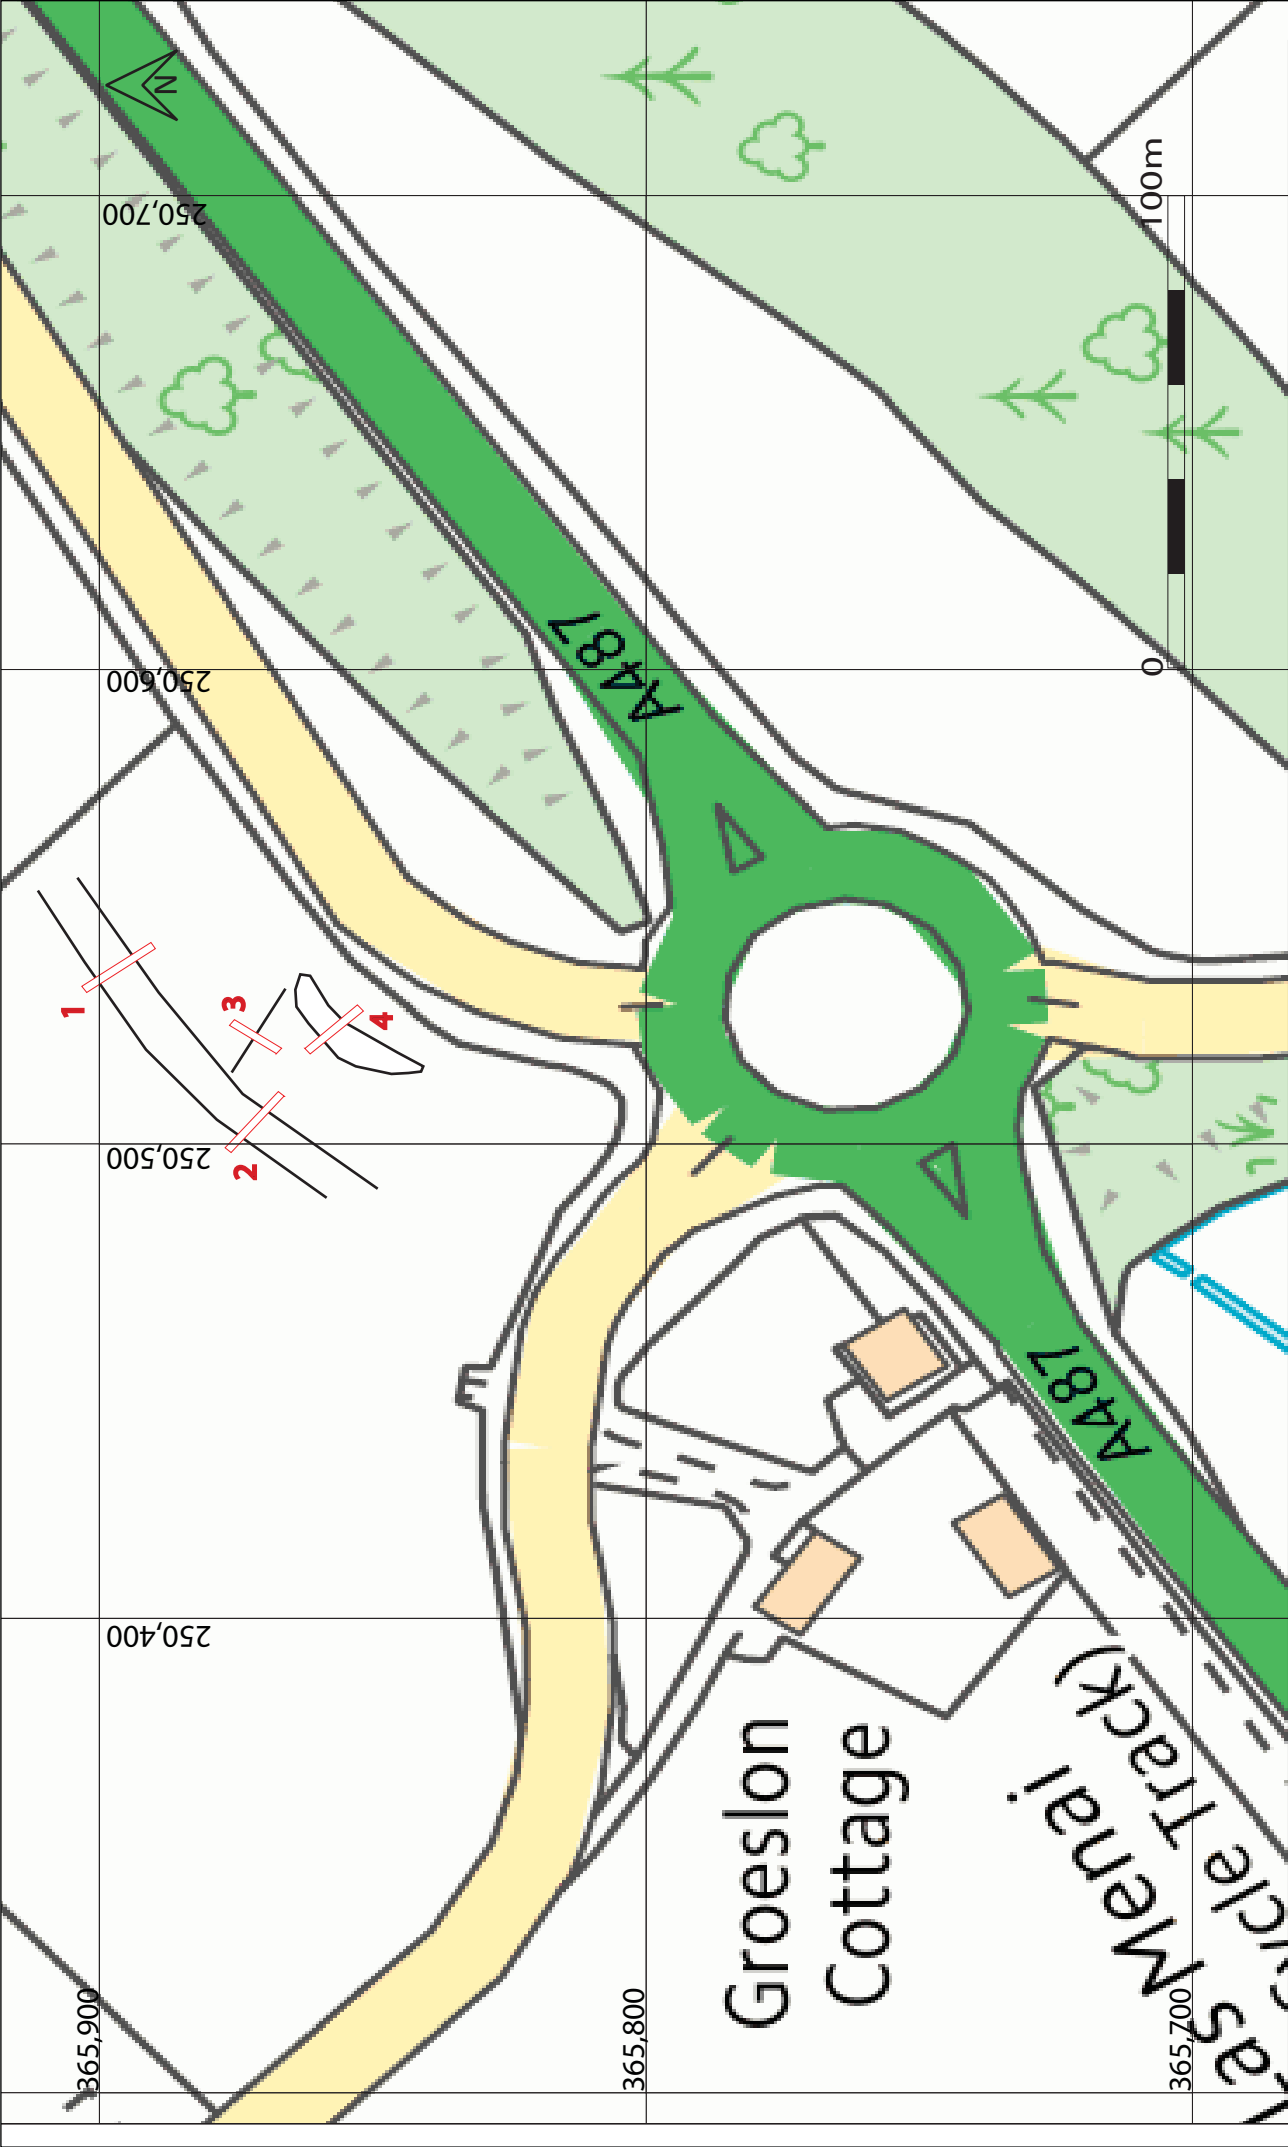
Figure 02: Location of trenches in relation to geophysical features in plot 143.

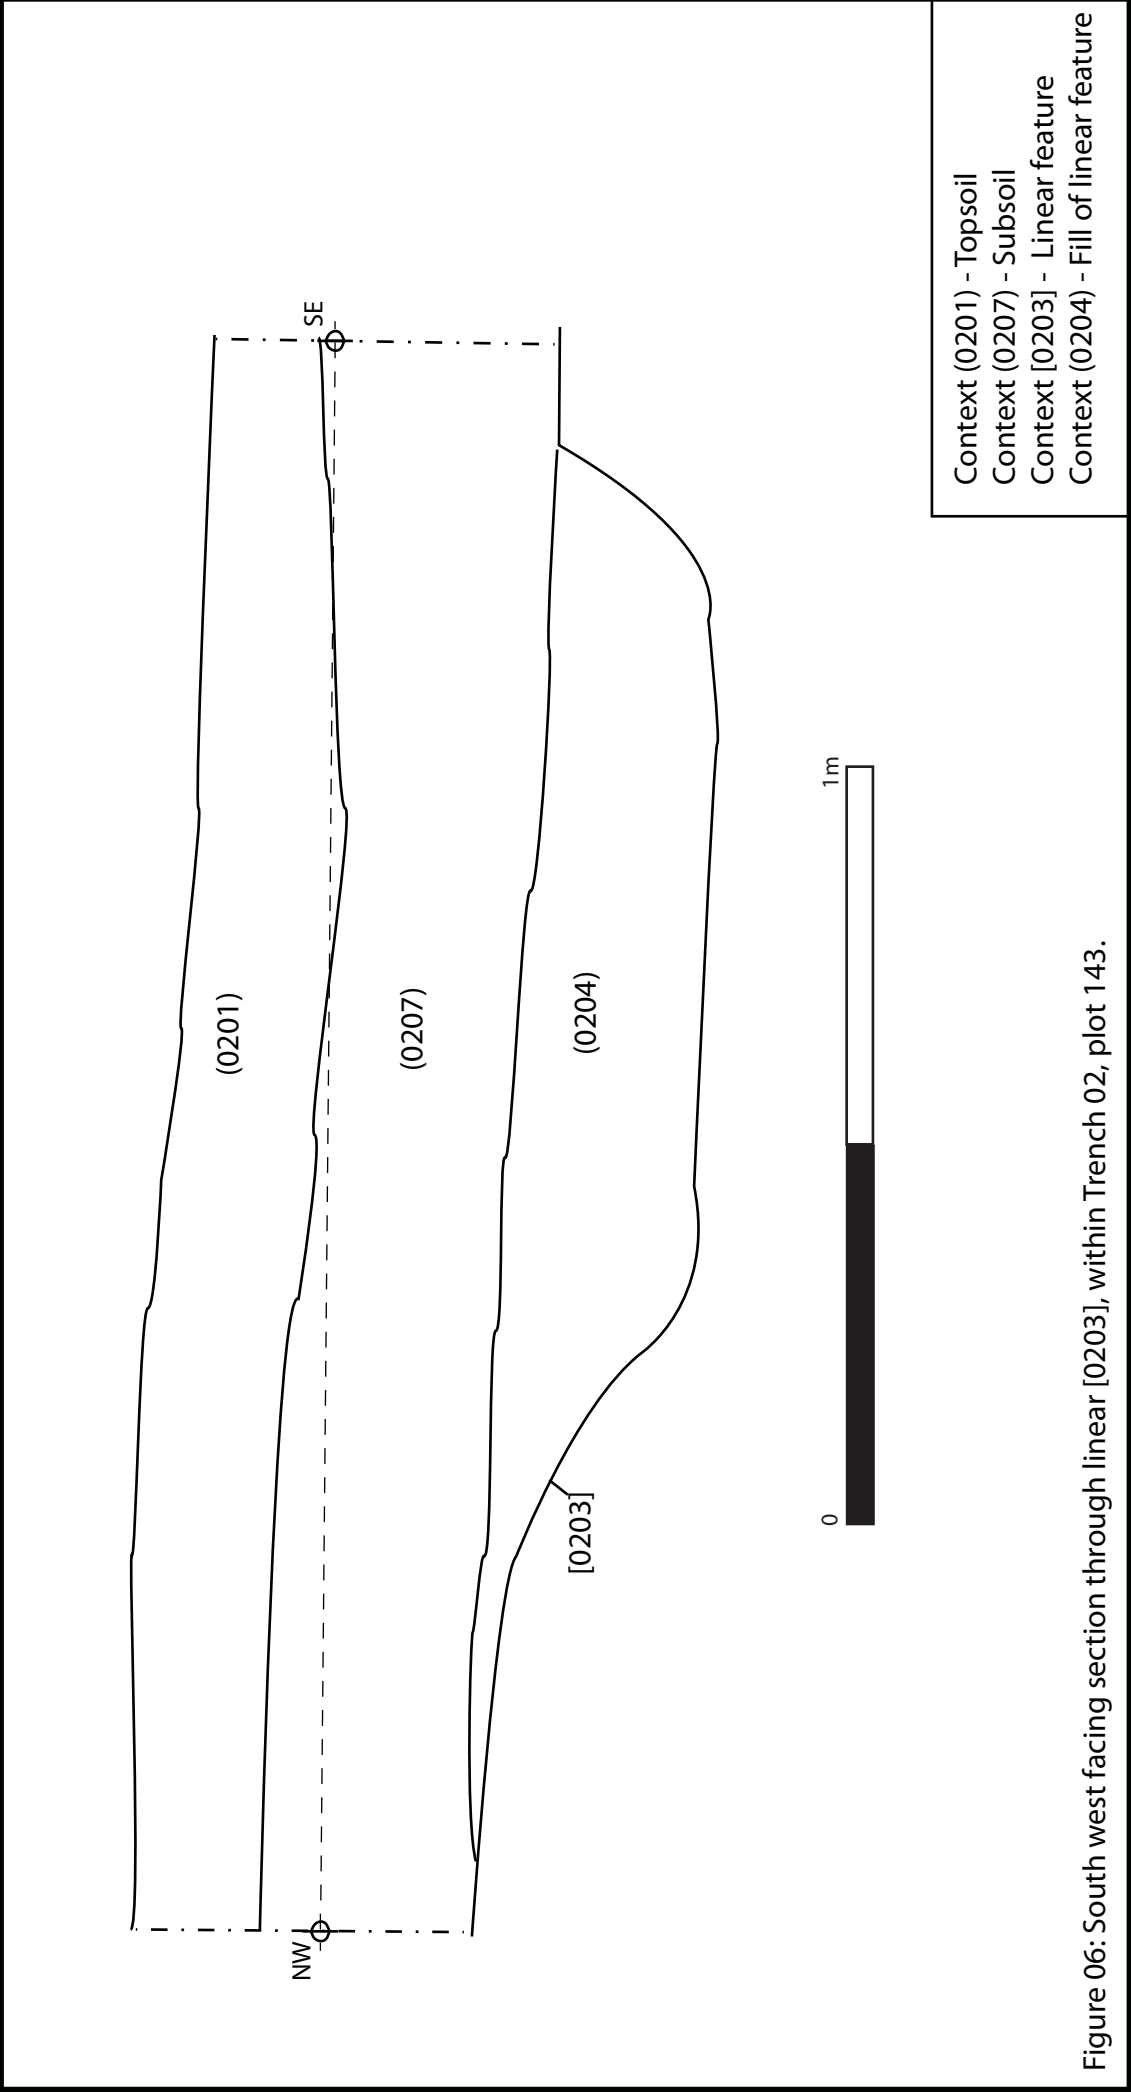
Figure 06: South west facing section through linear [0203], within Trench 02, plot 143.

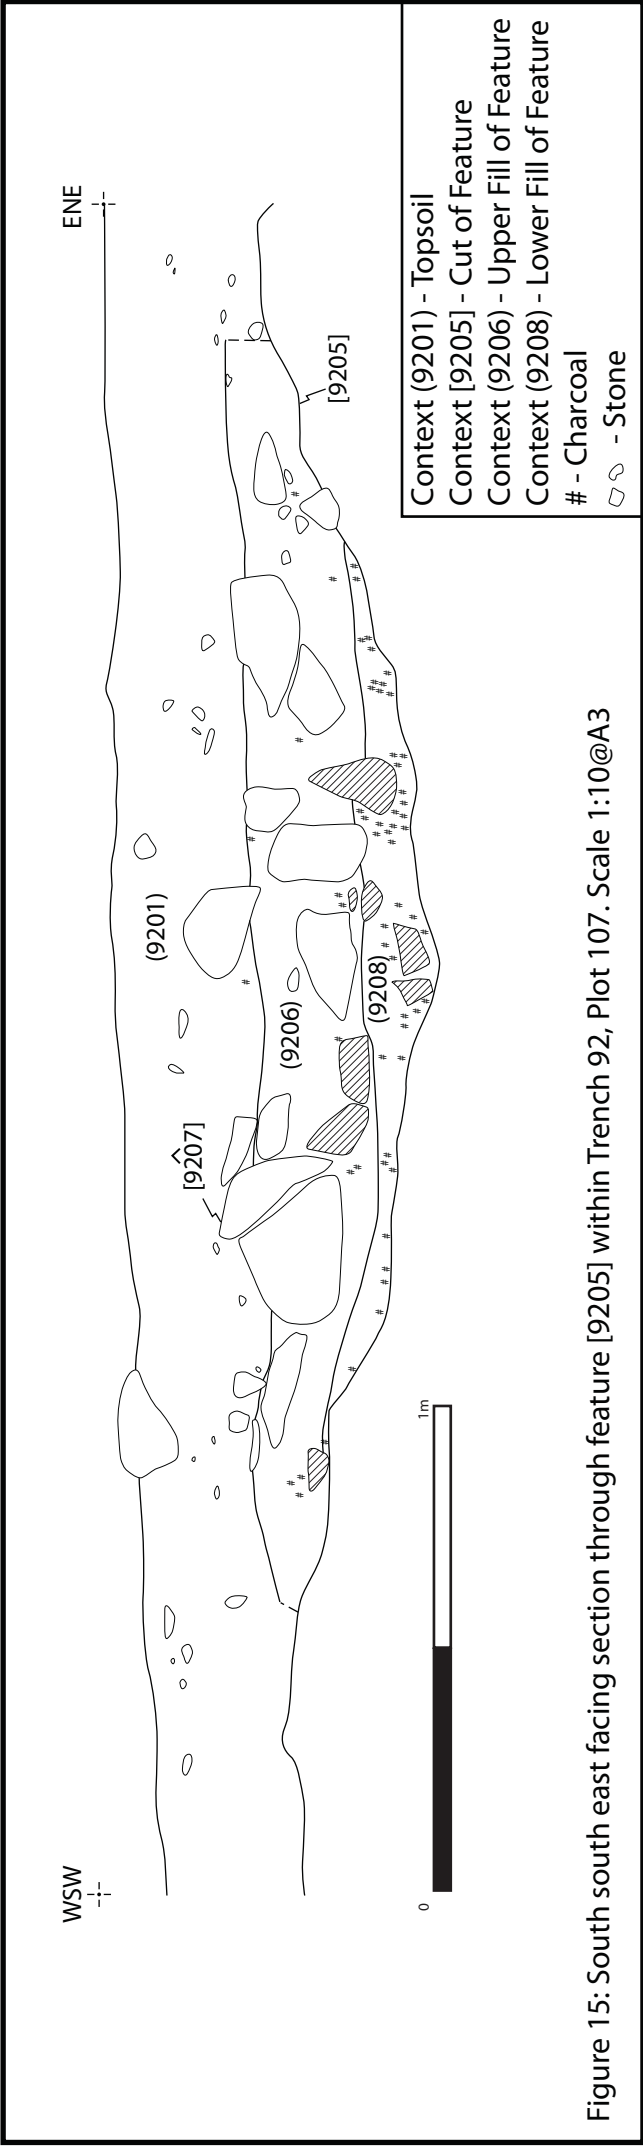
Figure 15: South south east facing section through feature [9205] within Trench 92, Plot 107. Scale 1:10@A3

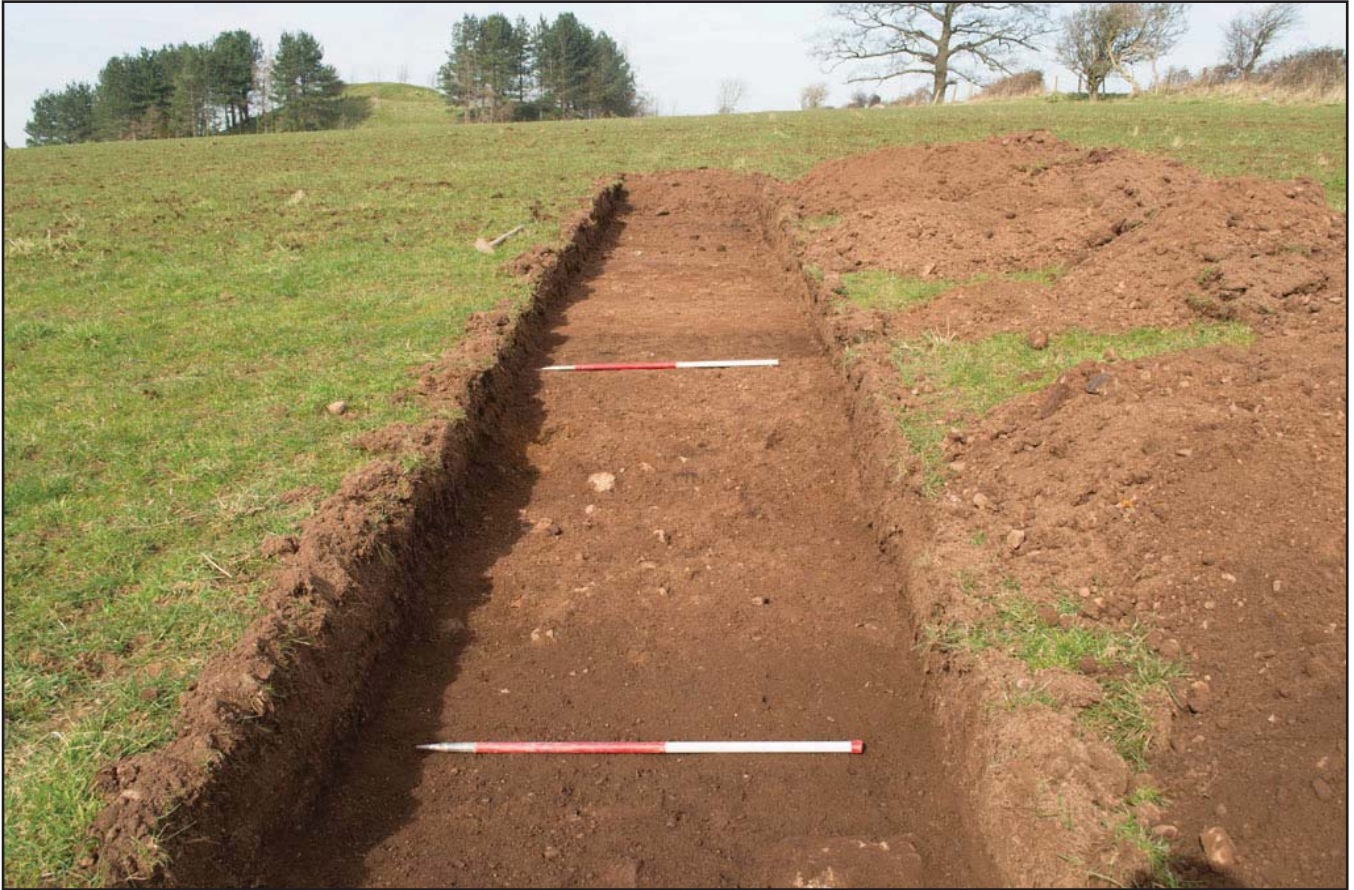
Plate 02: Pre-excavation shot of [0104] and [0106]. View from south east. 2x1m scale (archive image G2454\_104)

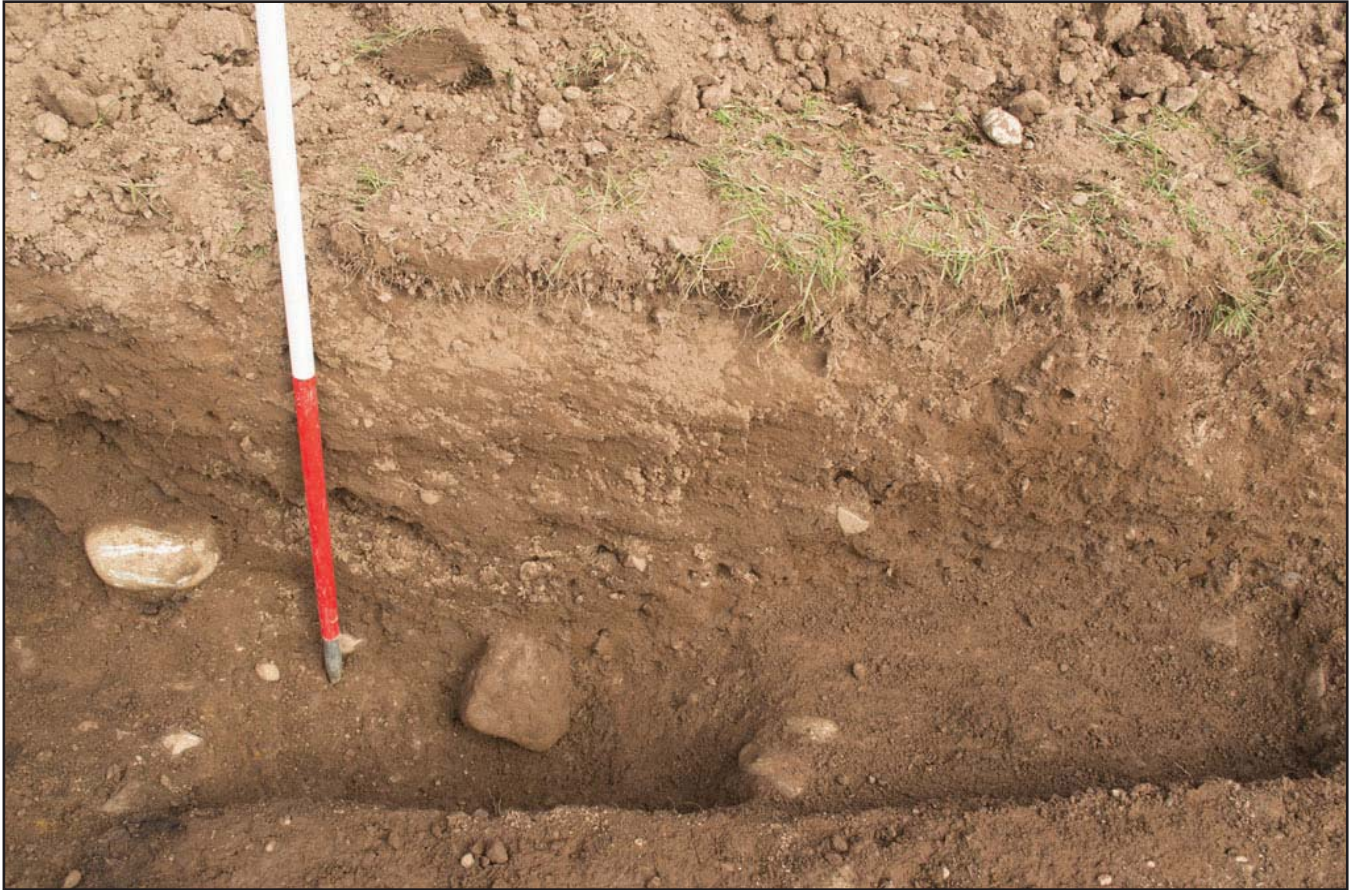
Plate 05: South west facing section linear [0108]. 1x1m scale (archive image G2454\_129)

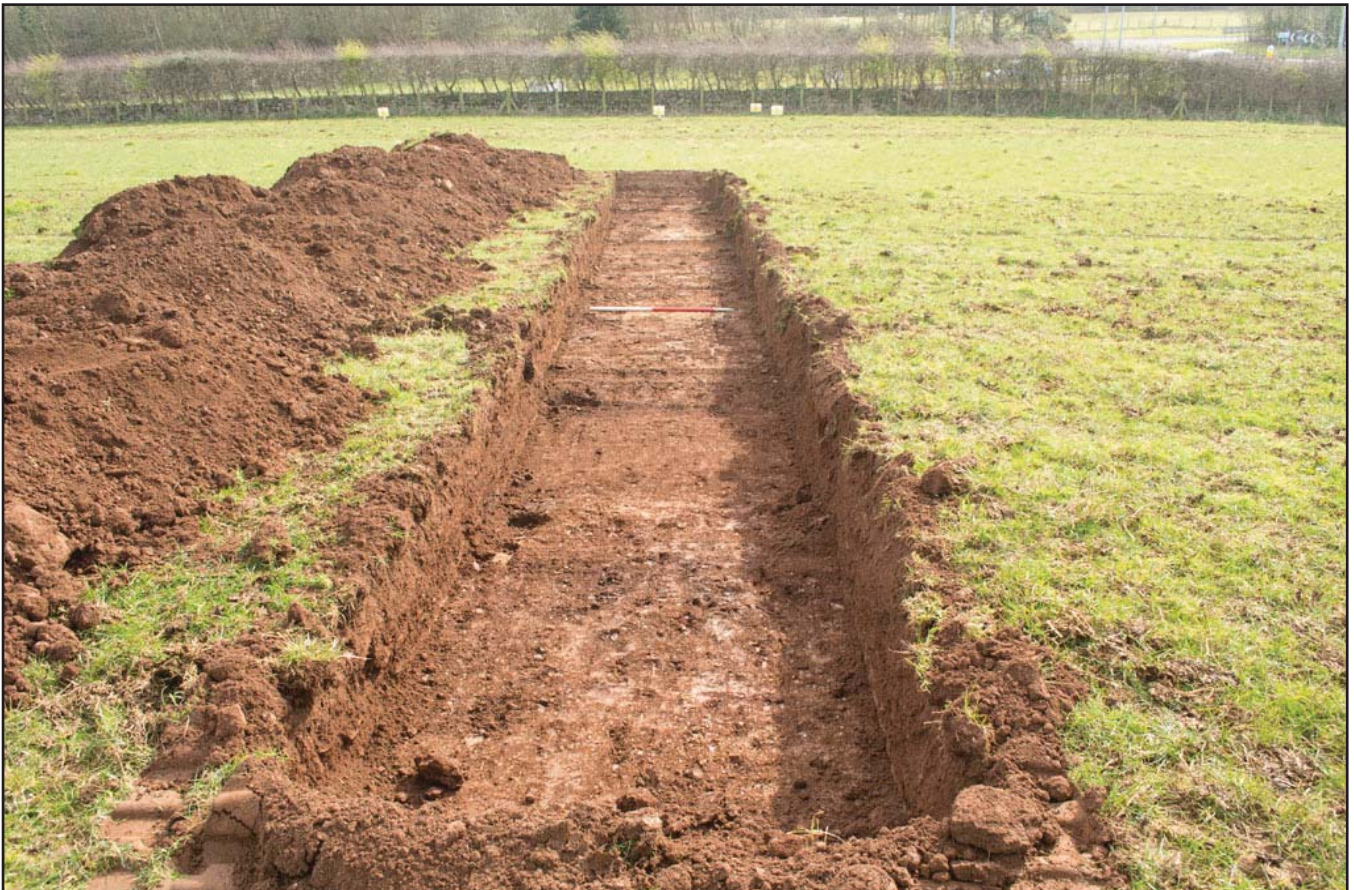
Plate 06: Pre-excavation shot of [0203] and [0205]. View from west. 1x1m scale (archive image G2454\_108)

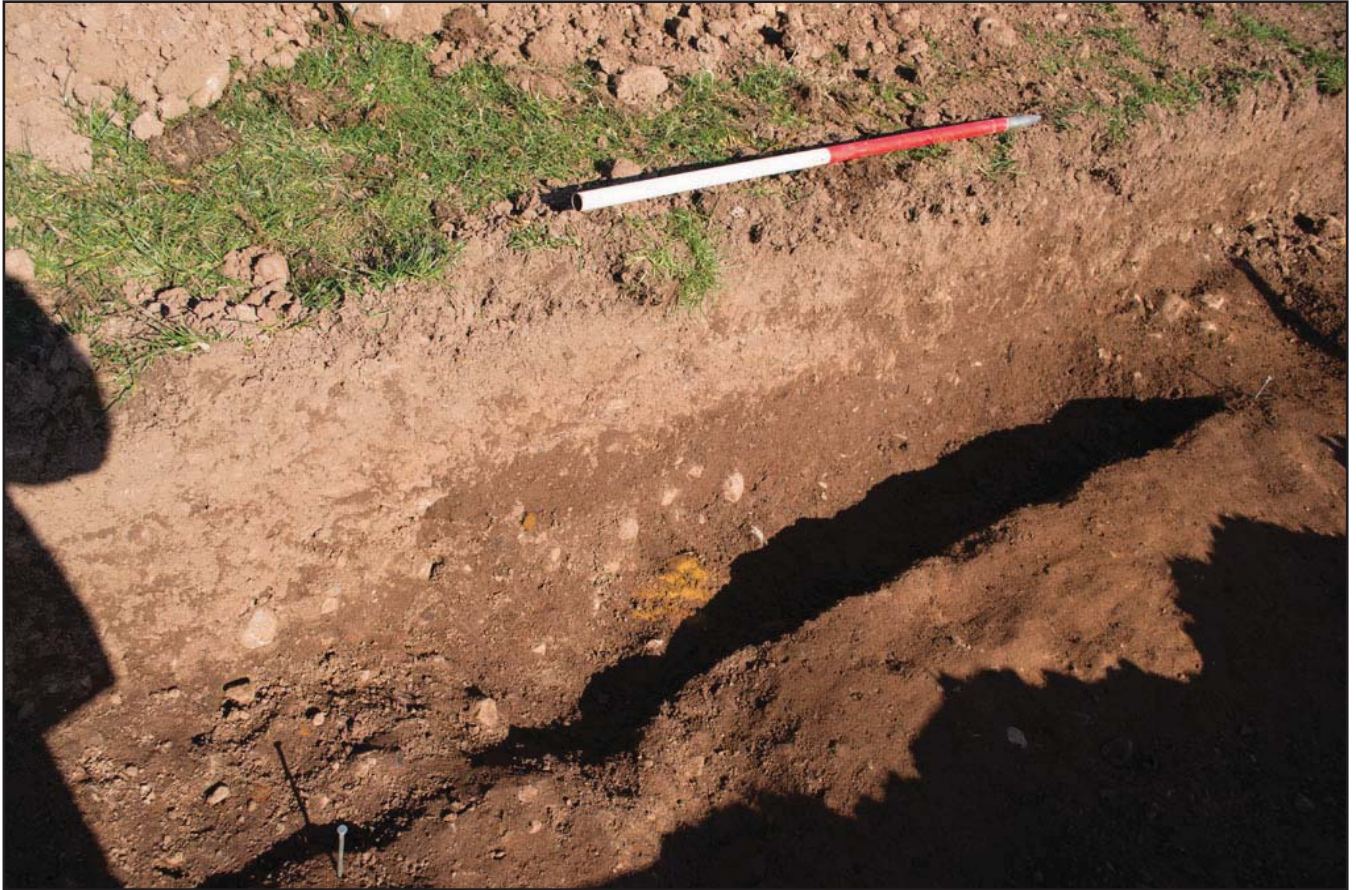
Plate 07: Post-excavation shot of [0203] - oblique. View from west. 1x1m scale (archive image G2454\_133)

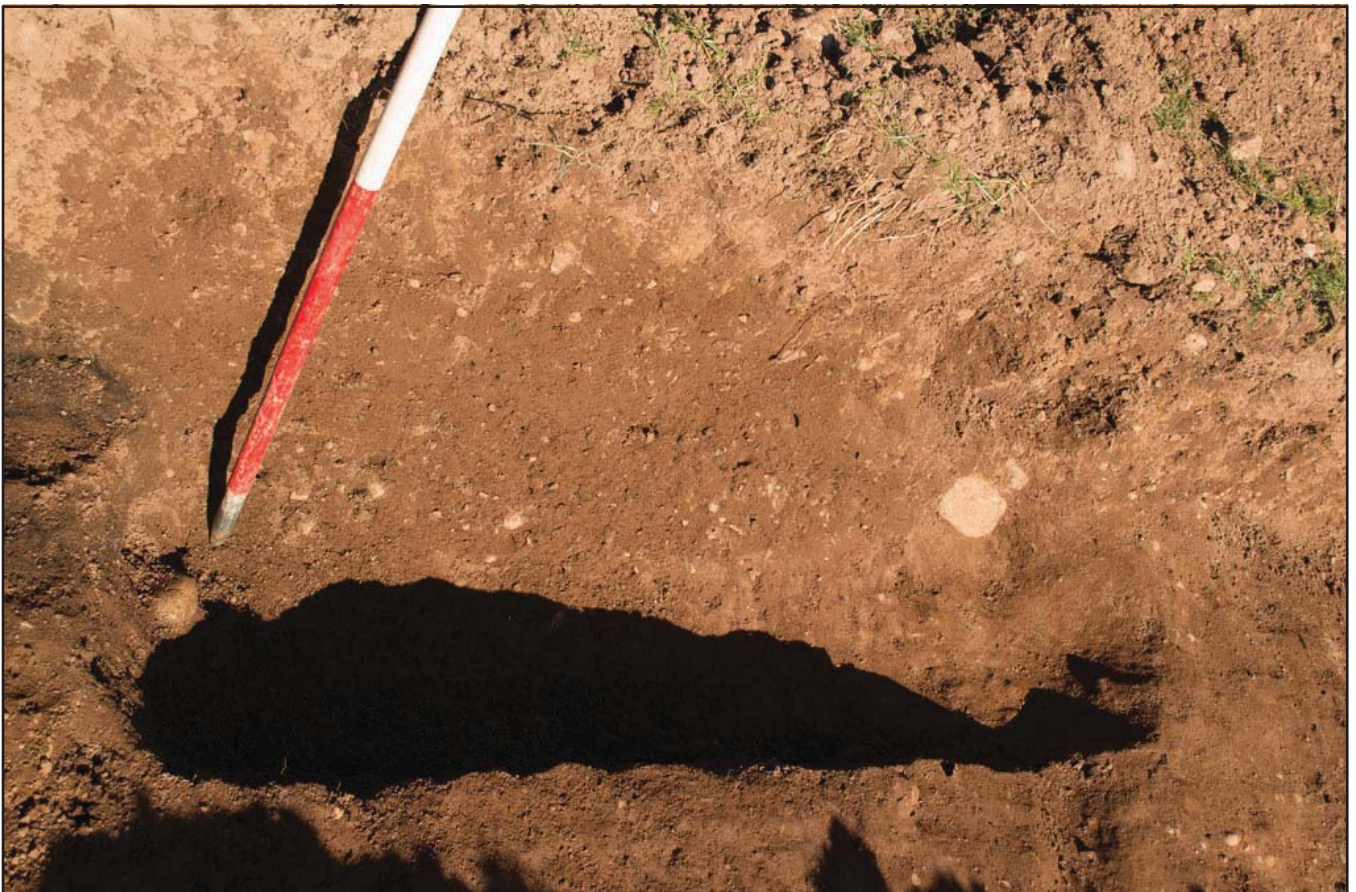
Plate 08: Post-excavation shot of [0205] - oblique. View from west. 1x1m scale (archive image G2454\_130)

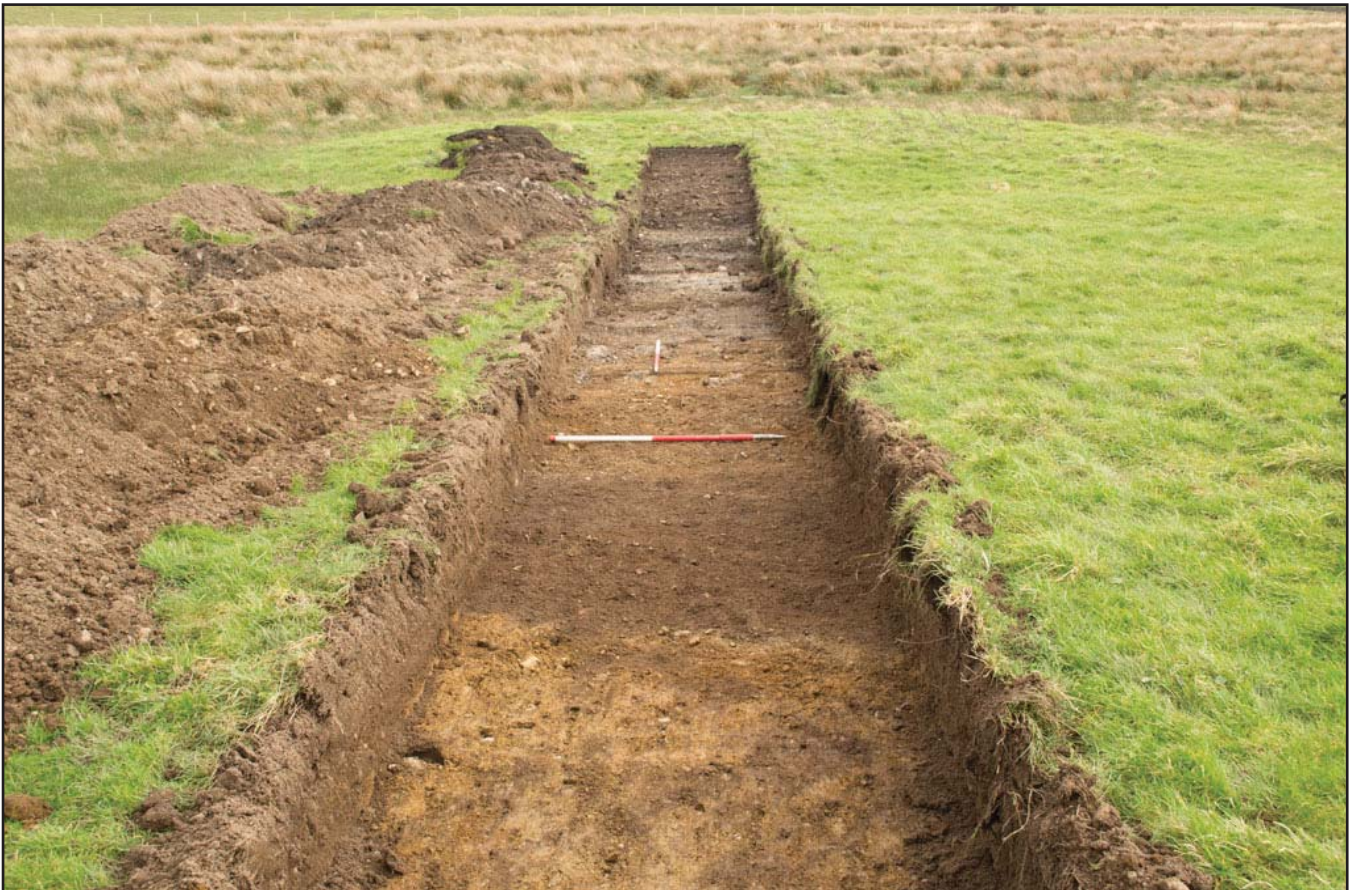
Plate 10: Post-excavation shot of Trench 18 with [1804] and burnt mound visible. 2x1m scale. View from north west (archive image G2454\_011)

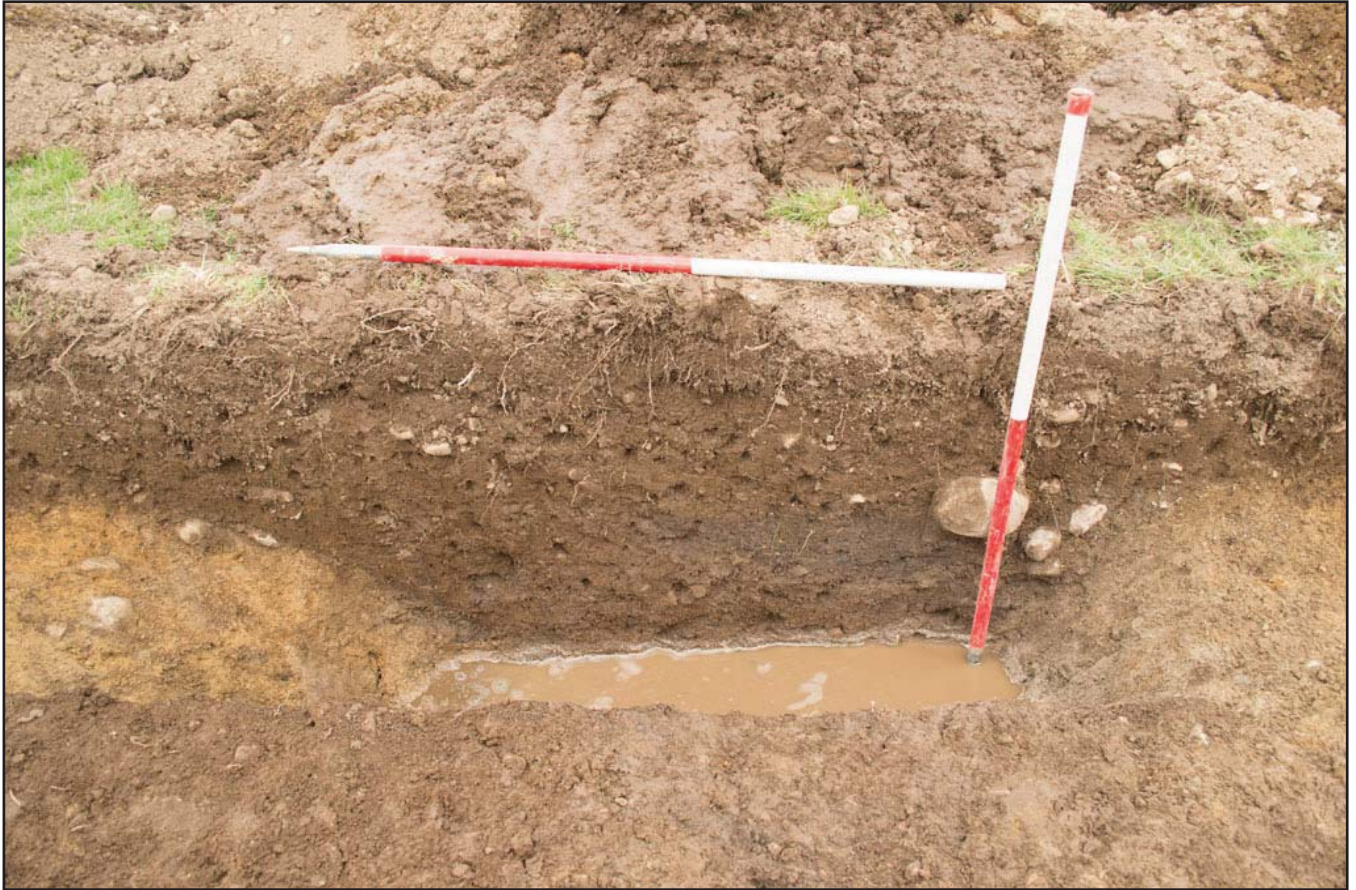
Plate 11: South east facing section through [1804]. View from south east. 2x1m scale (archive image G2454\_069)

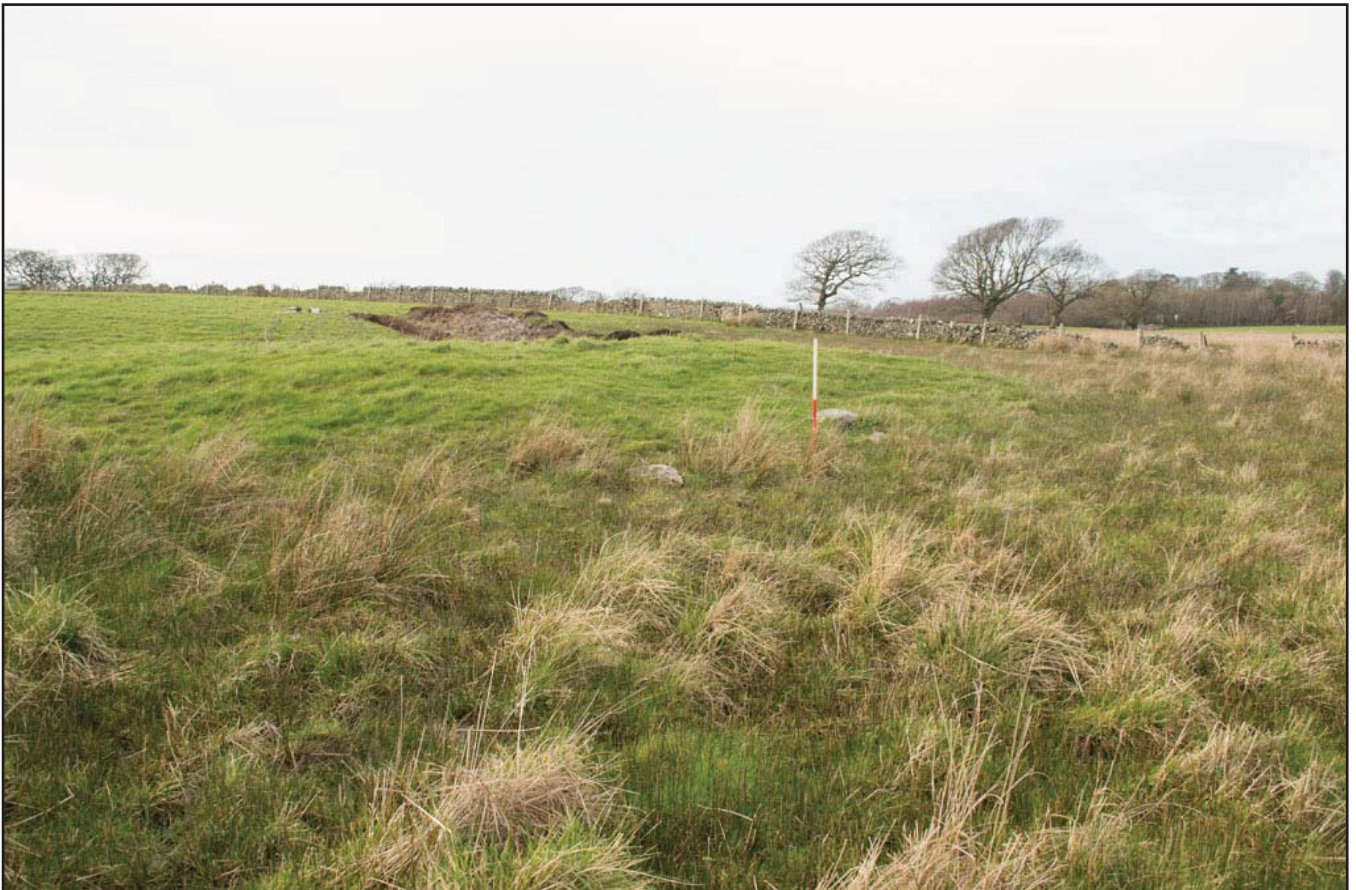
Plate 12: View of burnt mound in Plot 61. View from east. 1x1m scale (archive image G2454\_073)

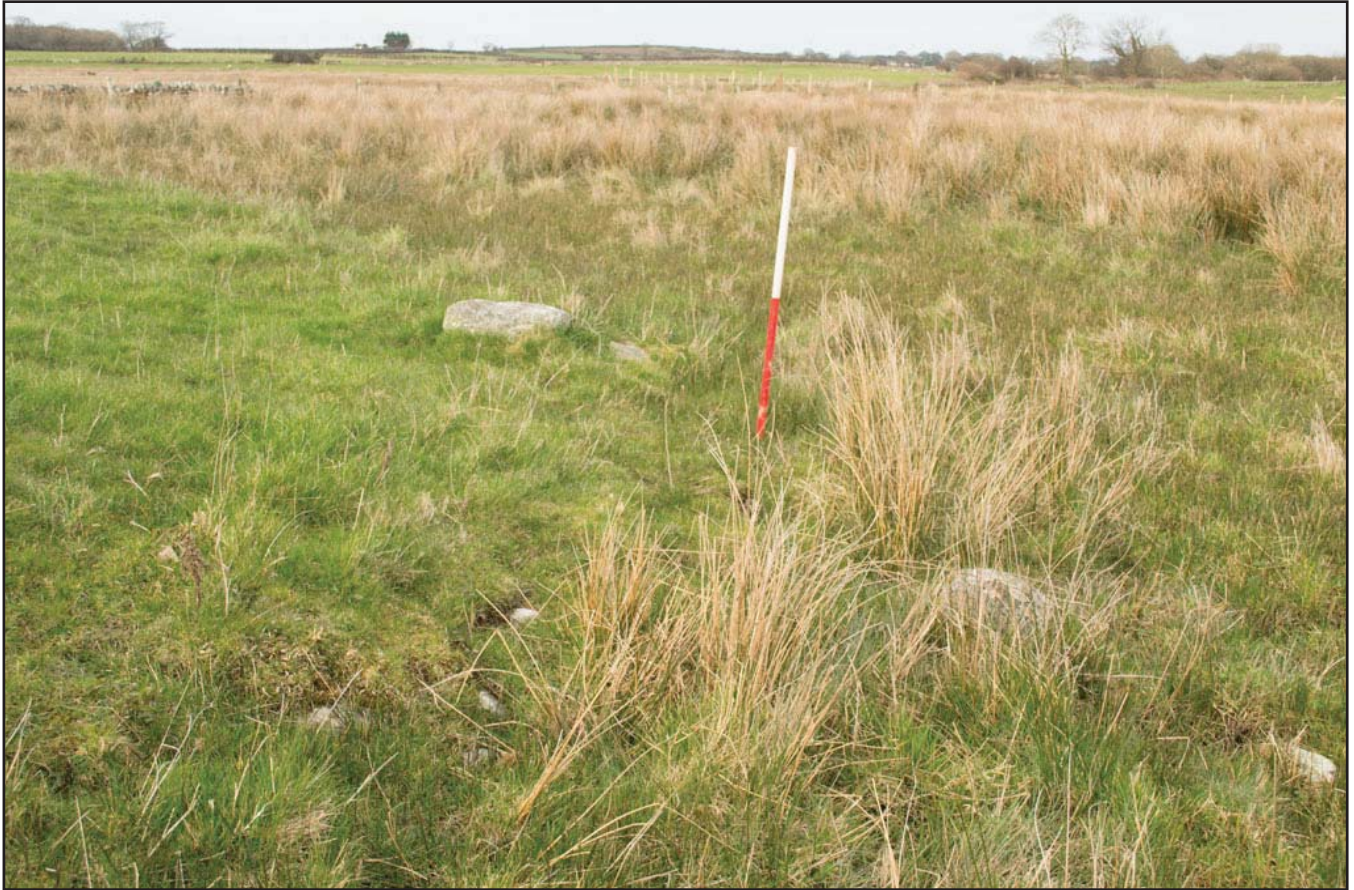
Plate 13: View of kerb stones along eastern edge of burnt mound. View from west. 1x1m scale (archive image G2454\_074)

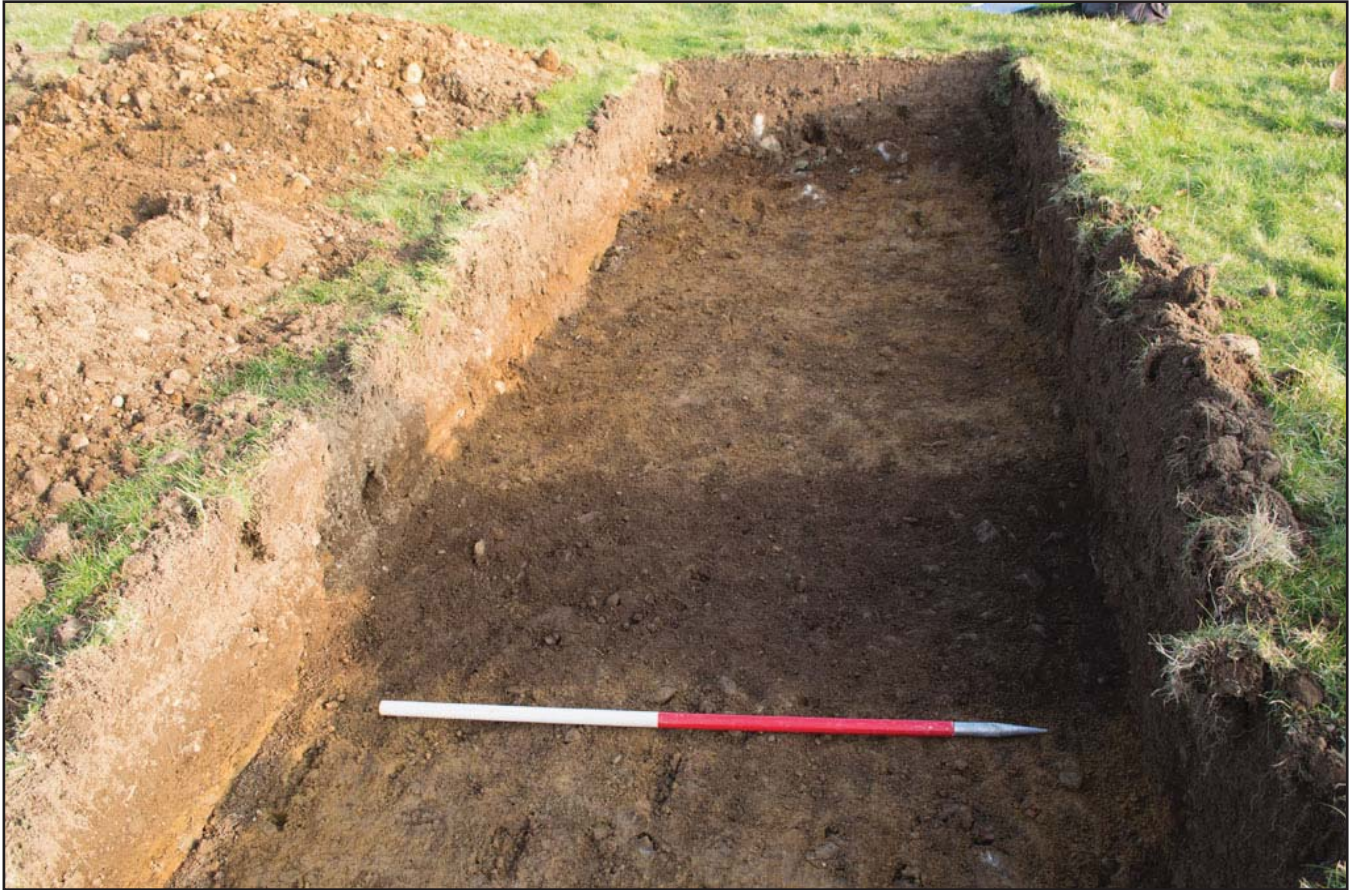
Plate 15: Pre-excavation shot of linear [9203]. View from north west. 1x1m scale (archive image G2454\_148)

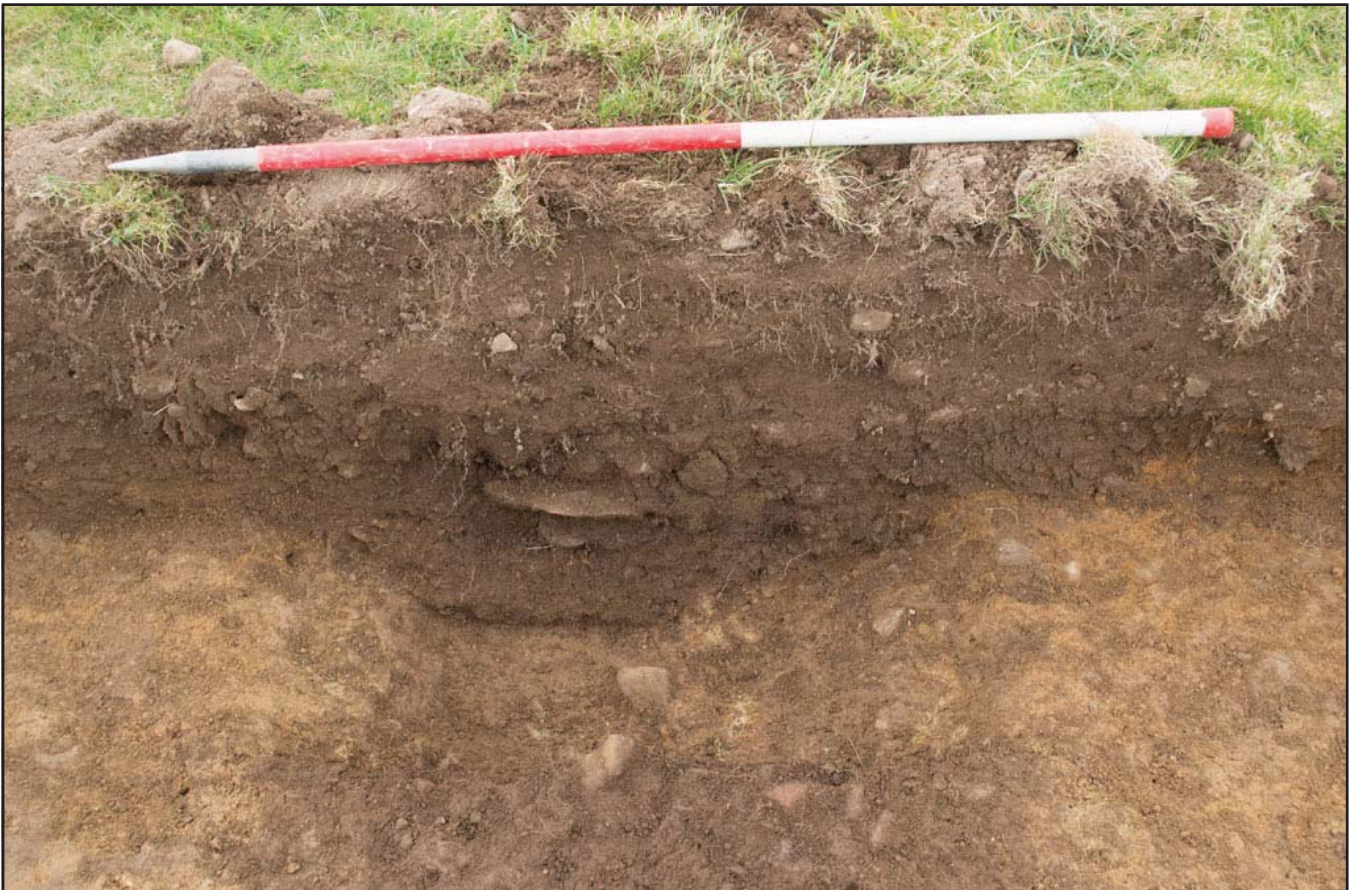
Plate 16: North east facing section through linear [9203]. 1x1m scale (archive image G2454\_161)

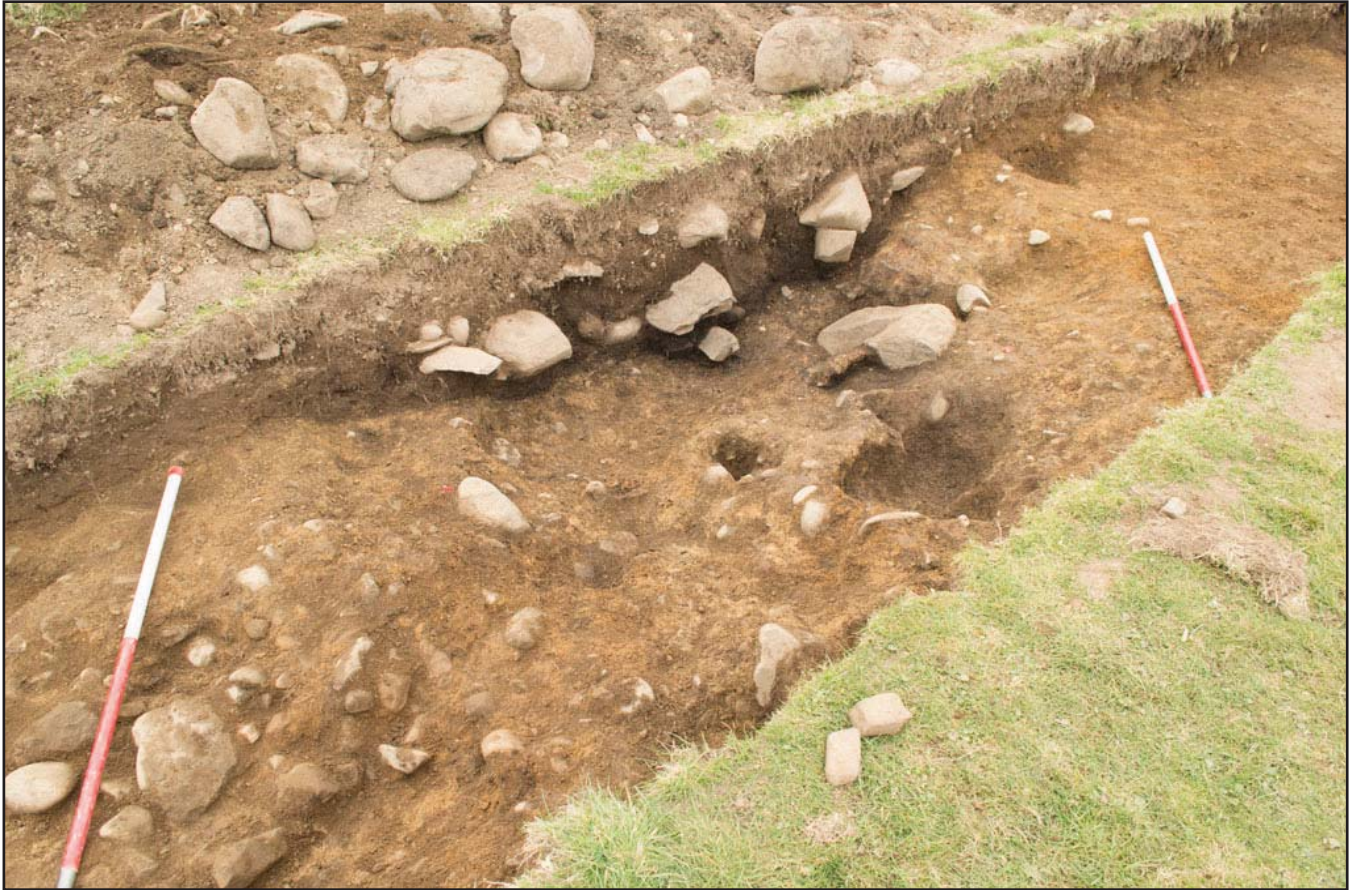
Plate 17: Post-ex shot of [9205] [9209] [9217] [9211] [9213] [9215]. View from south west. 2x1m scale (archive image G2454\_200)

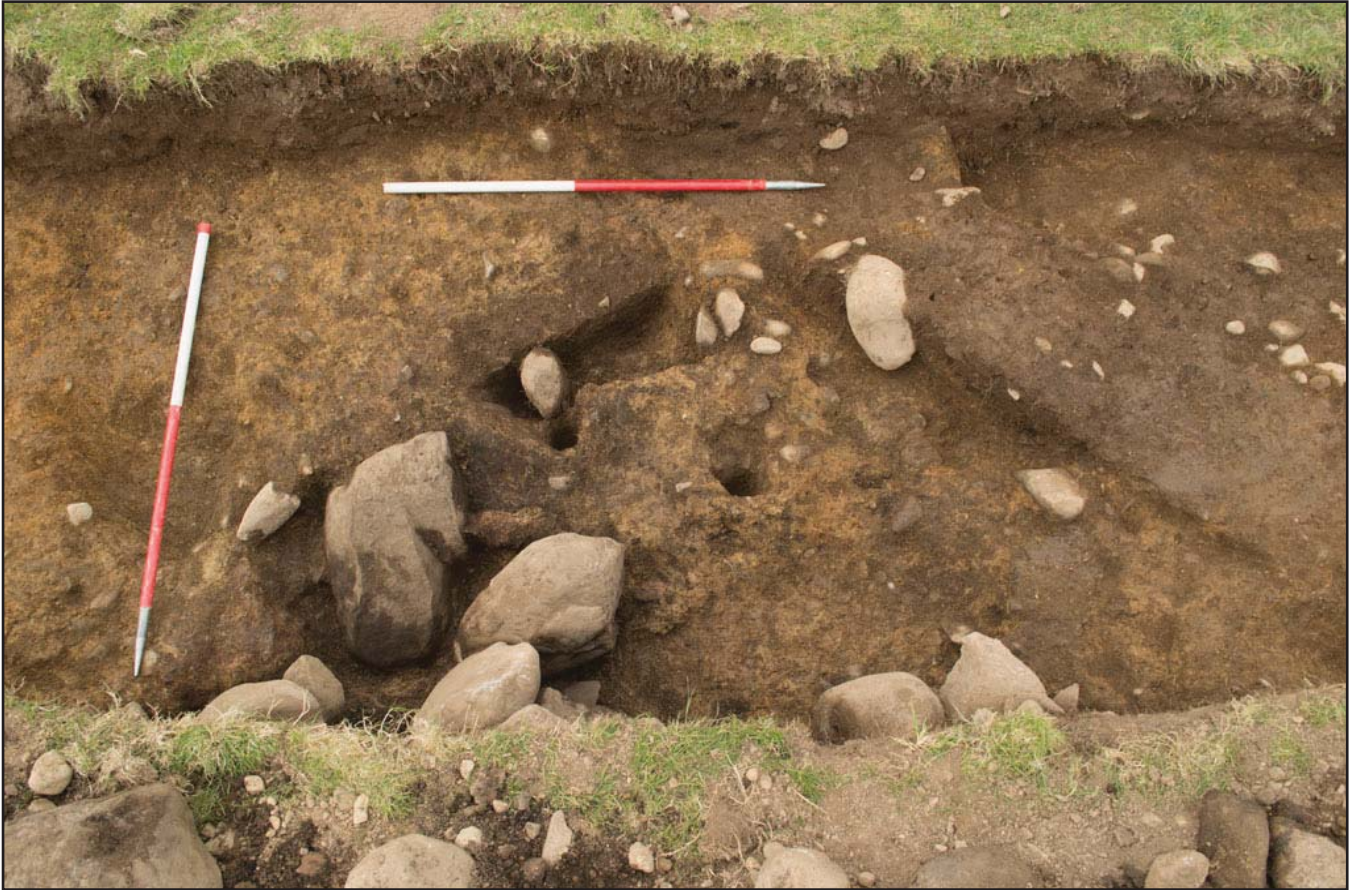
Plate 18: Post-ex shot of [9205]. View from north east. 2x1m scale (archive image G2454\_190)
