## **Appendix C.1 – Cultural Heritage Baseline**

CAERNARFON TO			
BONTNEWYDD ROAD SCHEME			
Subject			
ABSTRACTION AND INTERPRETATION OF GRADIOMETER ANOMALIES - VIEWPORT 1-2			
VINEYARD HOUSE UPTON UPON SEVERN WR8 0SA		T: 01684 592266 E: info@stratascan.co.uk www.stratascan.co.uk	
Scale

# A487 Caernarfon to Bontnewydd Bypass

## Archaeological Evaluation - Interim Report

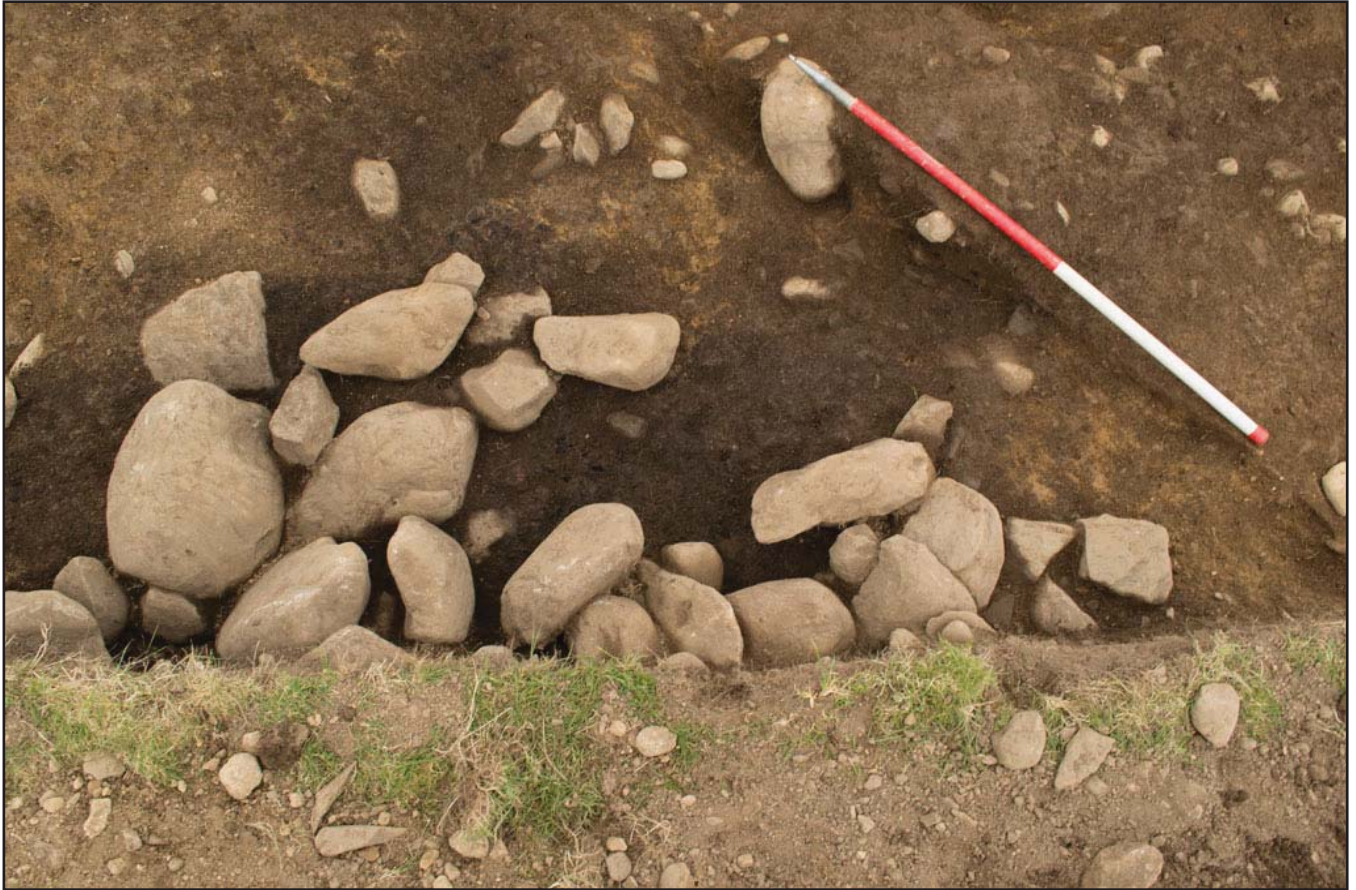
Plate 19: Mid-excavation photo of [9205] and [9207]. View from north east. 1x1m scale (archive image G2454\_178)

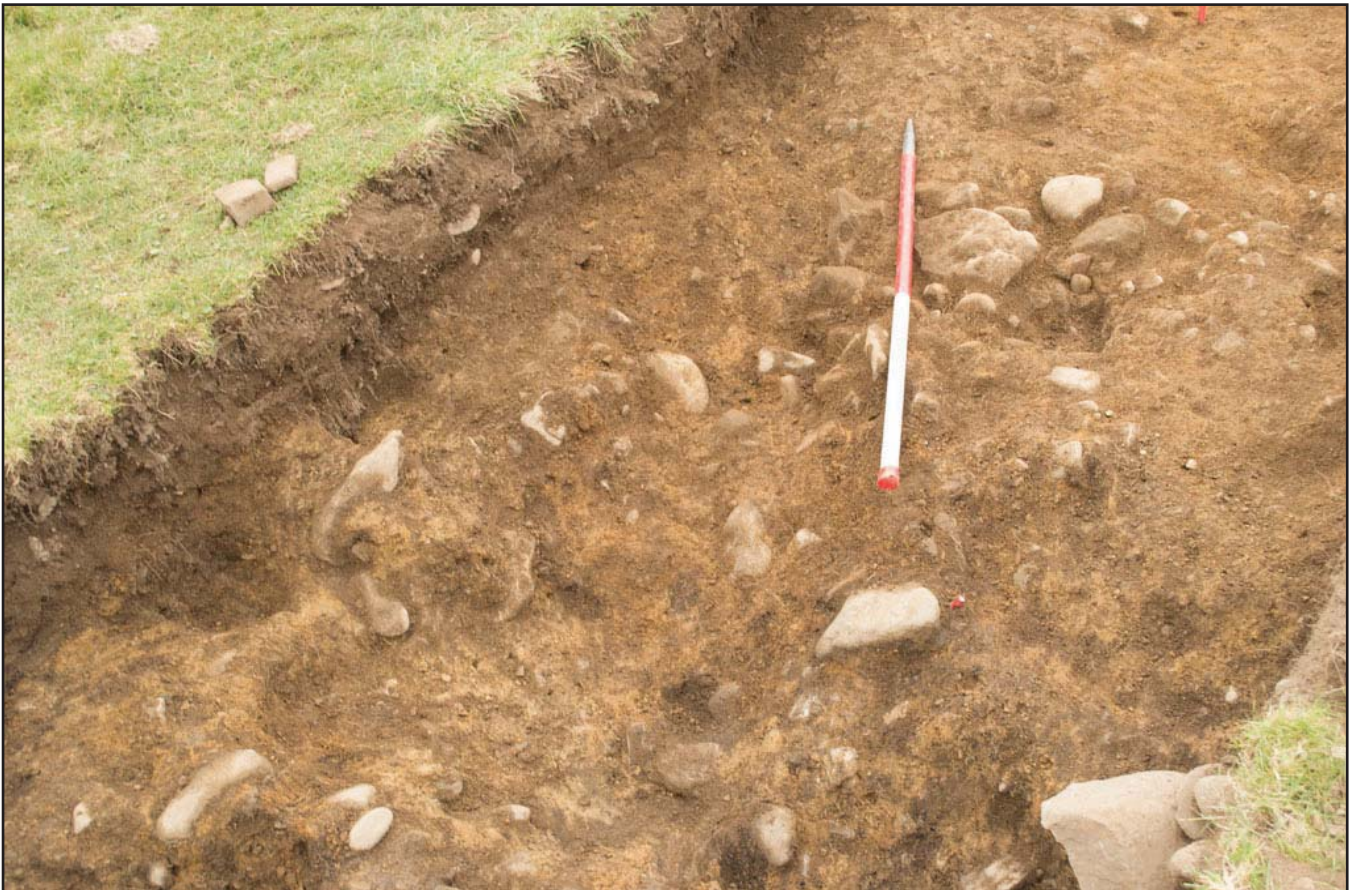
Plate 20: Post-excavation photo of [9219] and [9215]. View from south east. 1x1m scale (archive image G2454\_204)

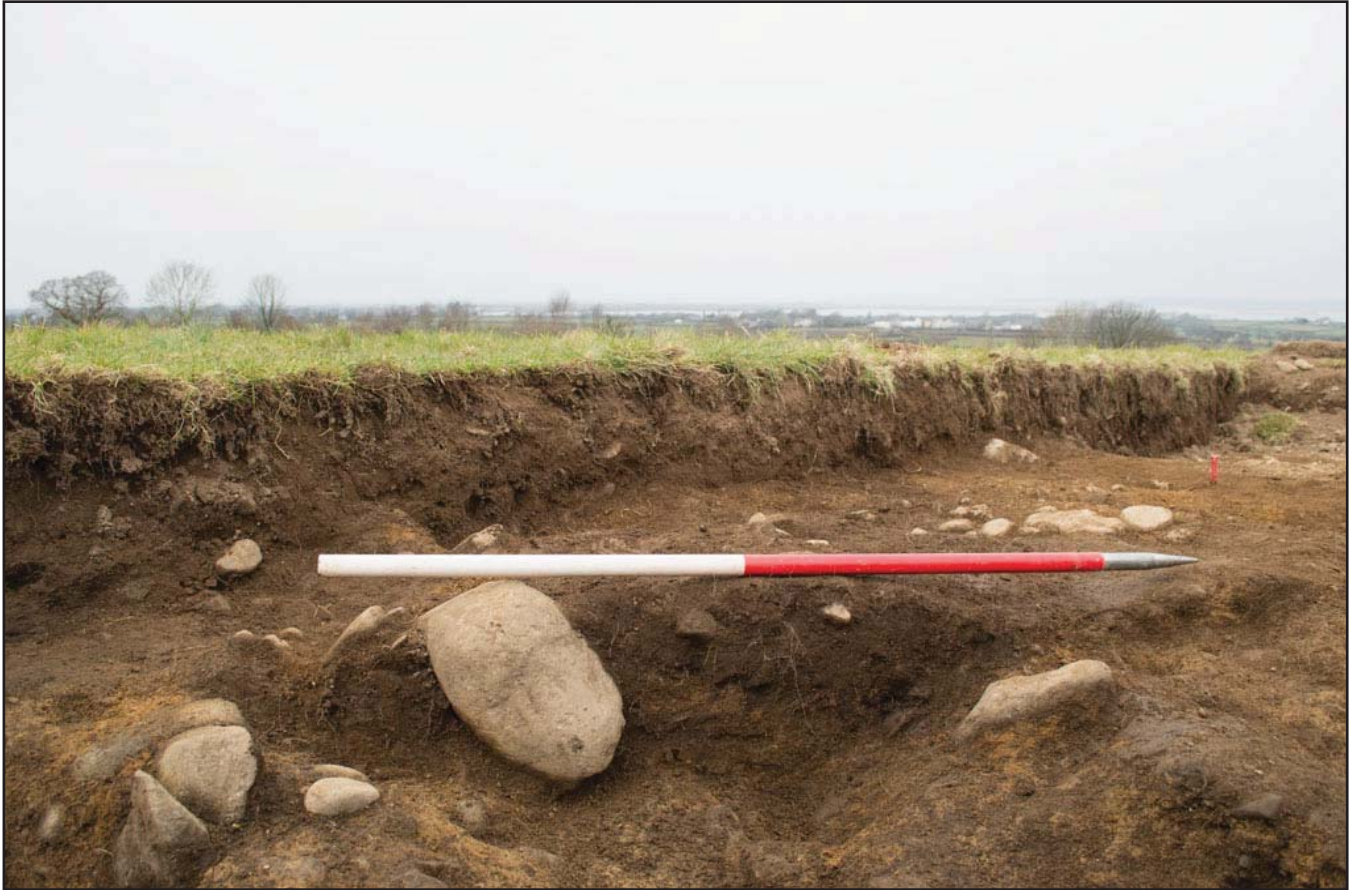
Plate 21: East facing section through [9215]. 1x1m scale (archive image G2454\_184)

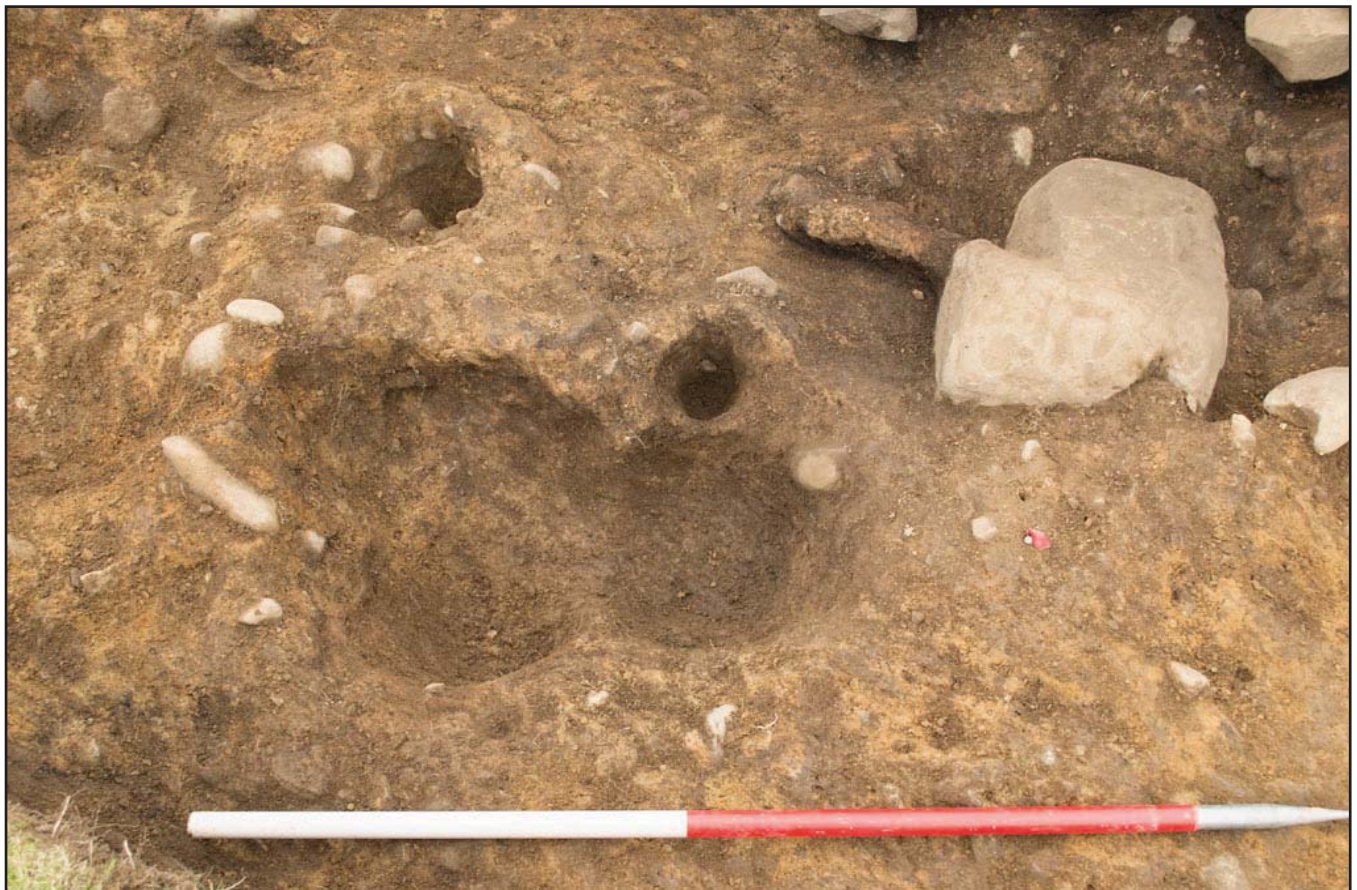
Plate 22: Post-excavation photo of pits [9209] and [9217], and postholes [9211] and [9213]. View from south south west. 1x1m scale (archive image G2454\_205)

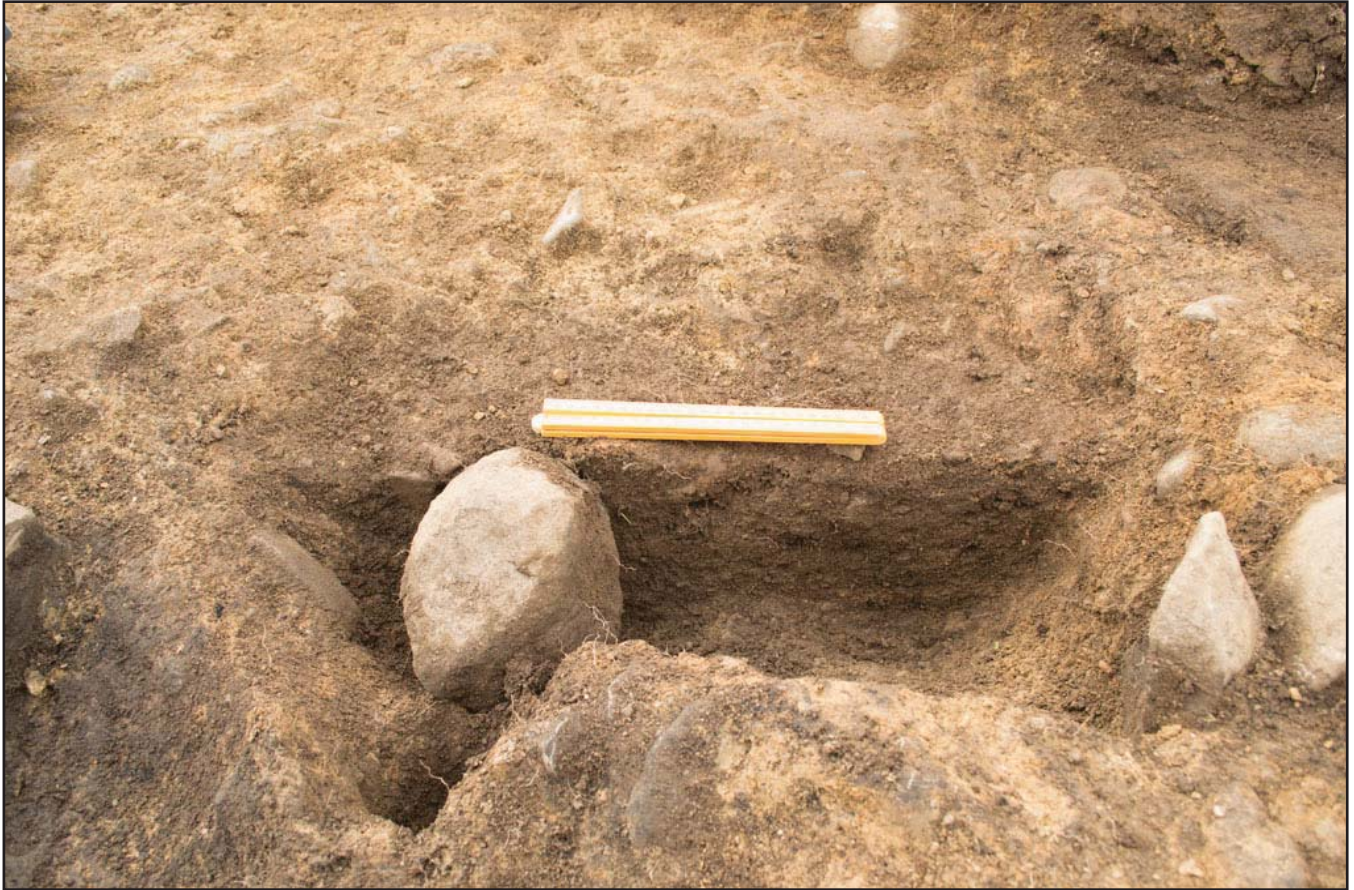
Plate 23: North east facing section through [9209] and [9217]. 1x0.25m scale (archive image G2454\_185)
