A40 PENBLEWIN TO REDSTONE CROSS IMPROVEMENTS

ENVIRONMENTAL STATEMENT
VOLUME 3C: TECHNICAL APPENDICES

July 2020

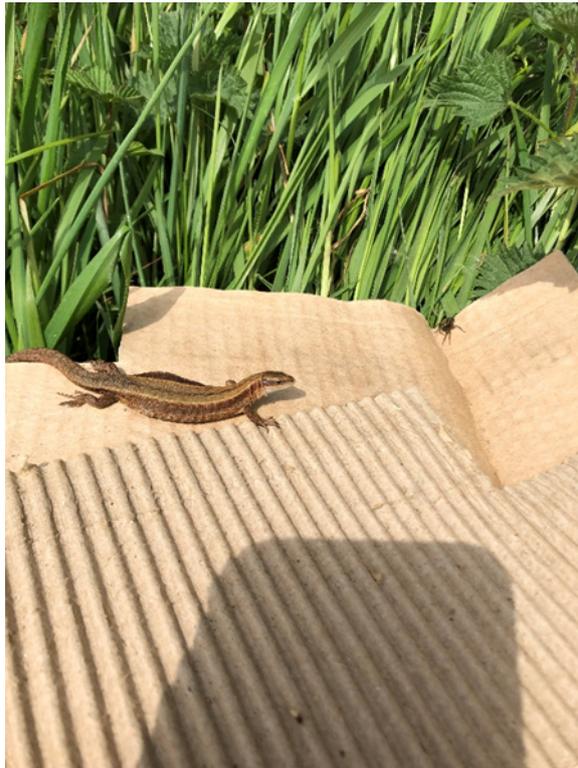
Photograph 1 Adult female common lizard recorded on 23rd April 2019 in Area 13 (during bat static detector survey visit).

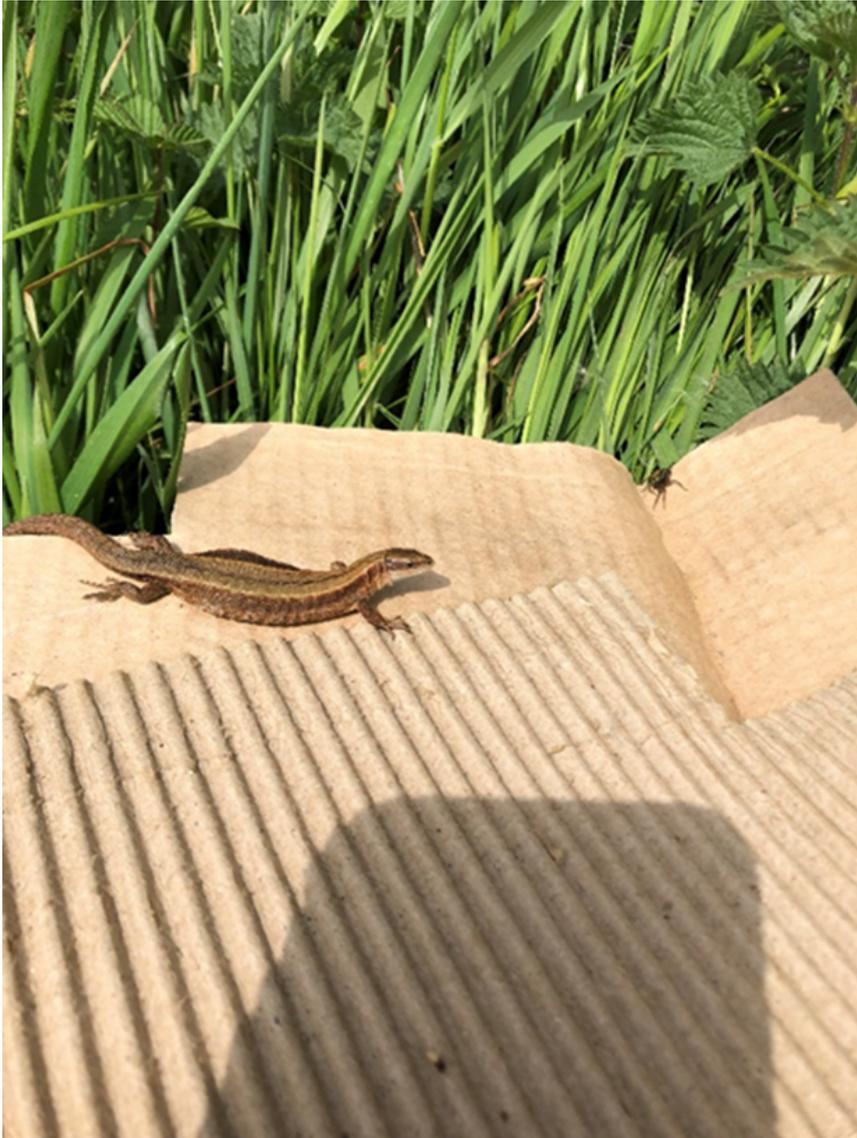
Photograph 1 Adult female common lizard recorded on 23rd April 2019 in Area 13 (during bat static detector survey visit).

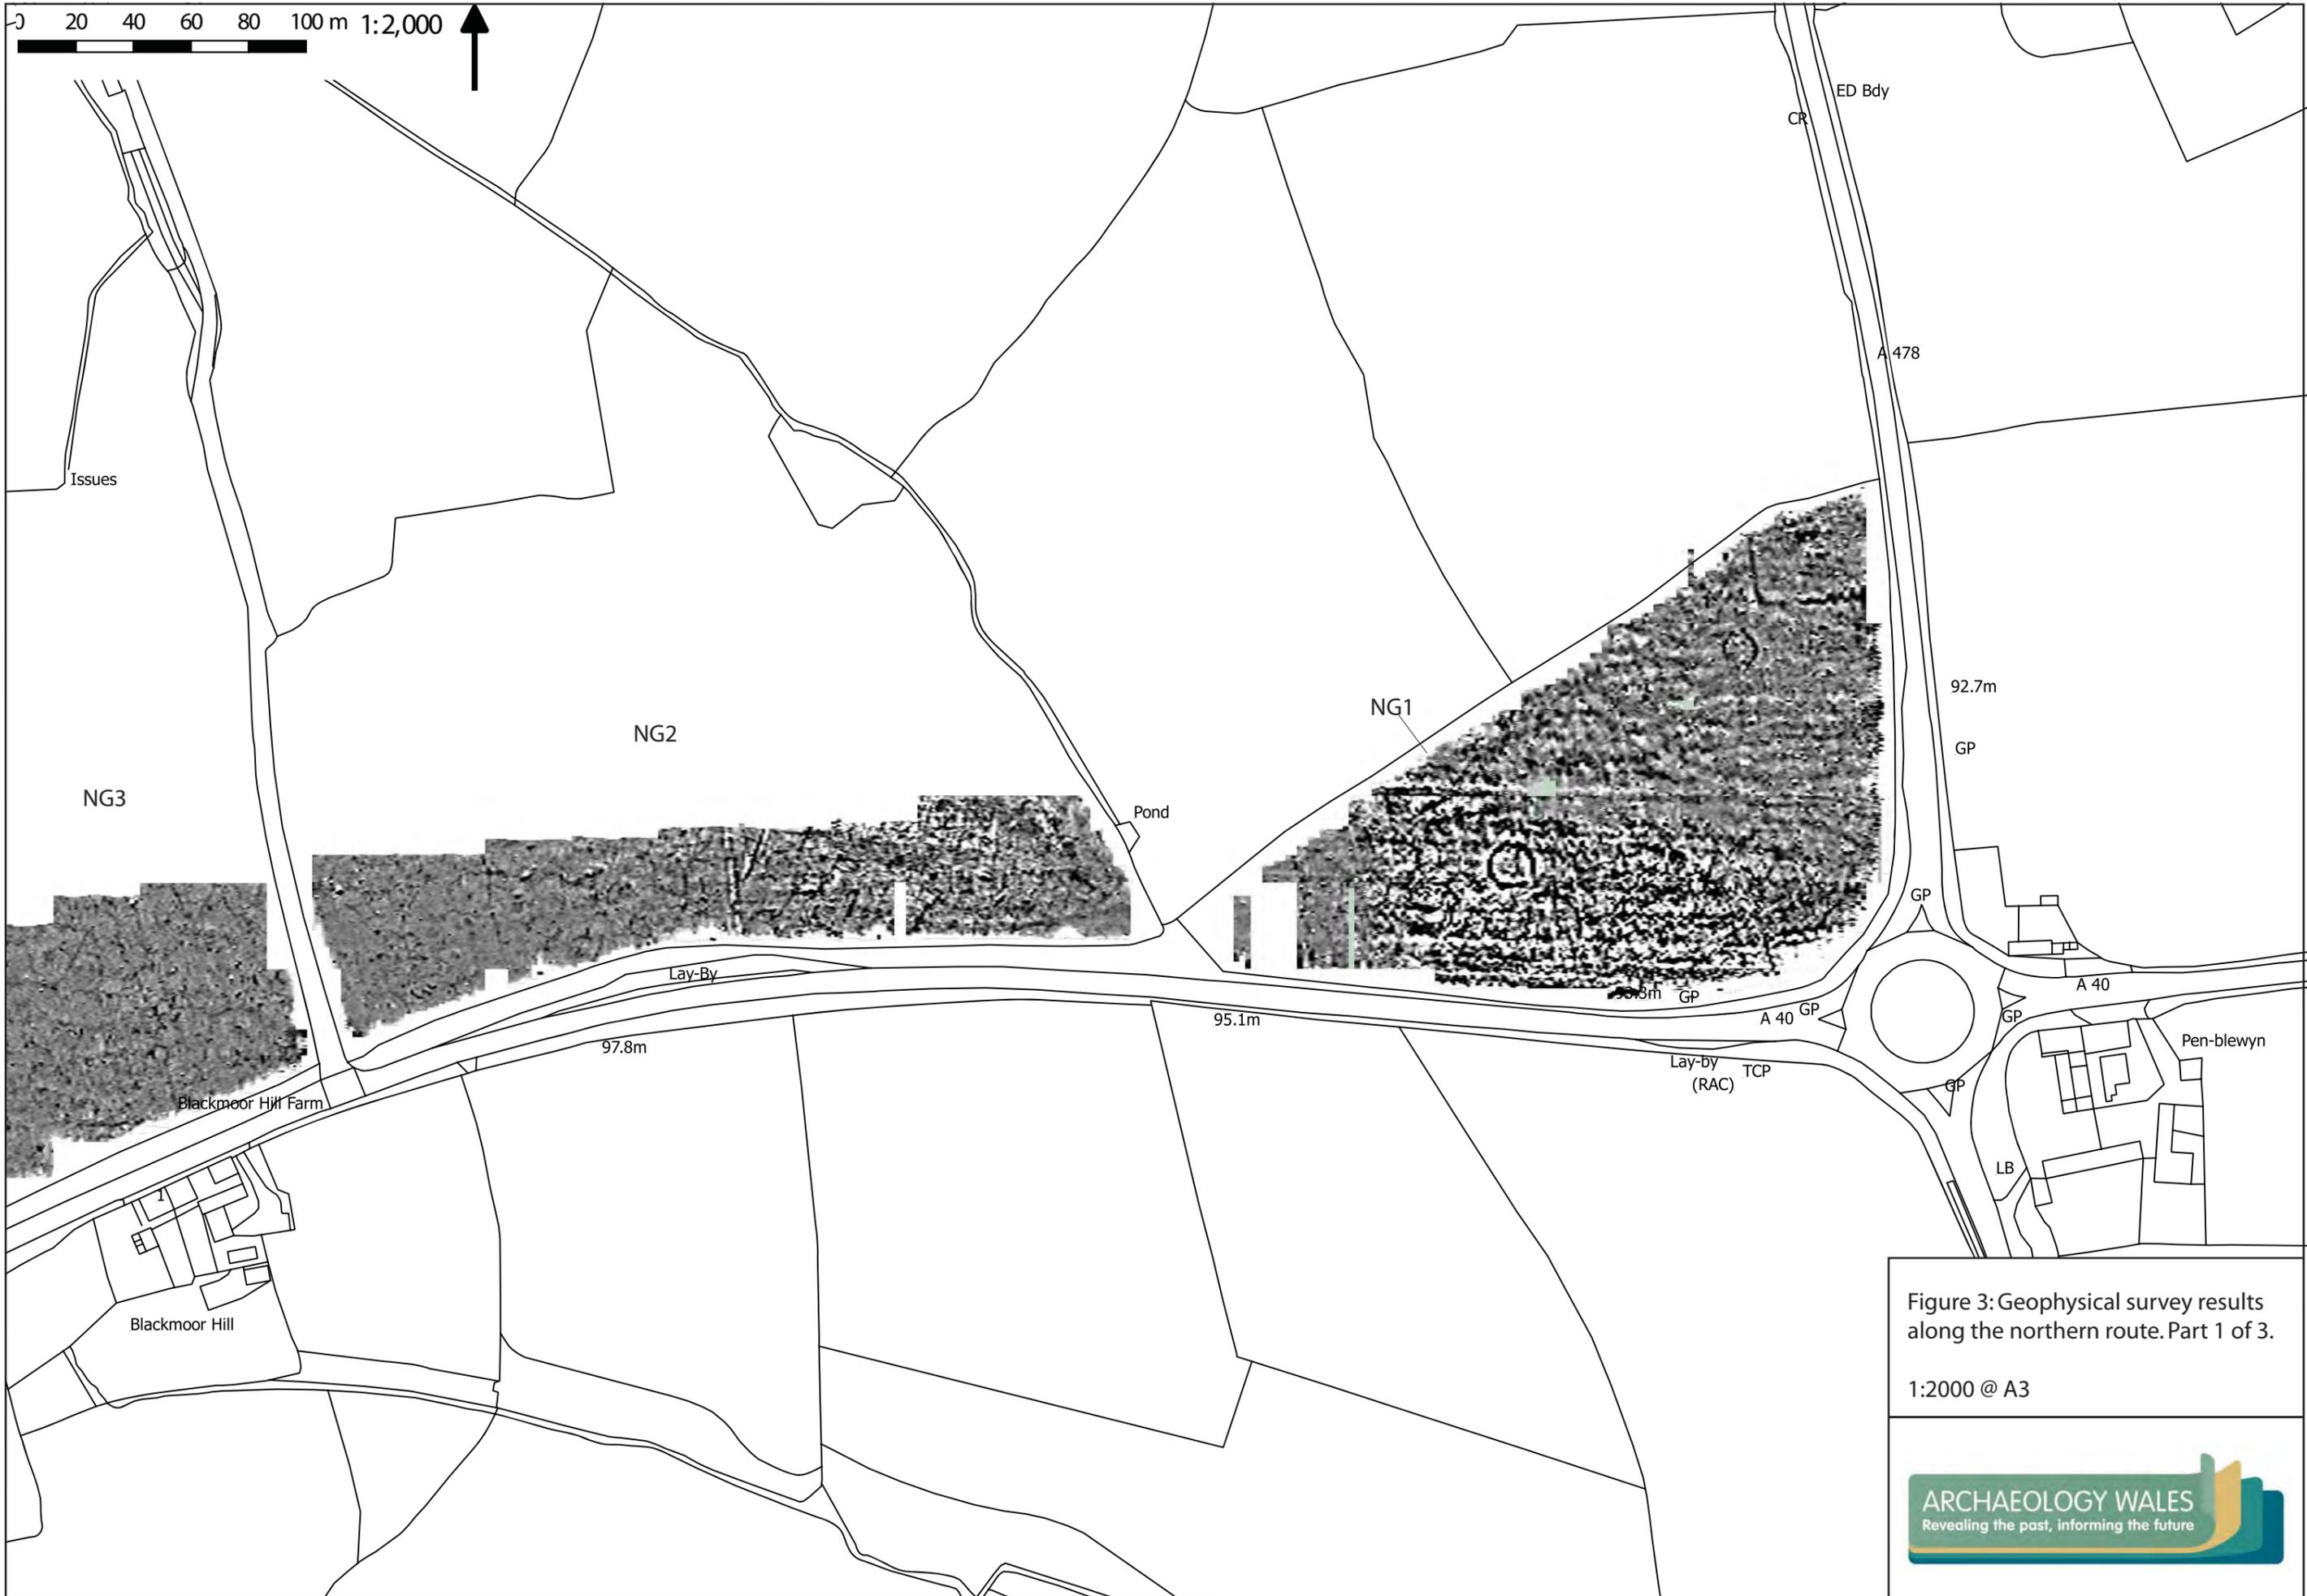
Figure 3: Geophysical survey results along the northern route. Part 1 of 3.

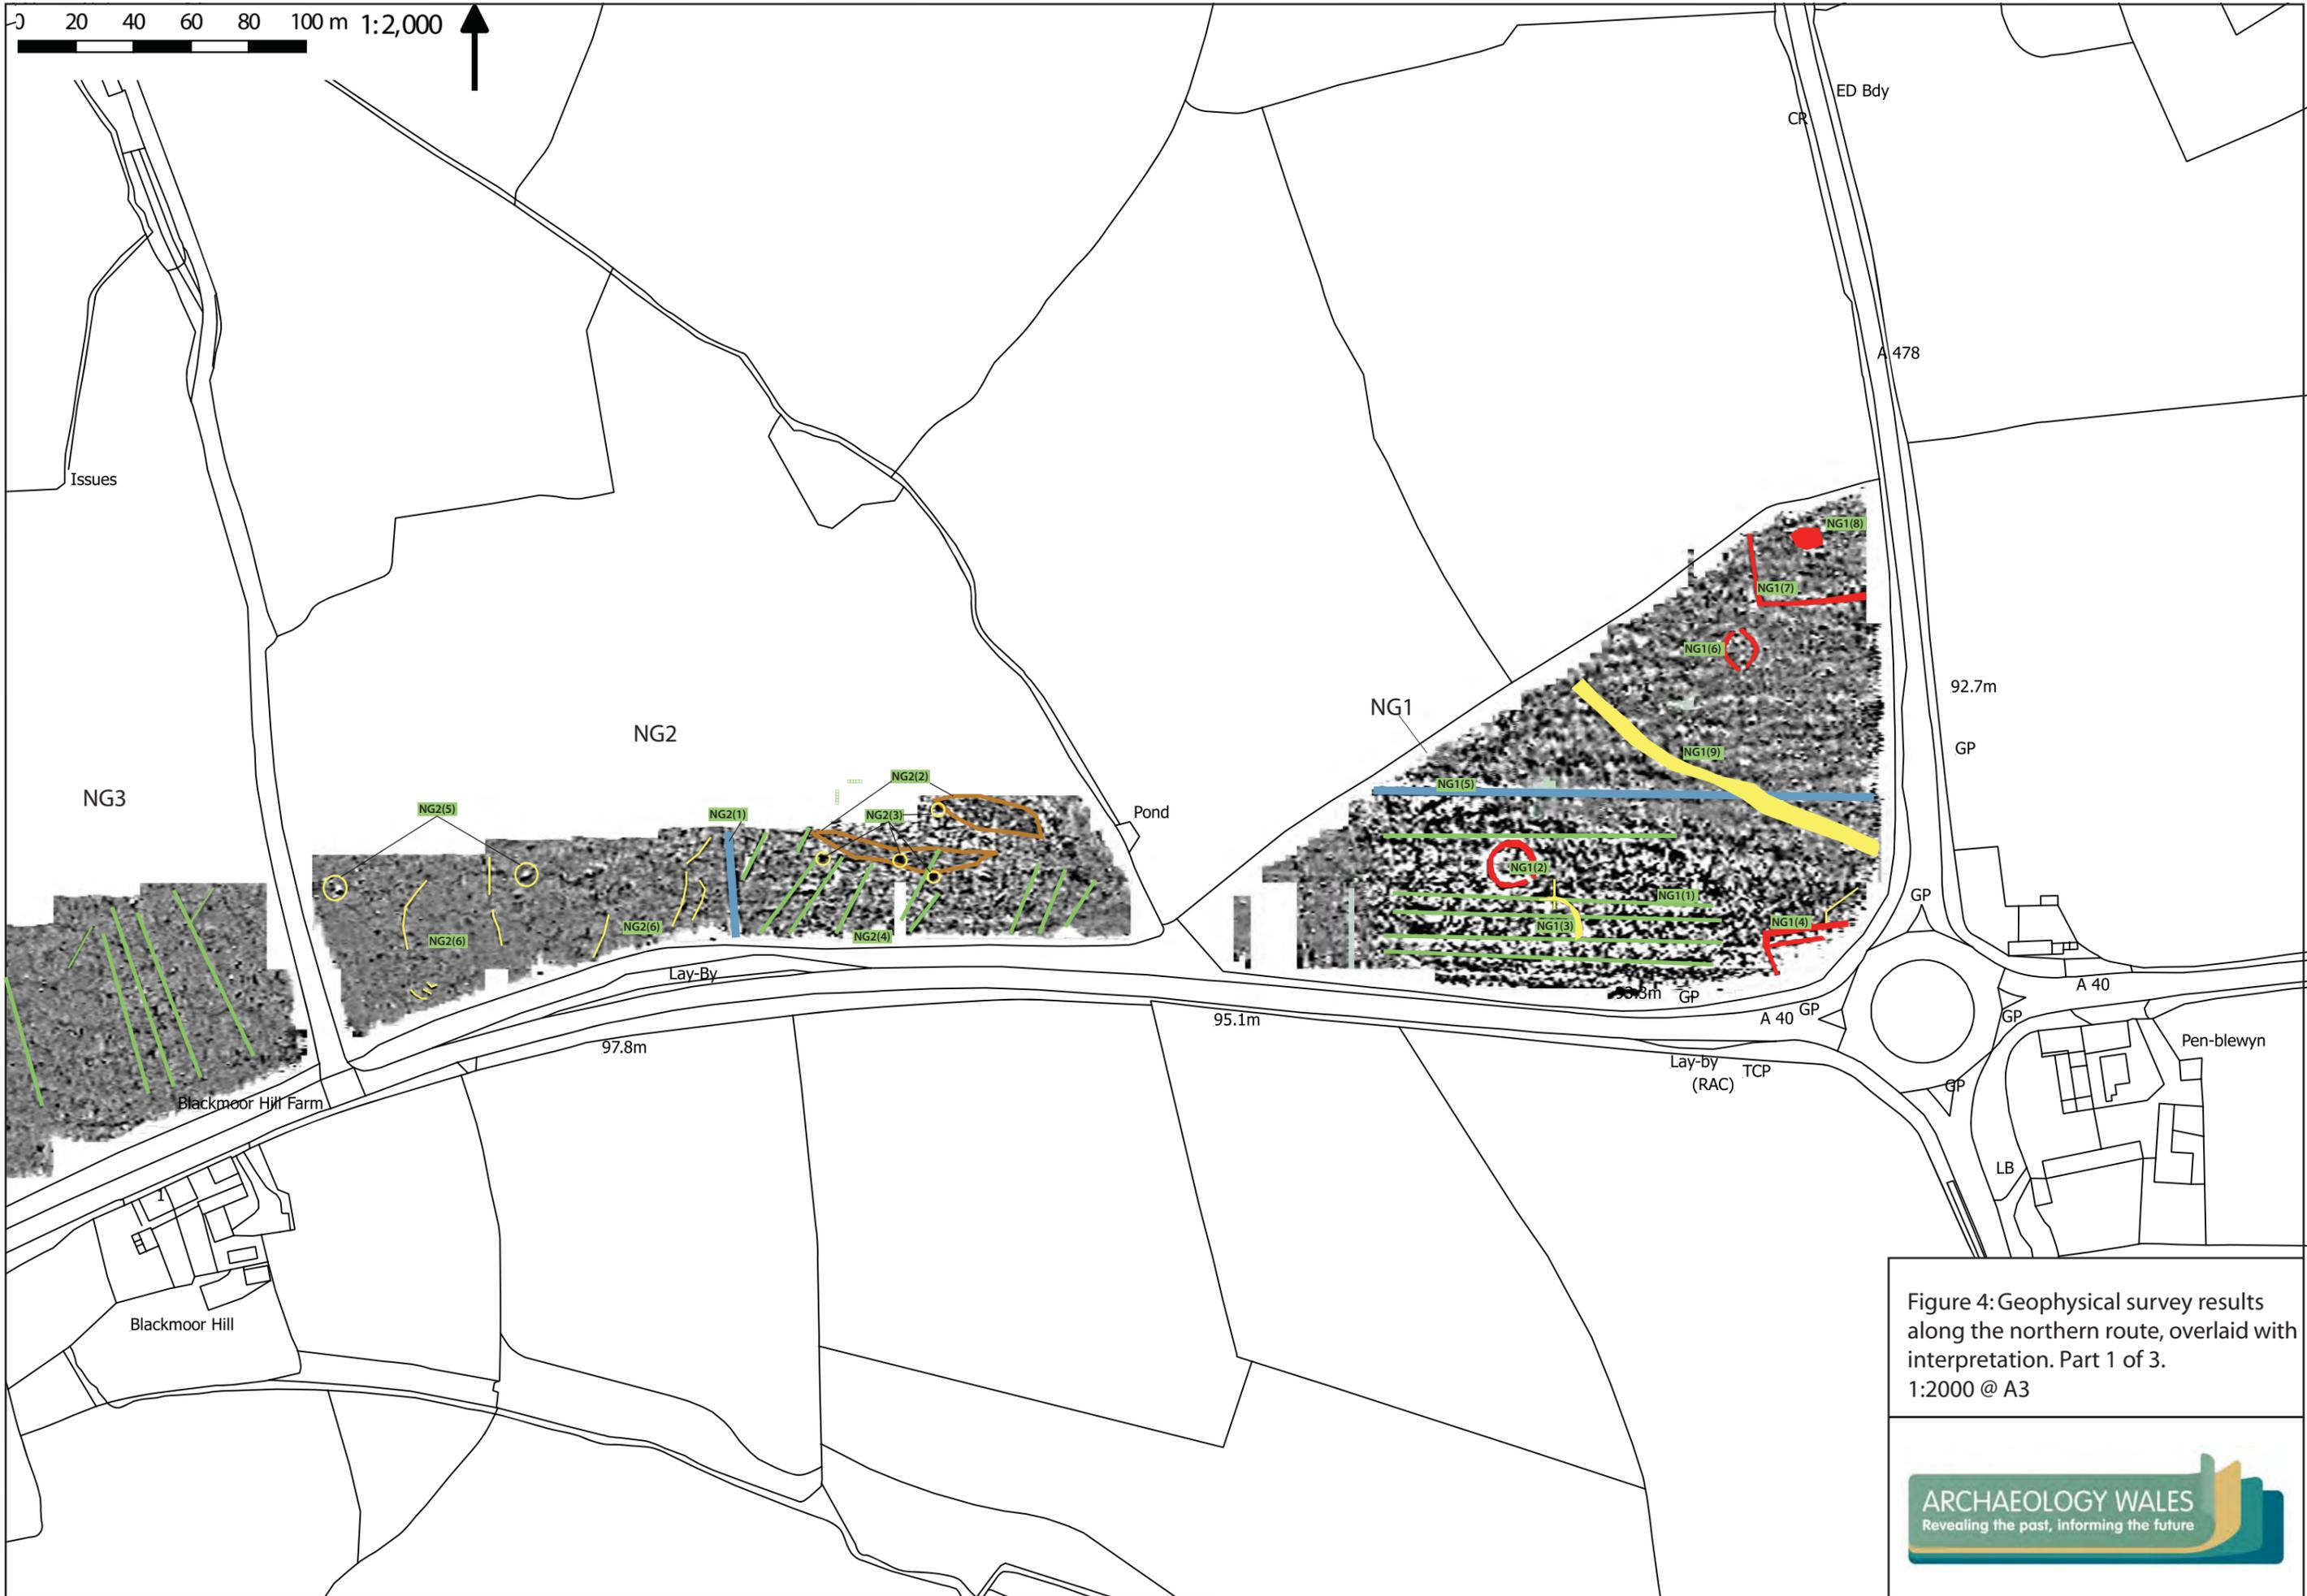
Figure 4: Geophysical survey results along the northern route, overlaid with interpretation. Part 1 of 3. 1:2000 @ A3

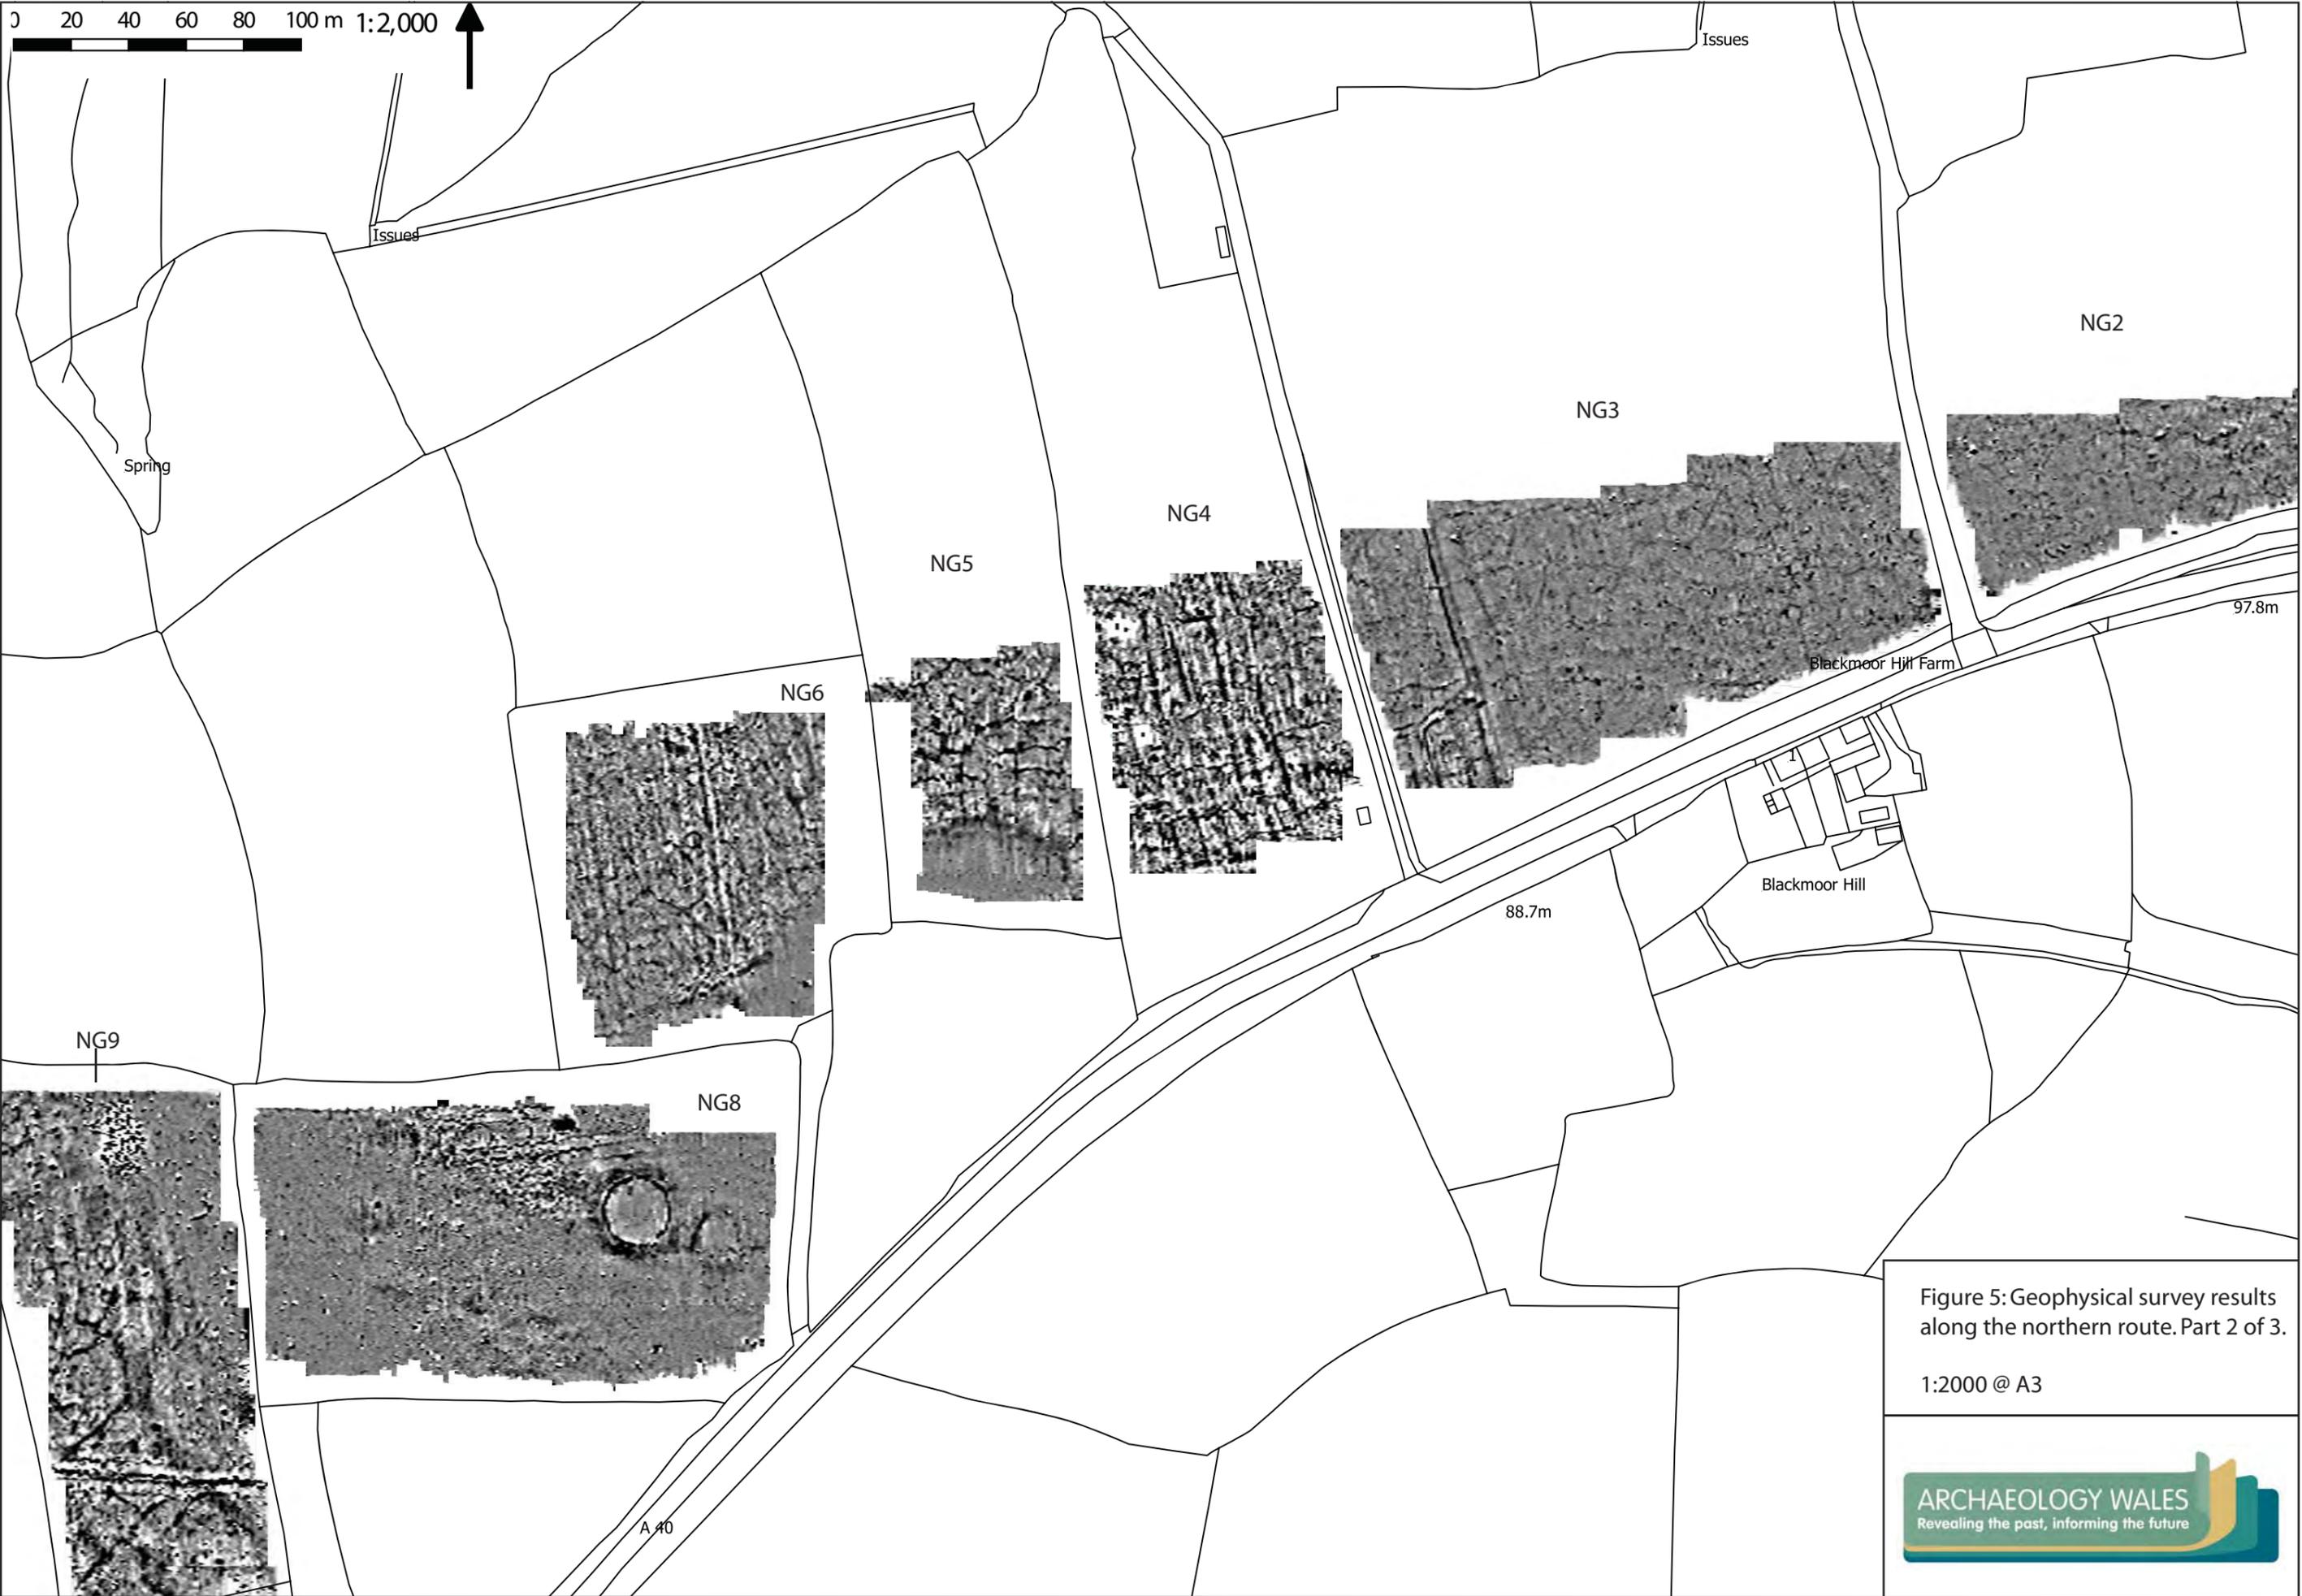
Figure 5: Geophysical survey results along the northern route. Part 2 of 3.

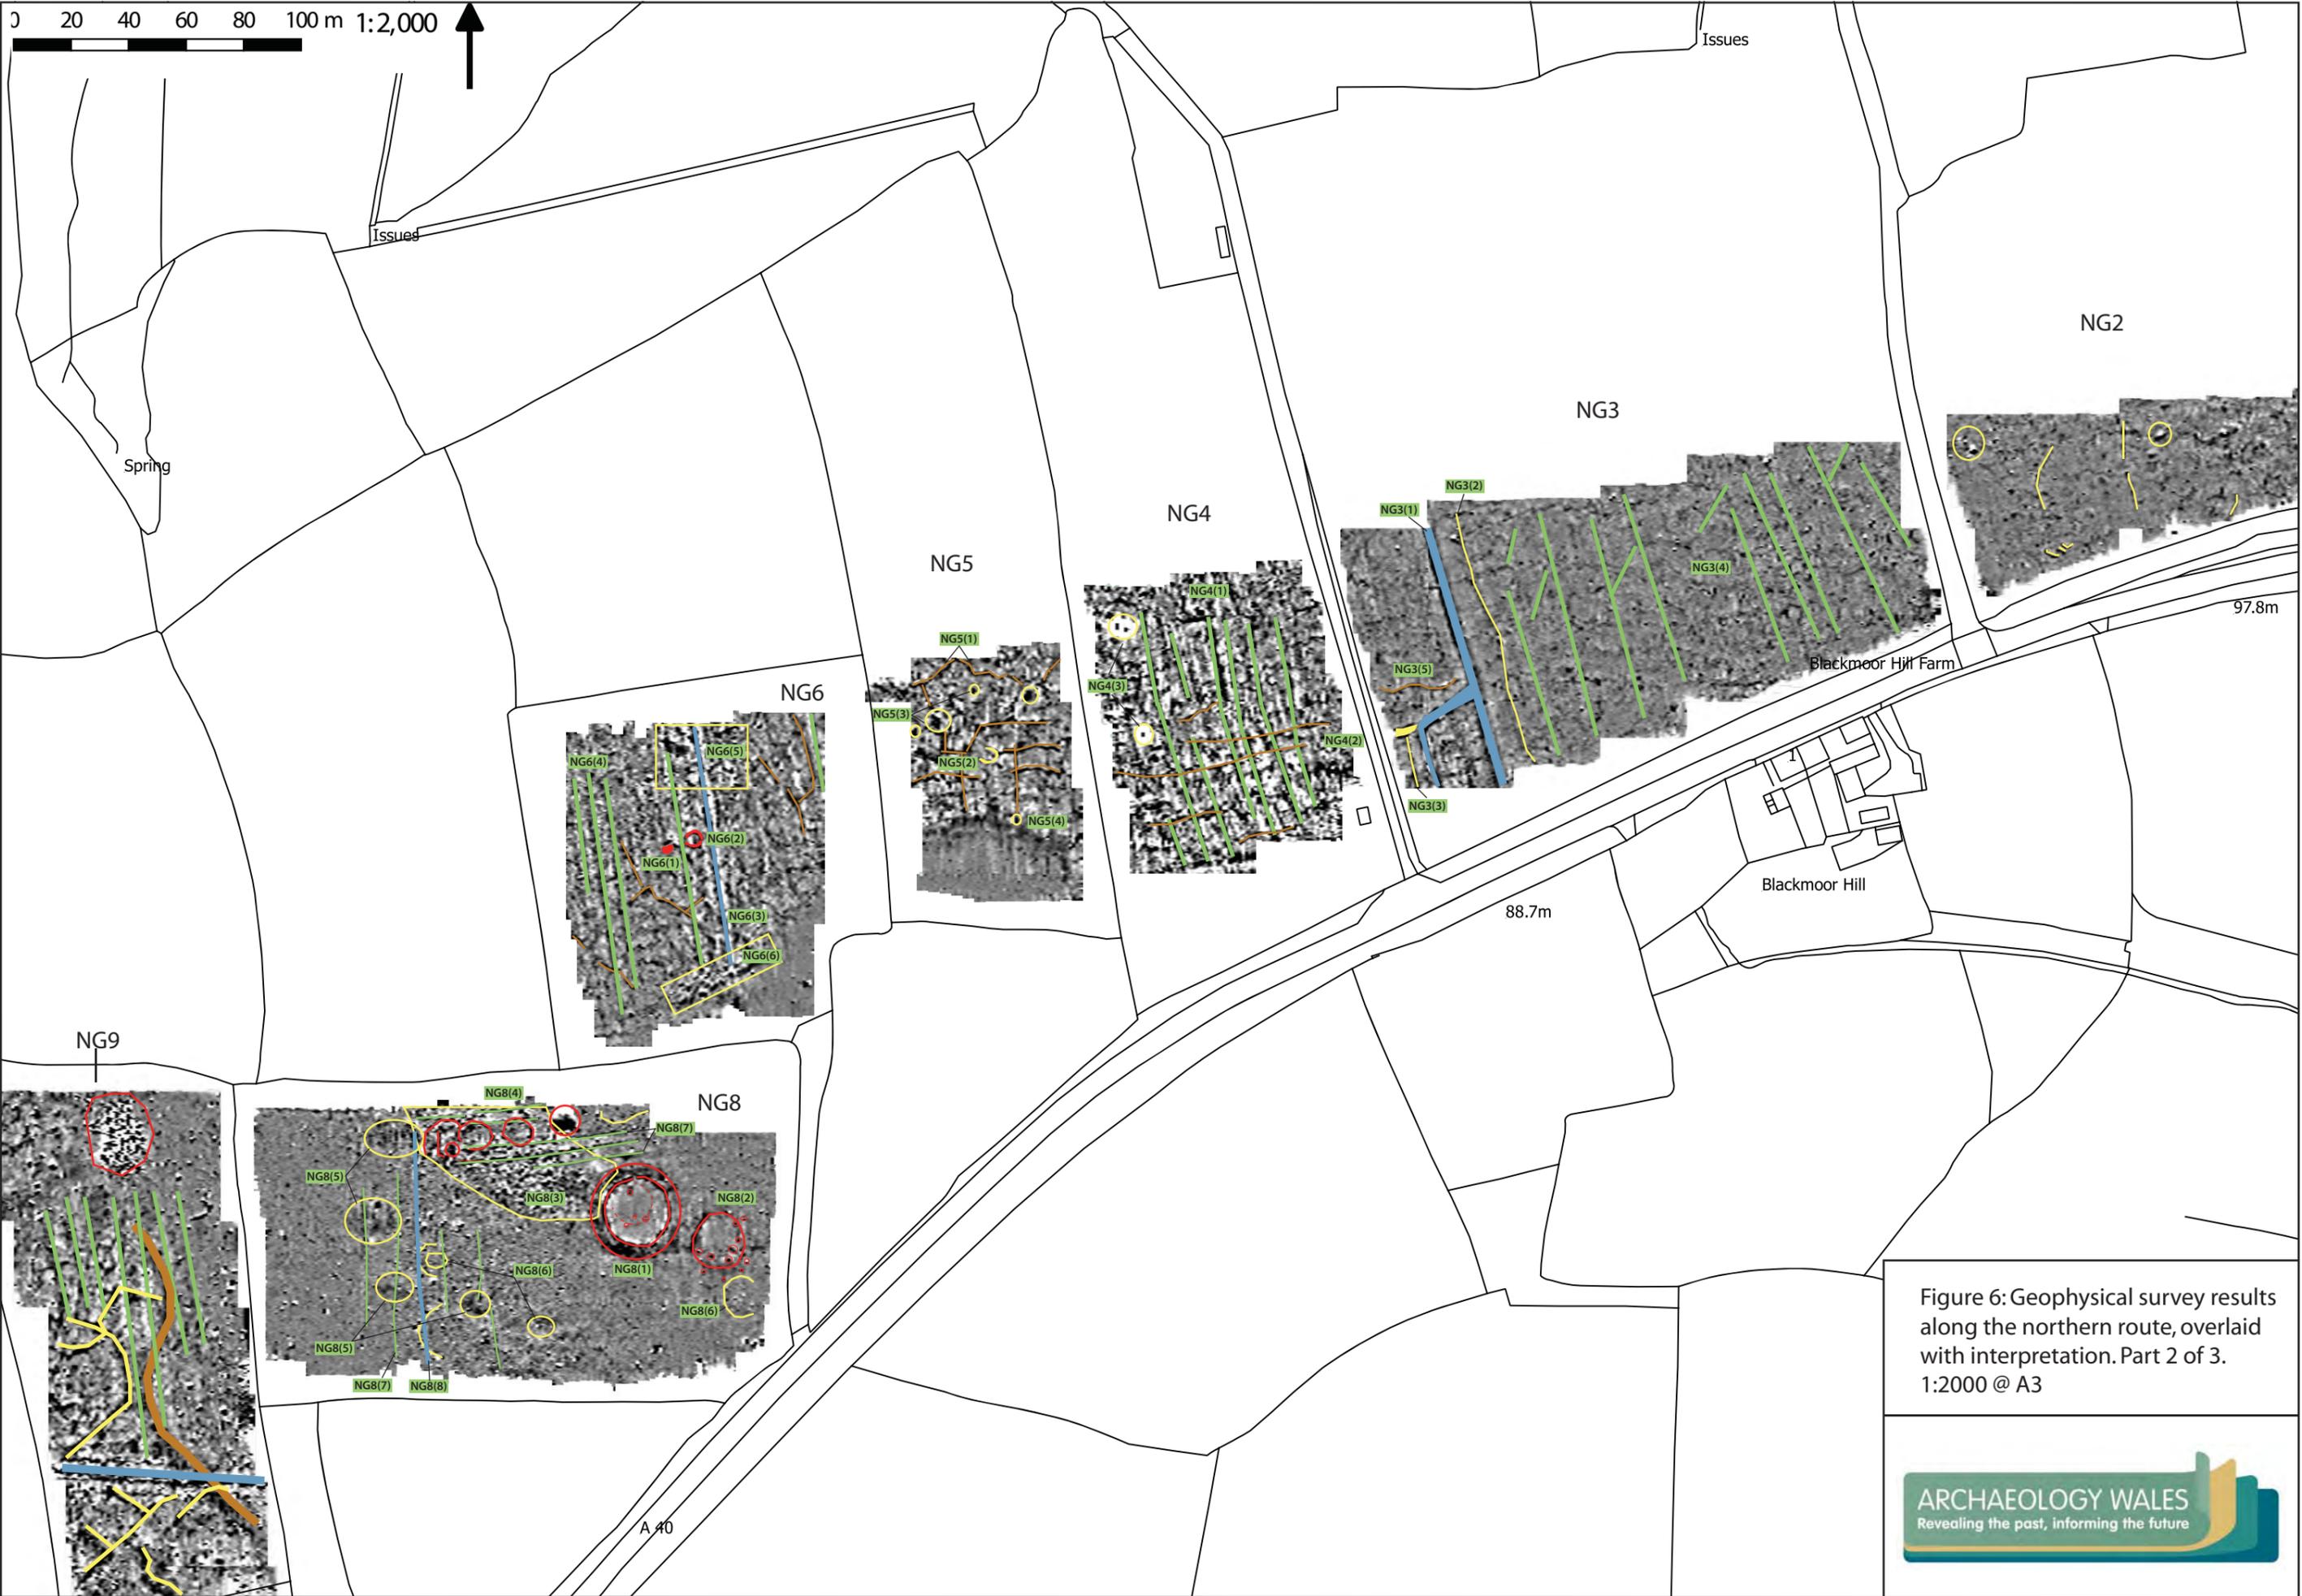
Figure 6: Geophysical survey results along the northern route, overlaid with interpretation. Part 2 of 3. 1:2000 @ A3

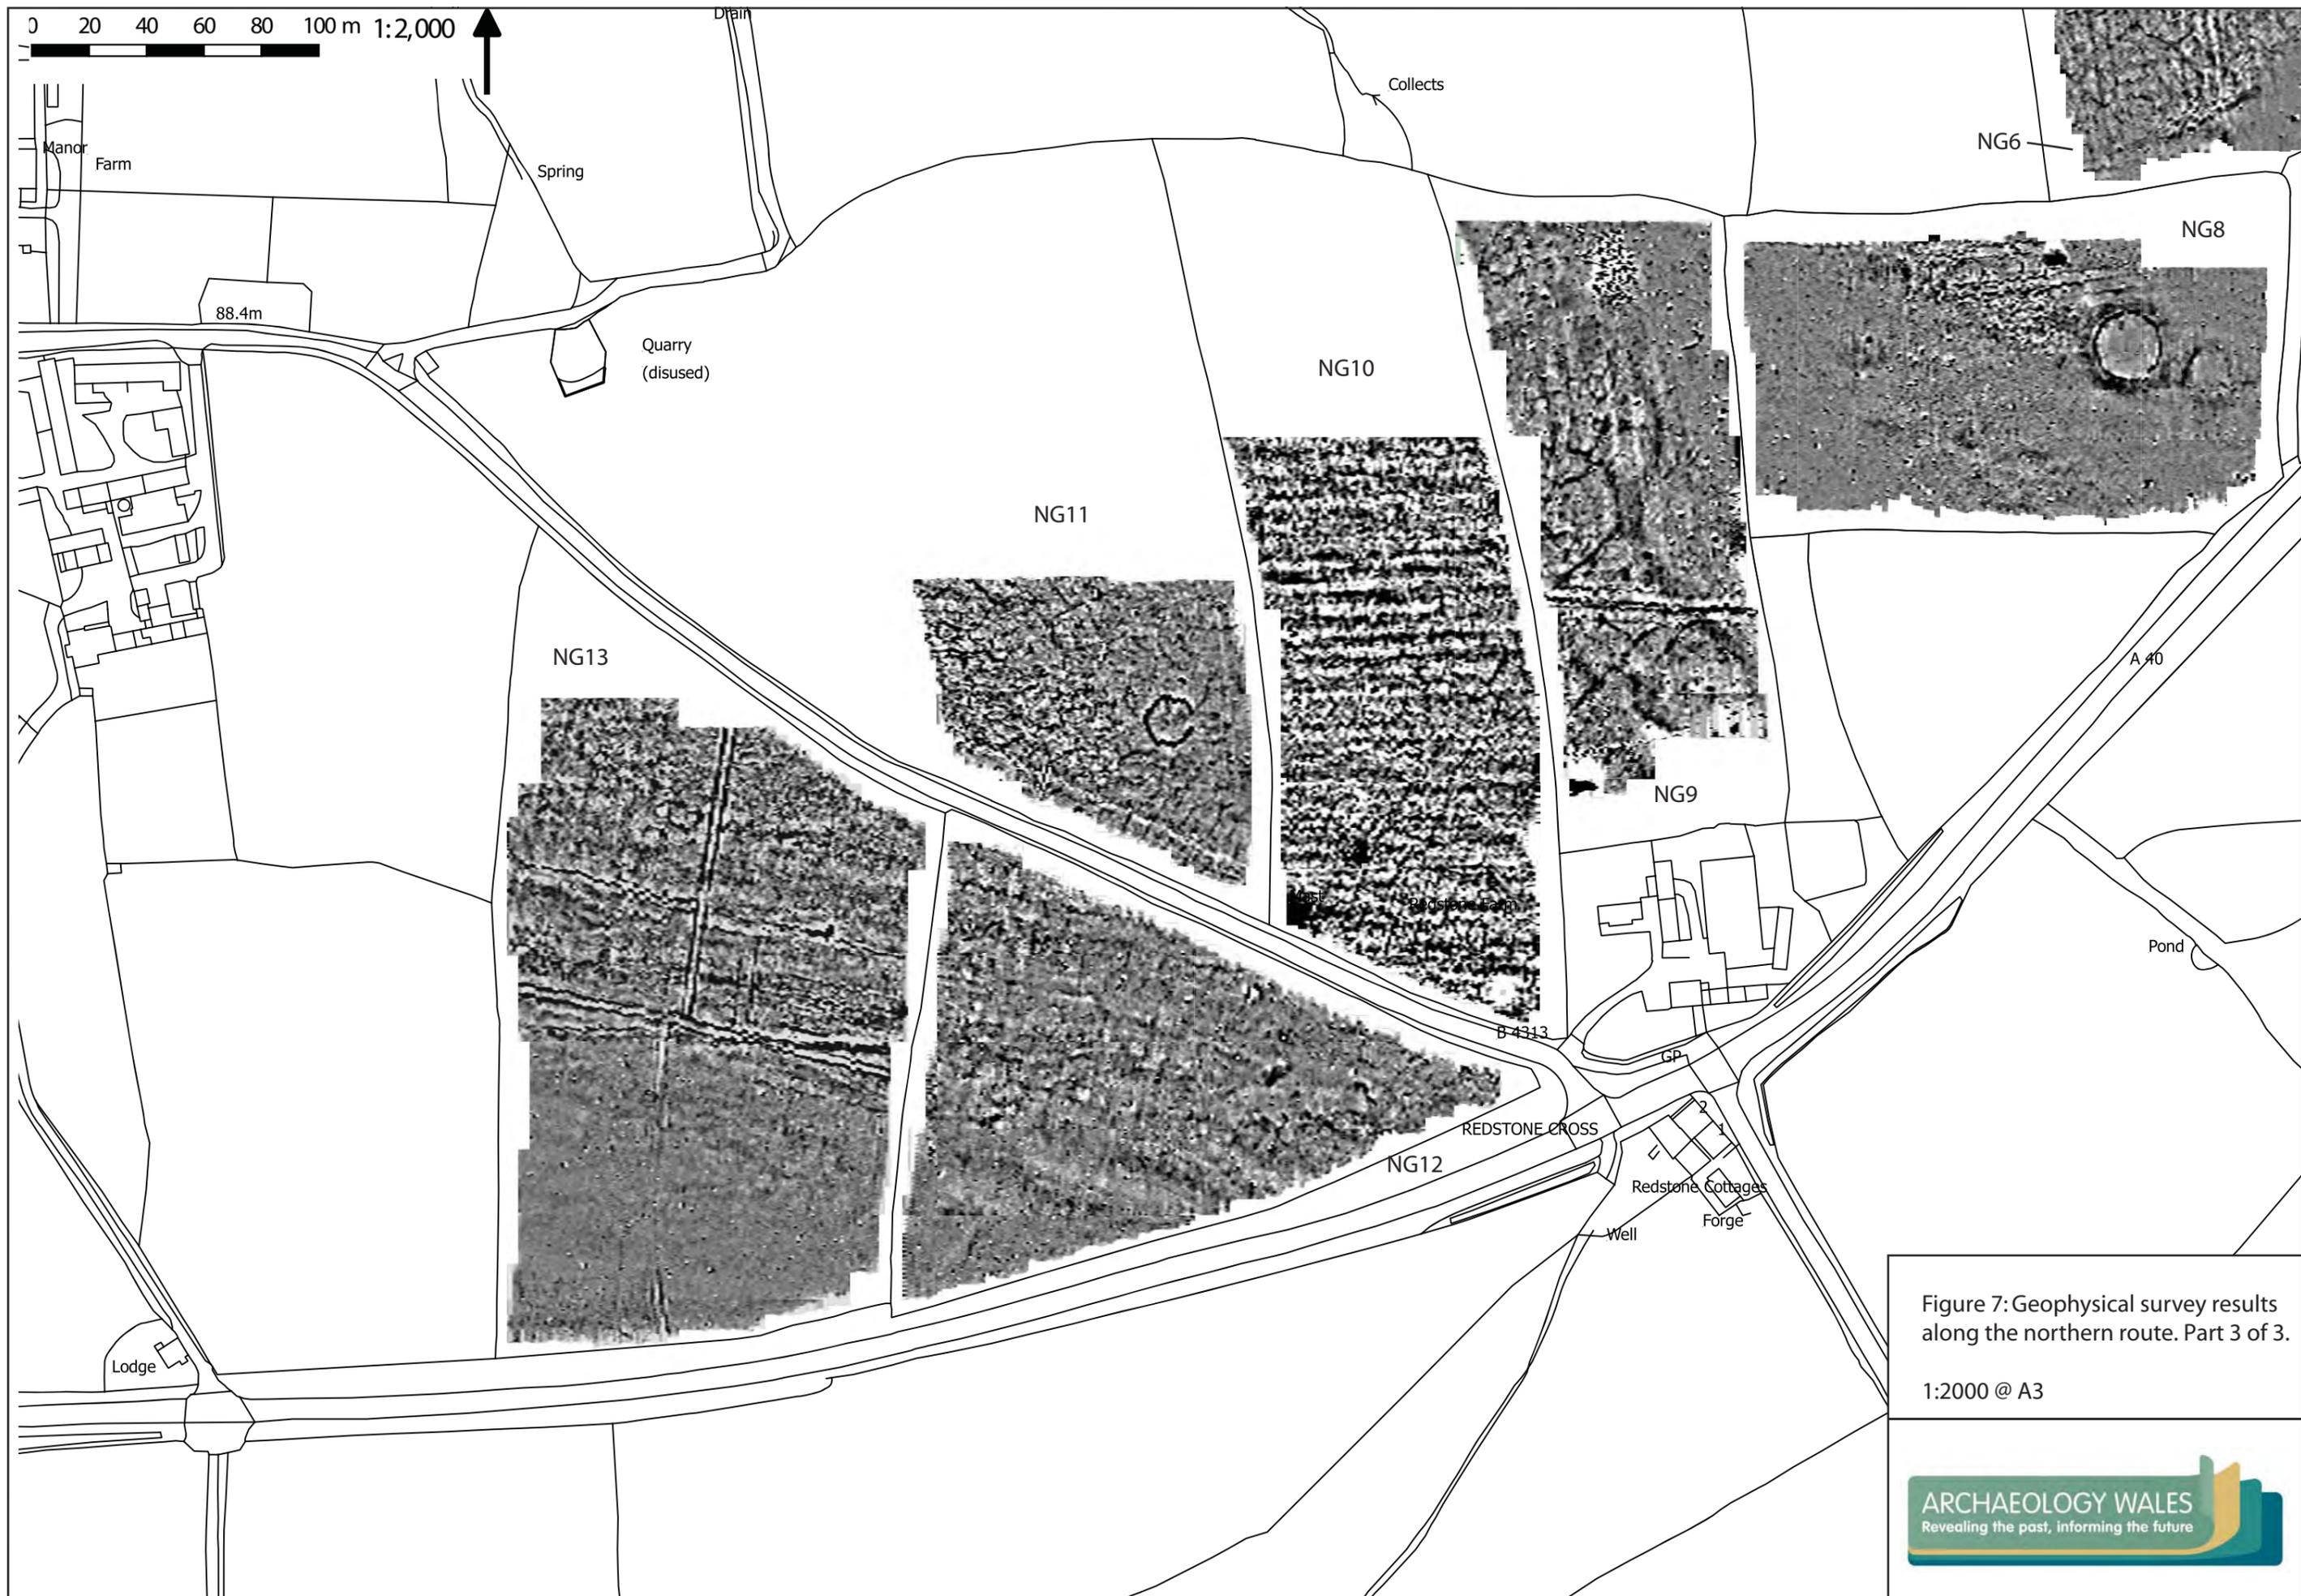
Figure 7: Geophysical survey results along the northern route. Part 3 of 3.
