A40 PENBLEWIN TO REDSTONE CROSS IMPROVEMENTS

ENVIRONMENTAL STATEMENT
VOLUME 3C: TECHNICAL APPENDICES

July 2020

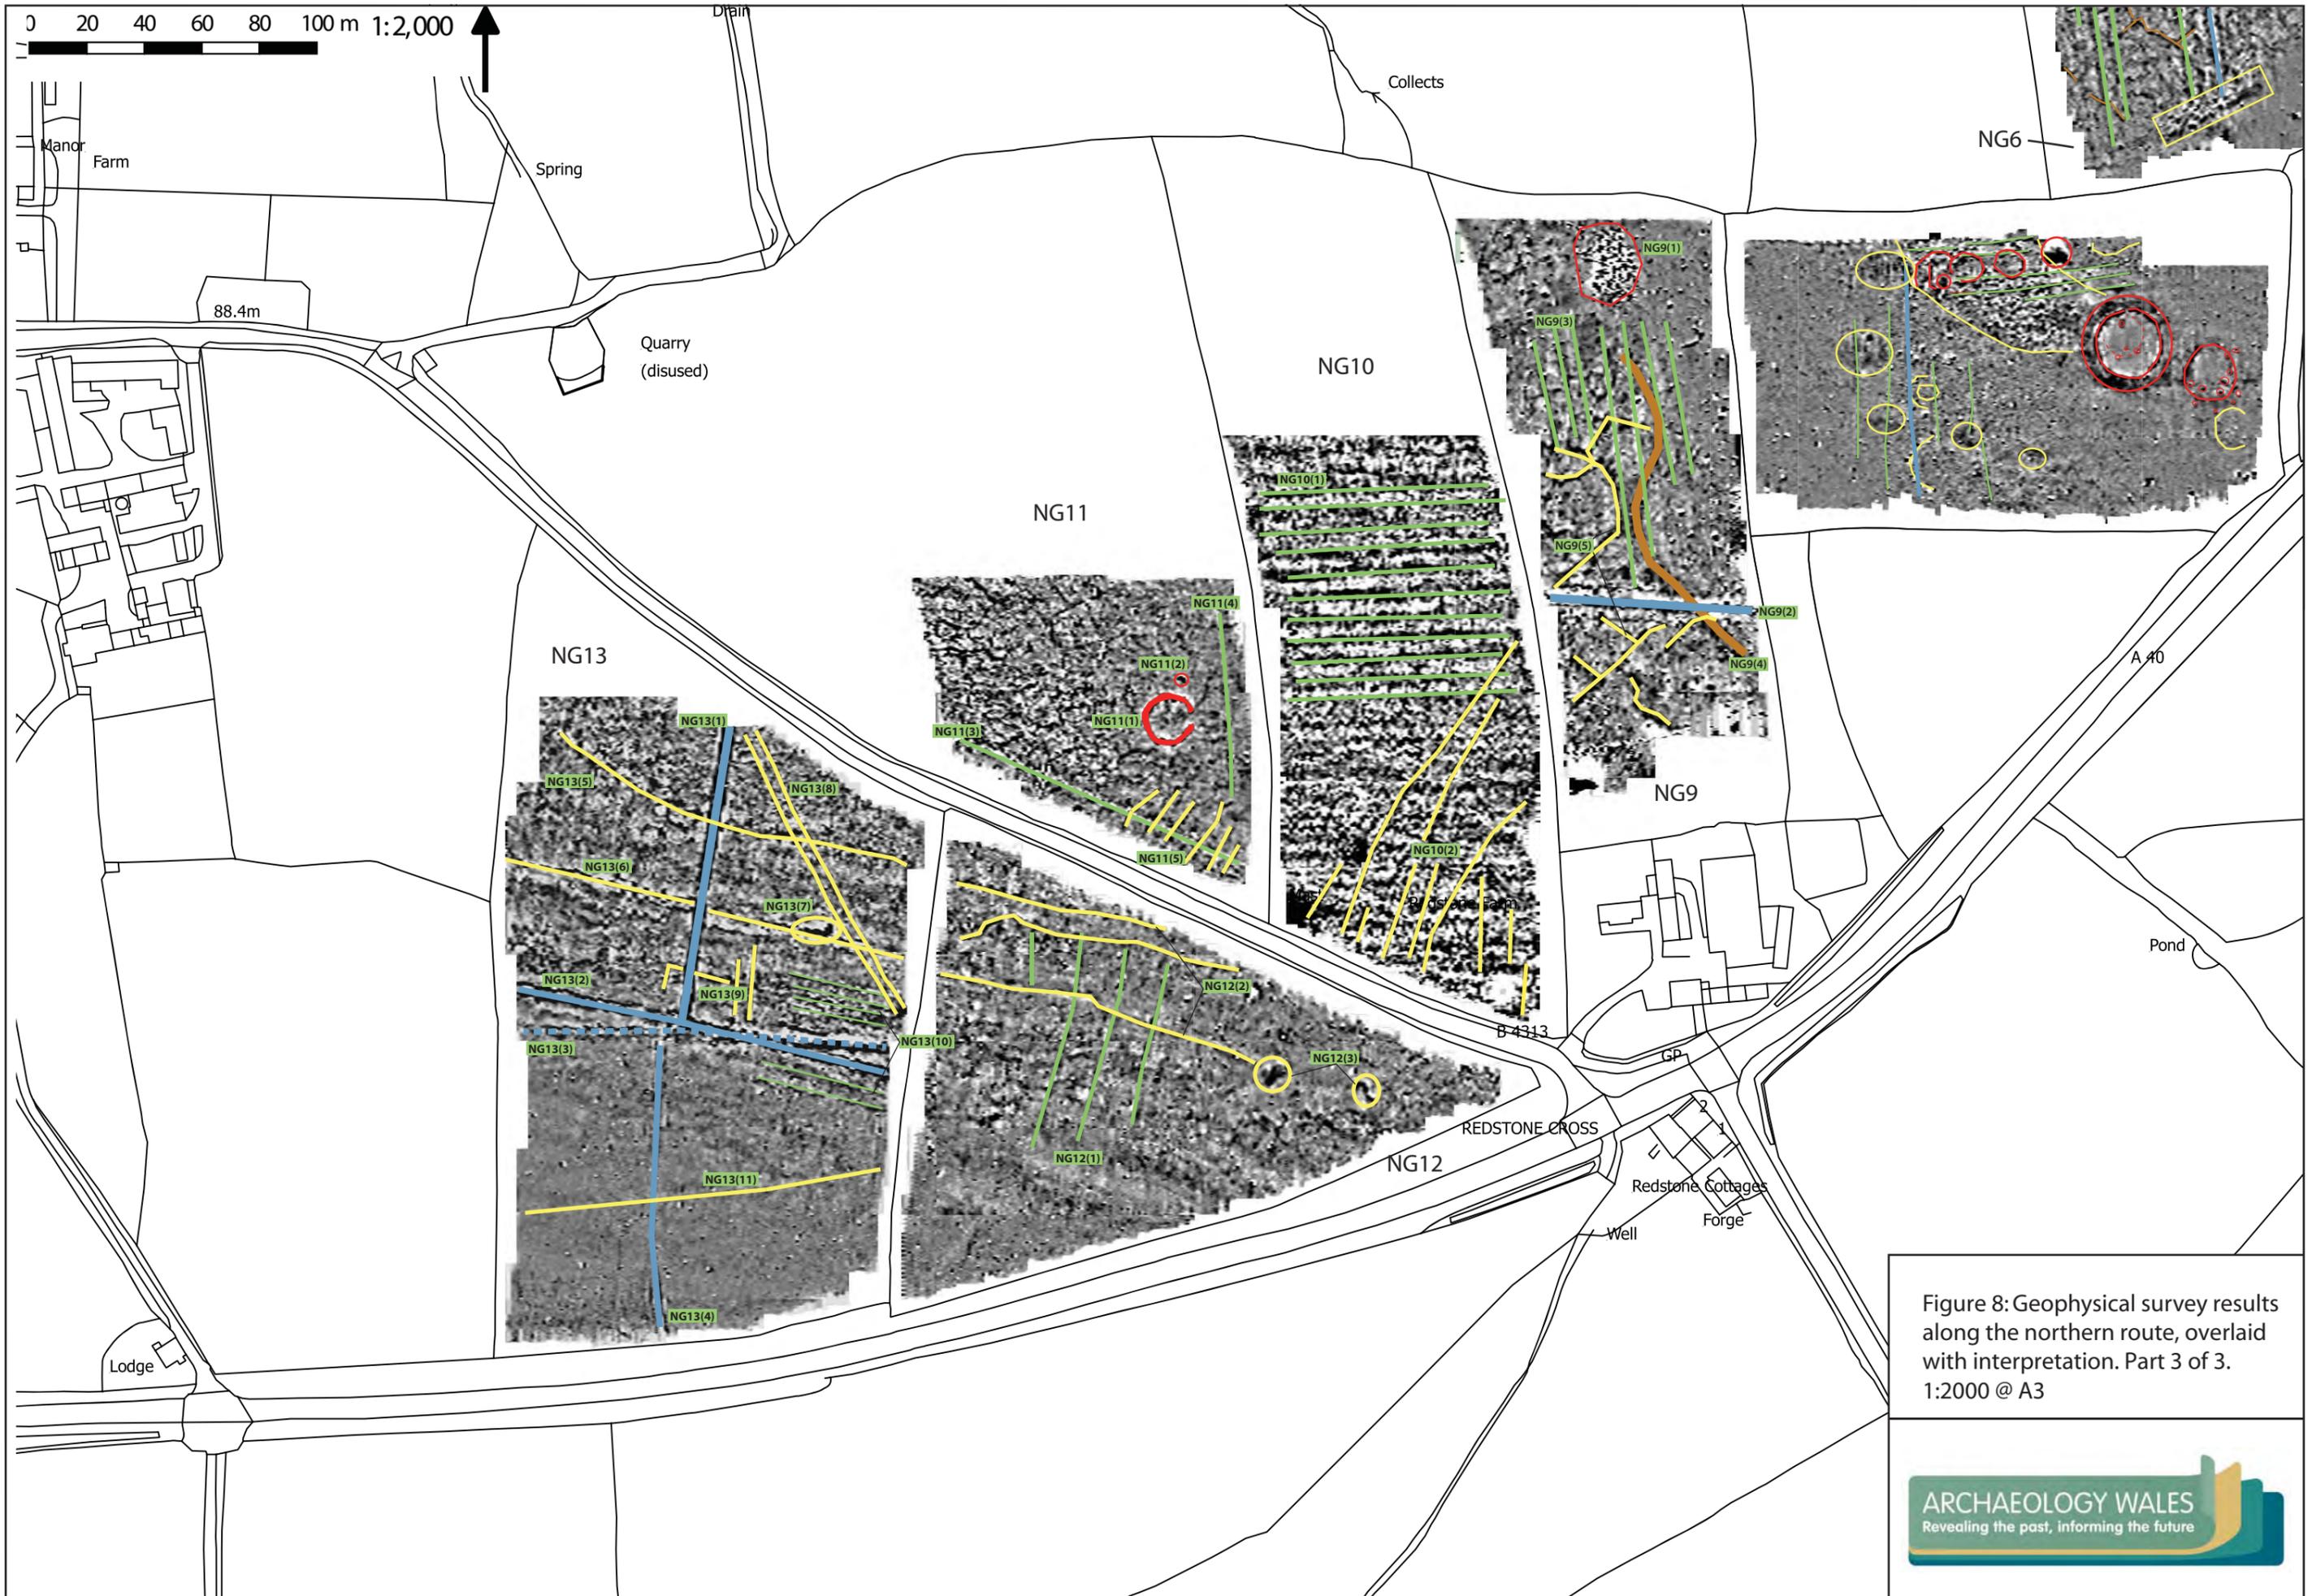
Figure 8: Geophysical survey results along the northern route, overlaid with interpretation. Part 3 of 3.
1:2000 @ A3

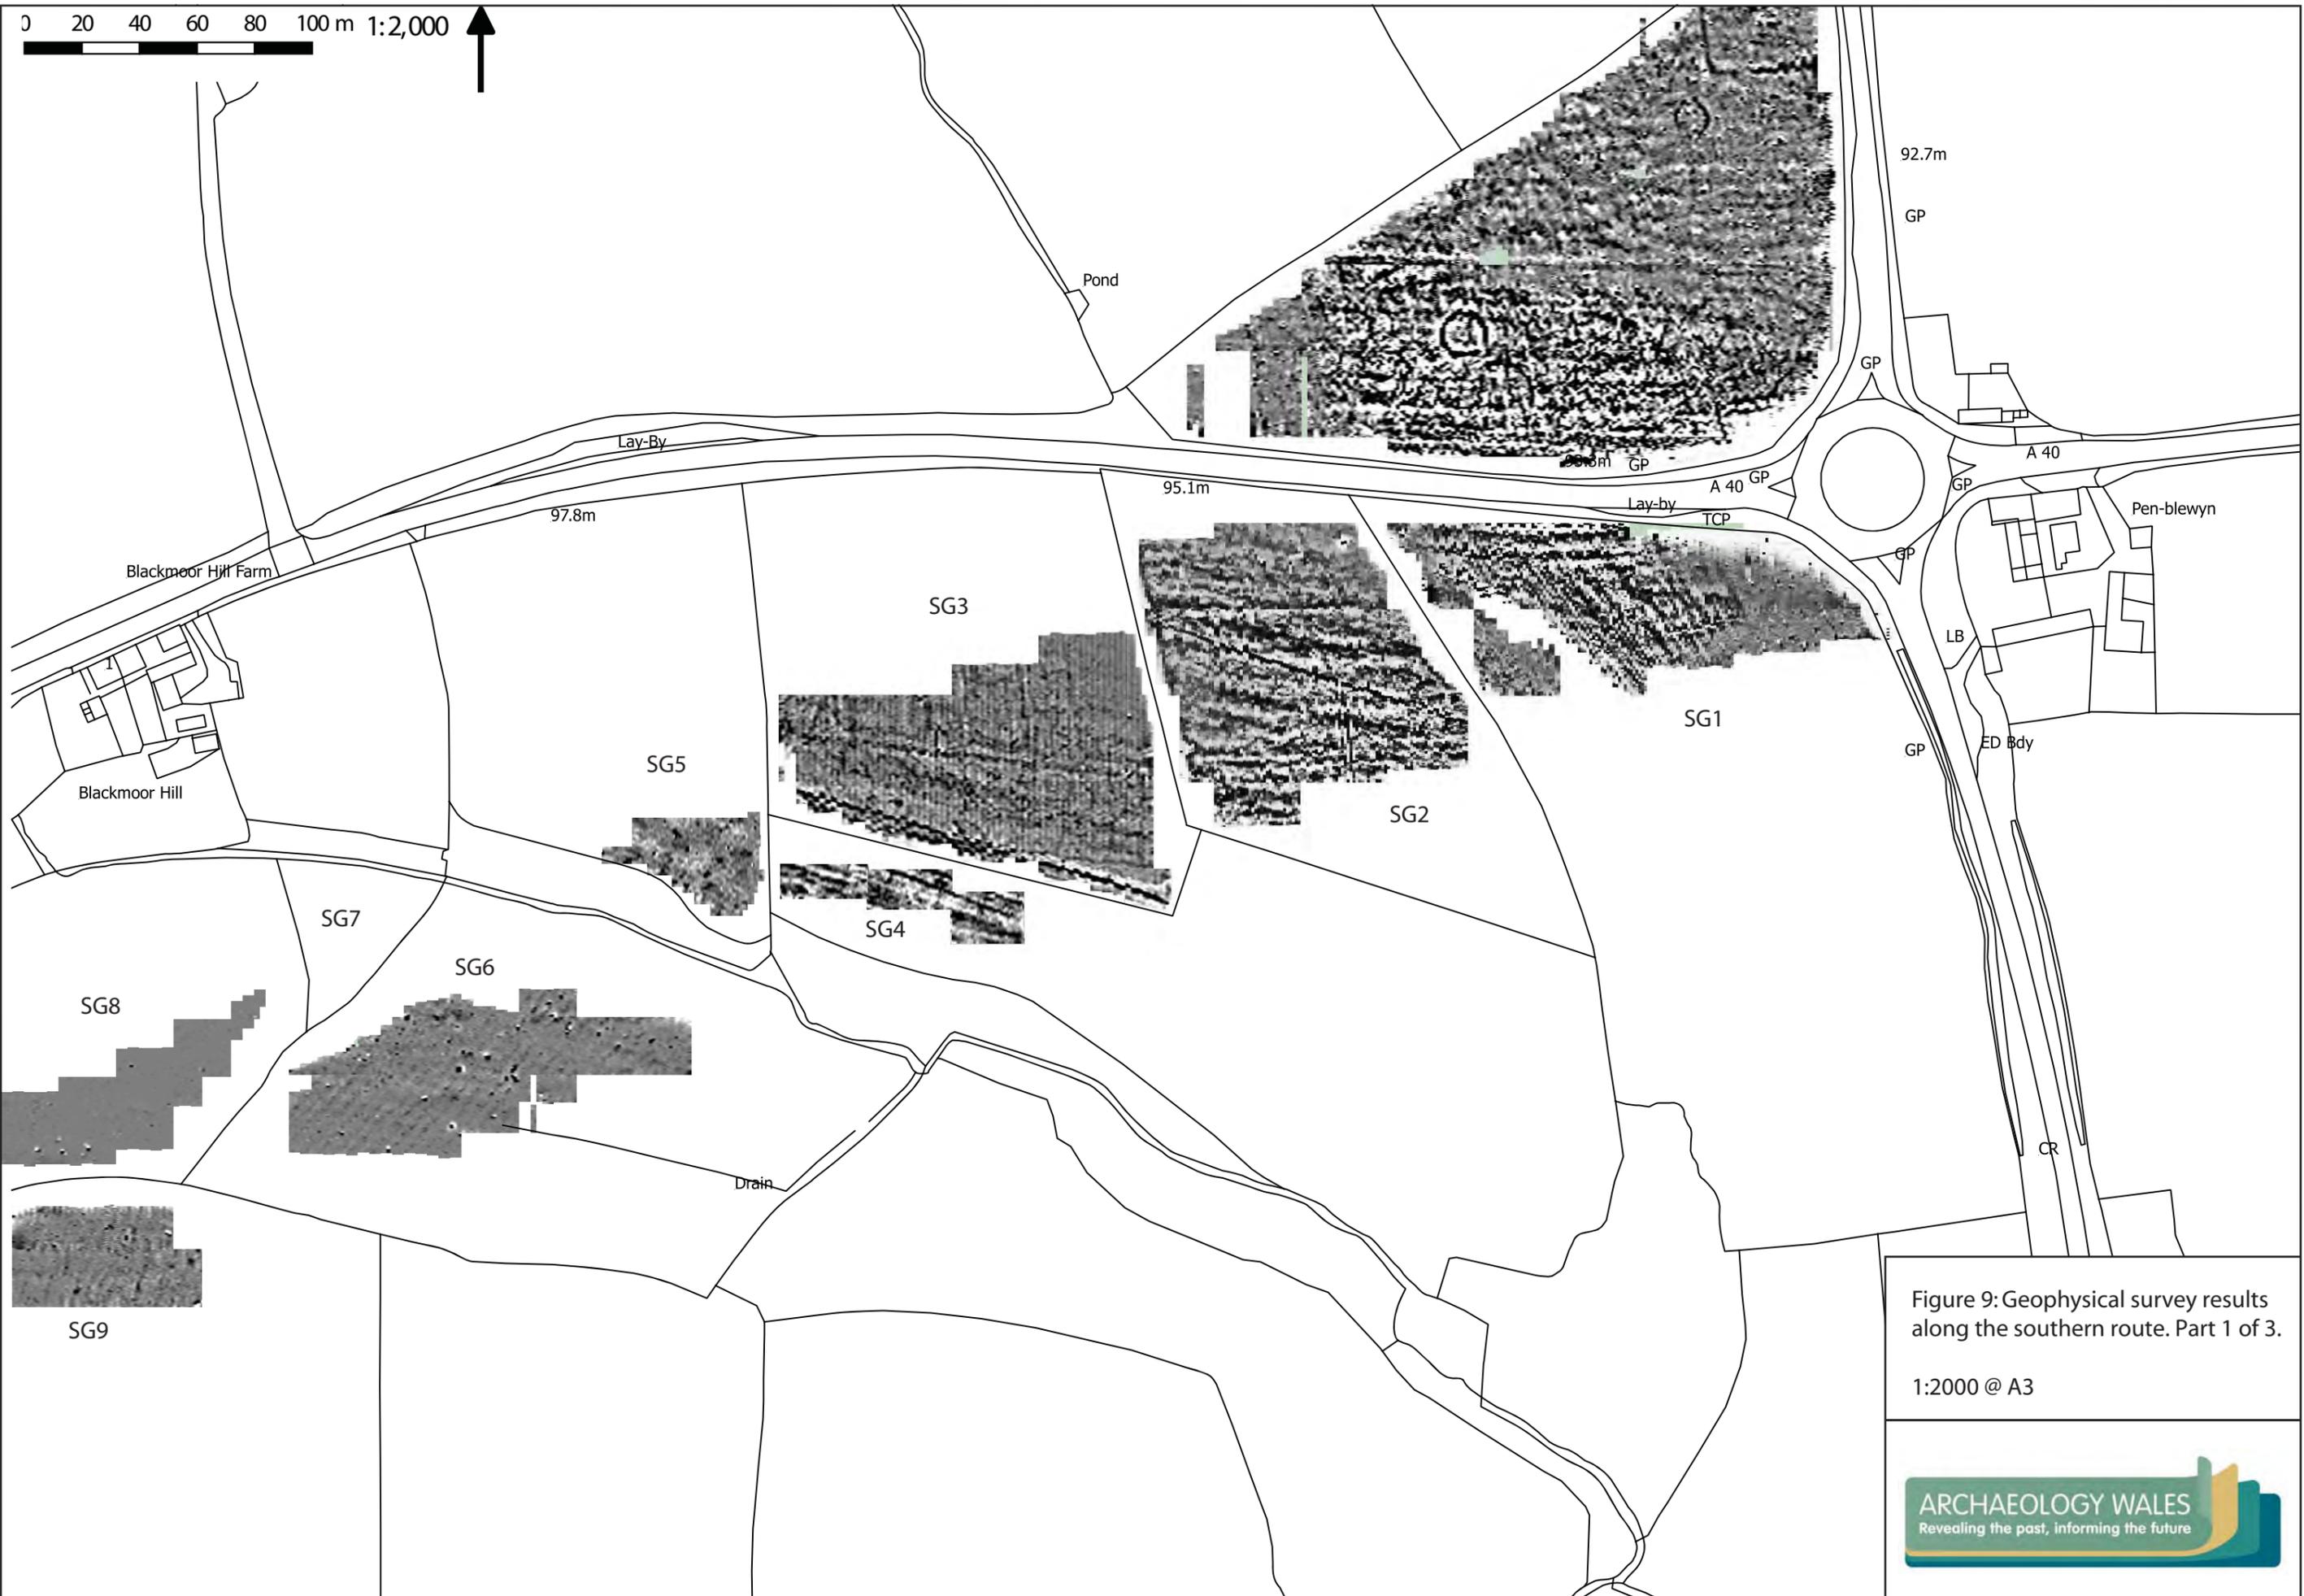
Figure 9: Geophysical survey results along the southern route. Part 1 of 3.
1:2000 @ A3

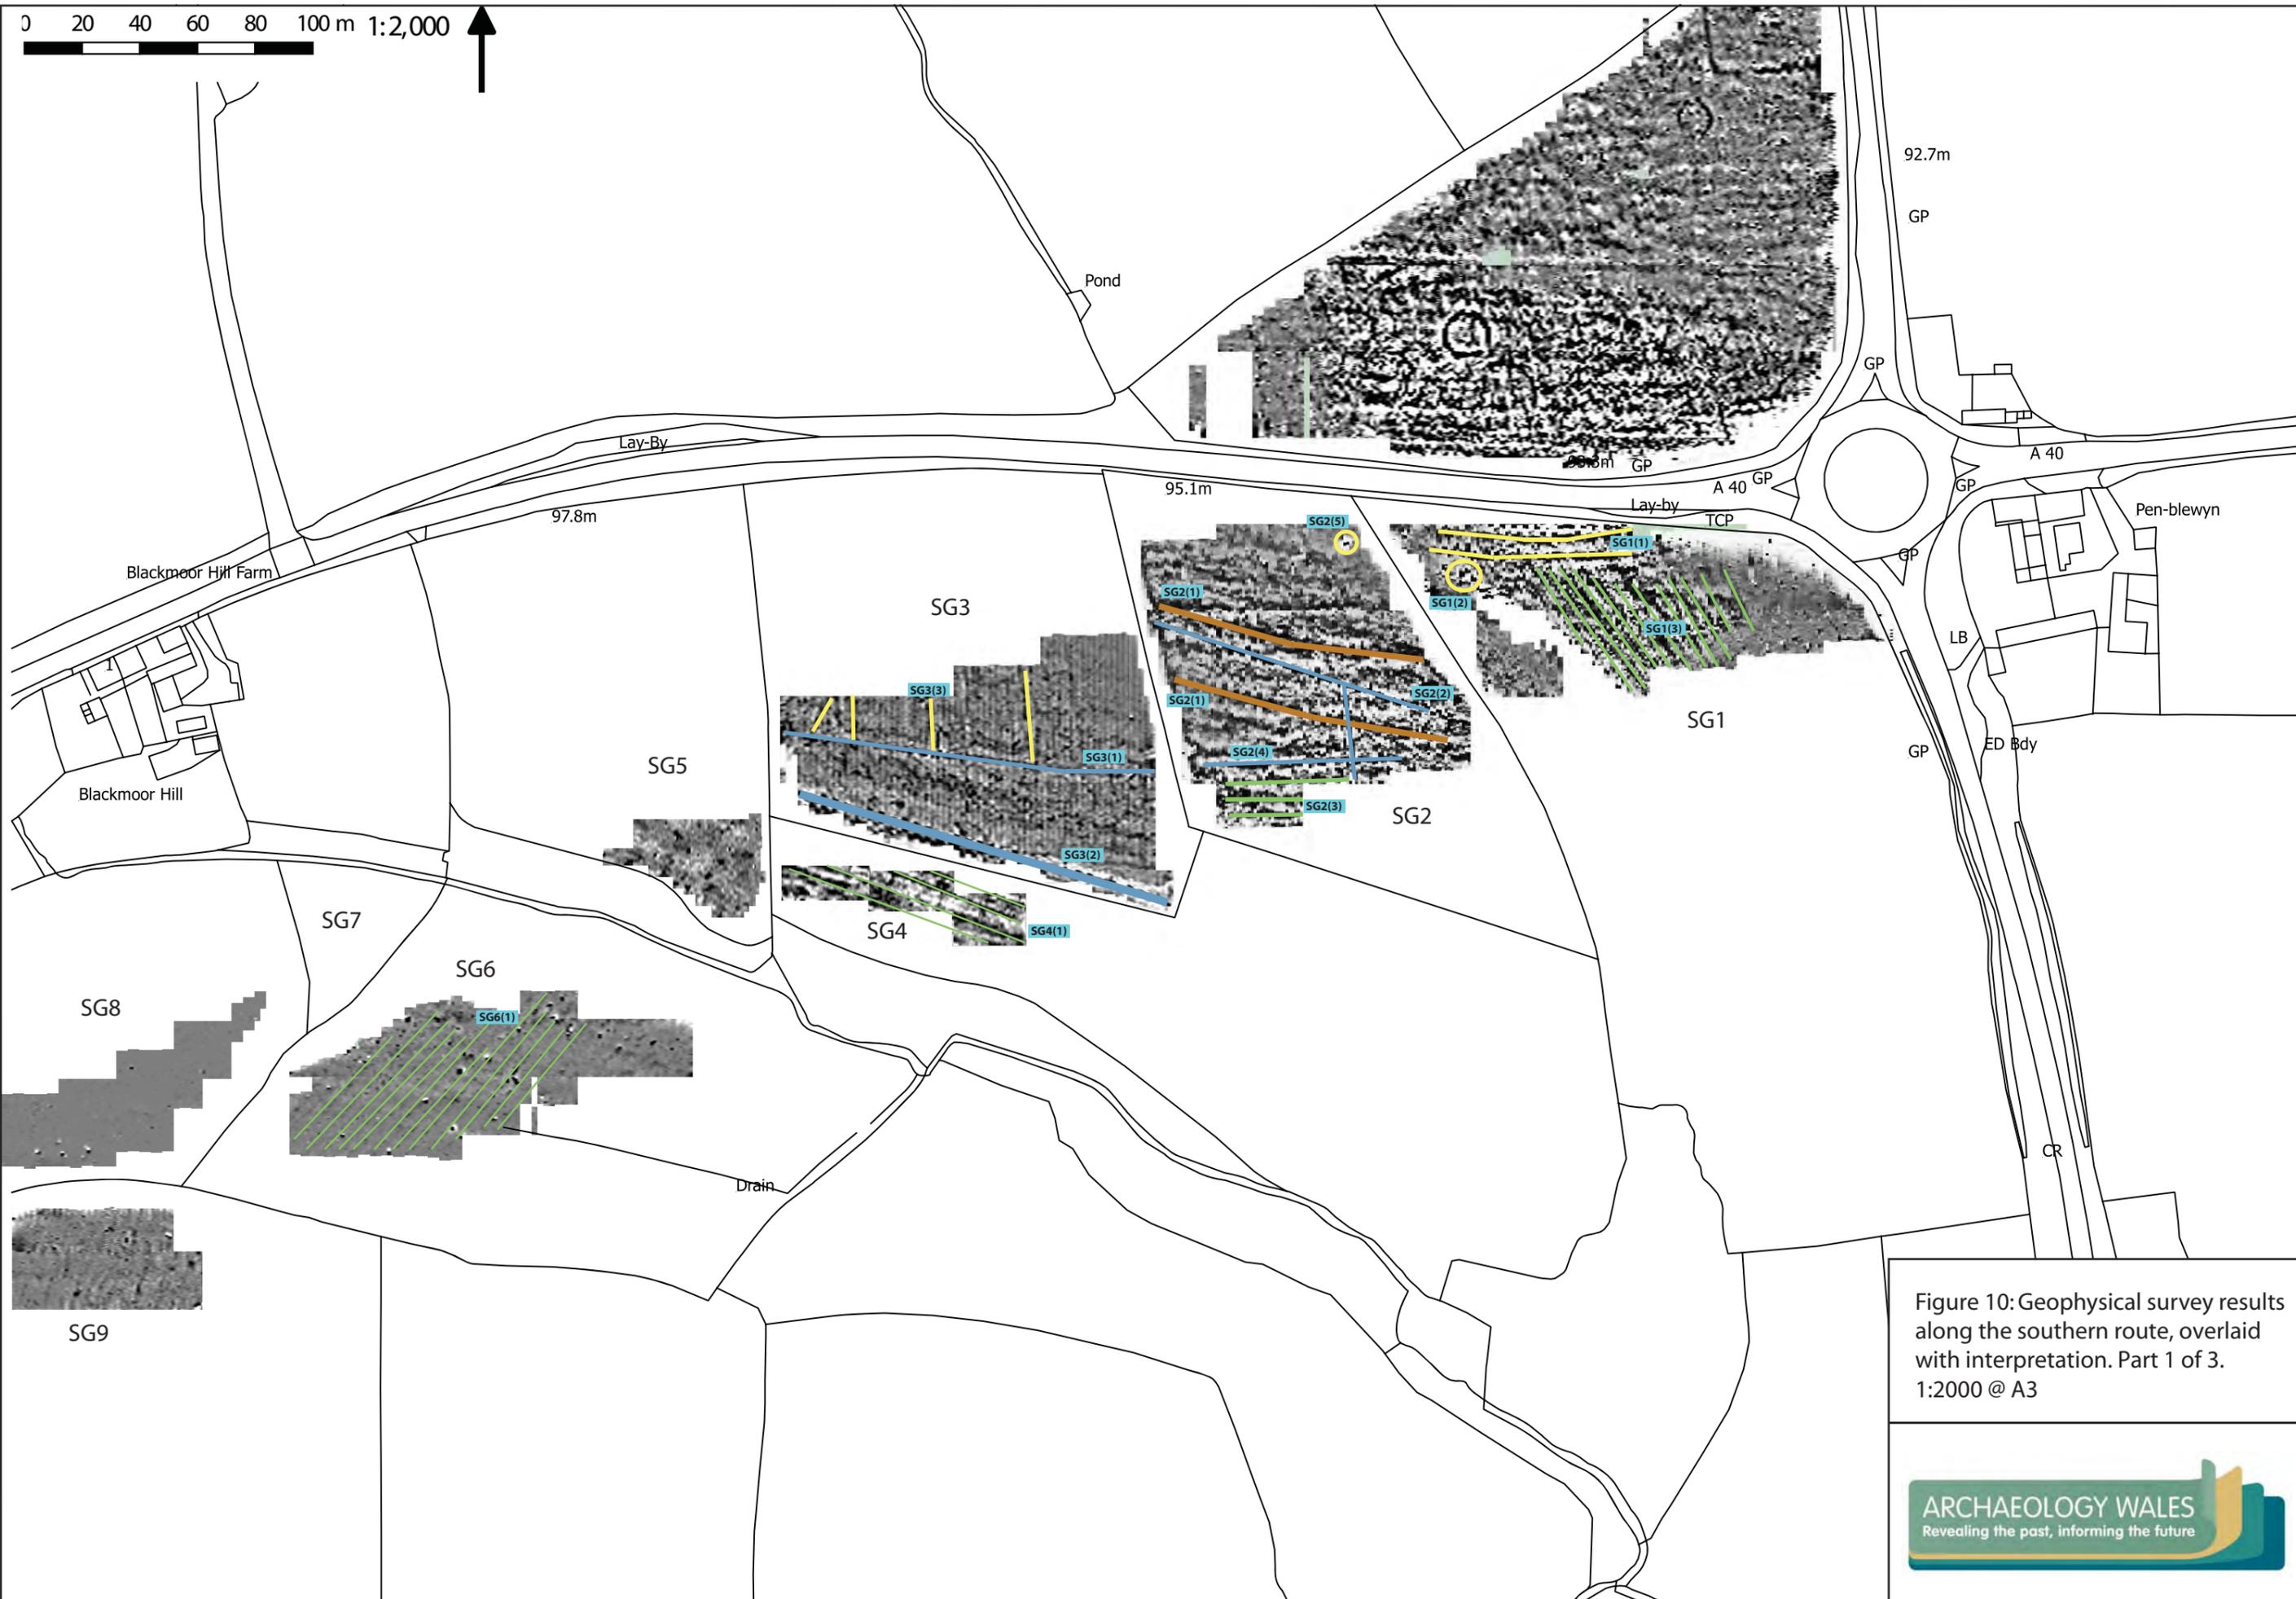
Figure 10: Geophysical survey results along the southern route, overlaid with interpretation. Part 1 of 3. 1:2000 @ A3

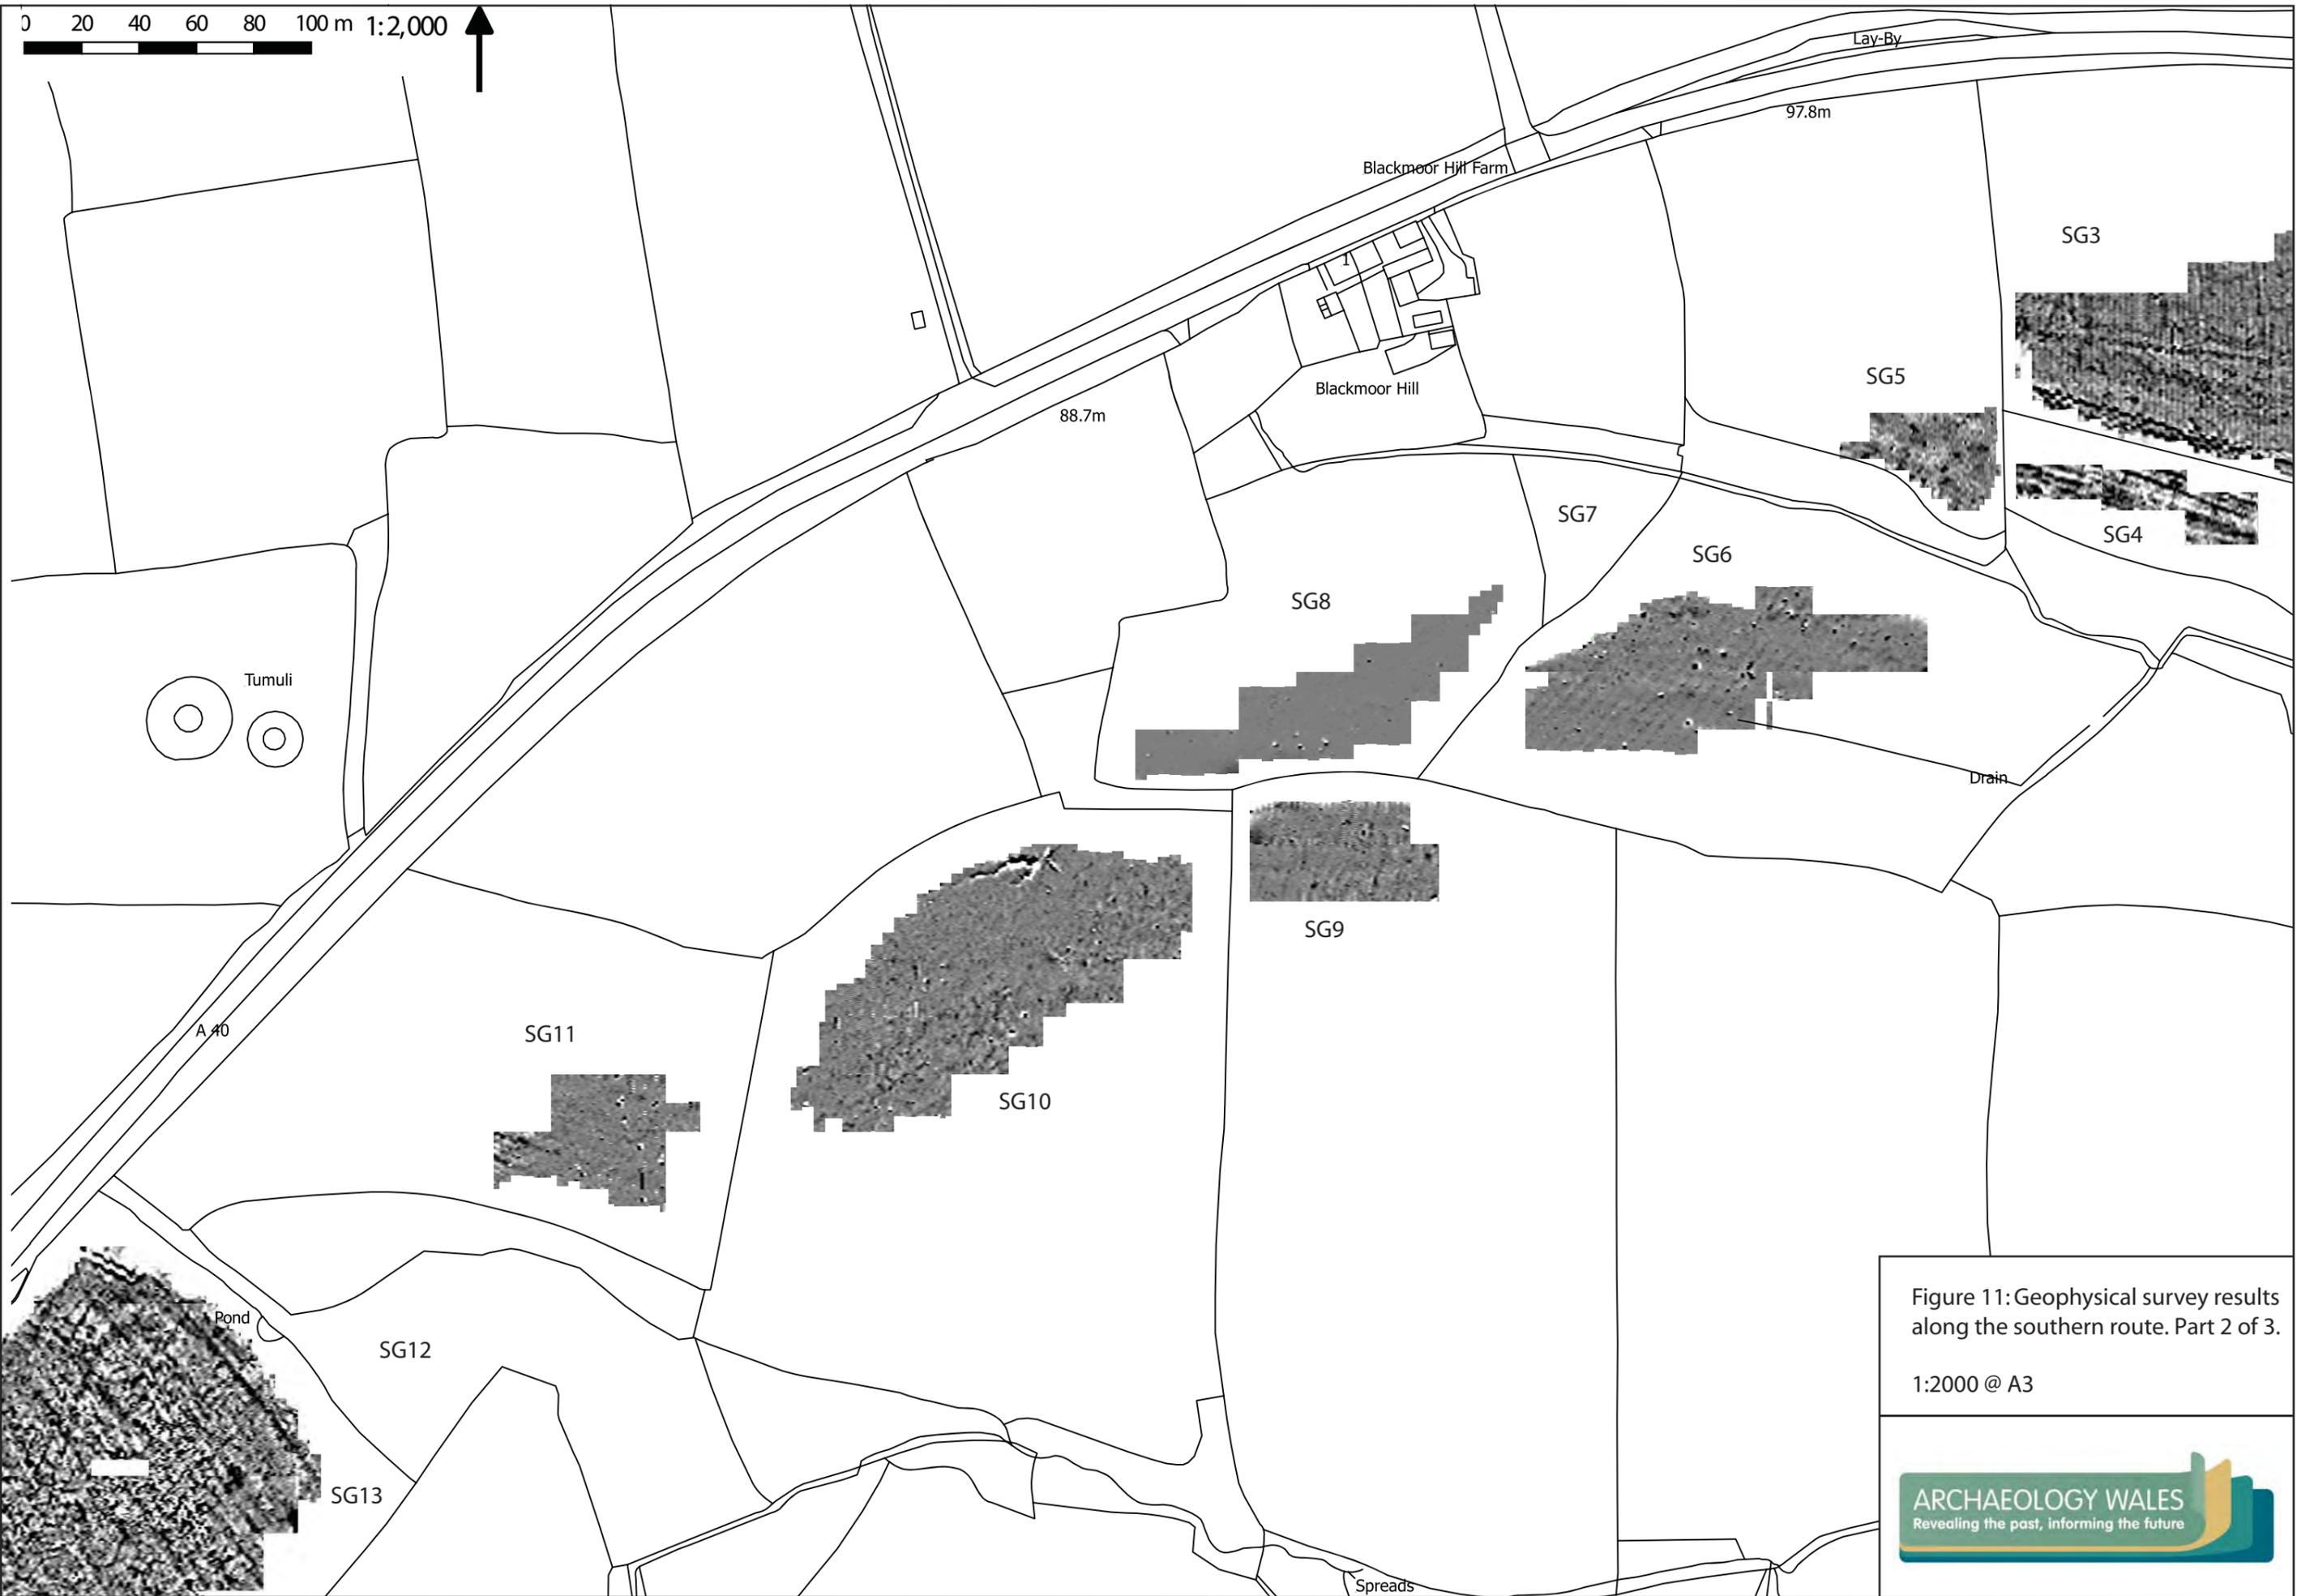
Figure 11: Geophysical survey results along the southern route. Part 2 of 3.
1:2000 @ A3

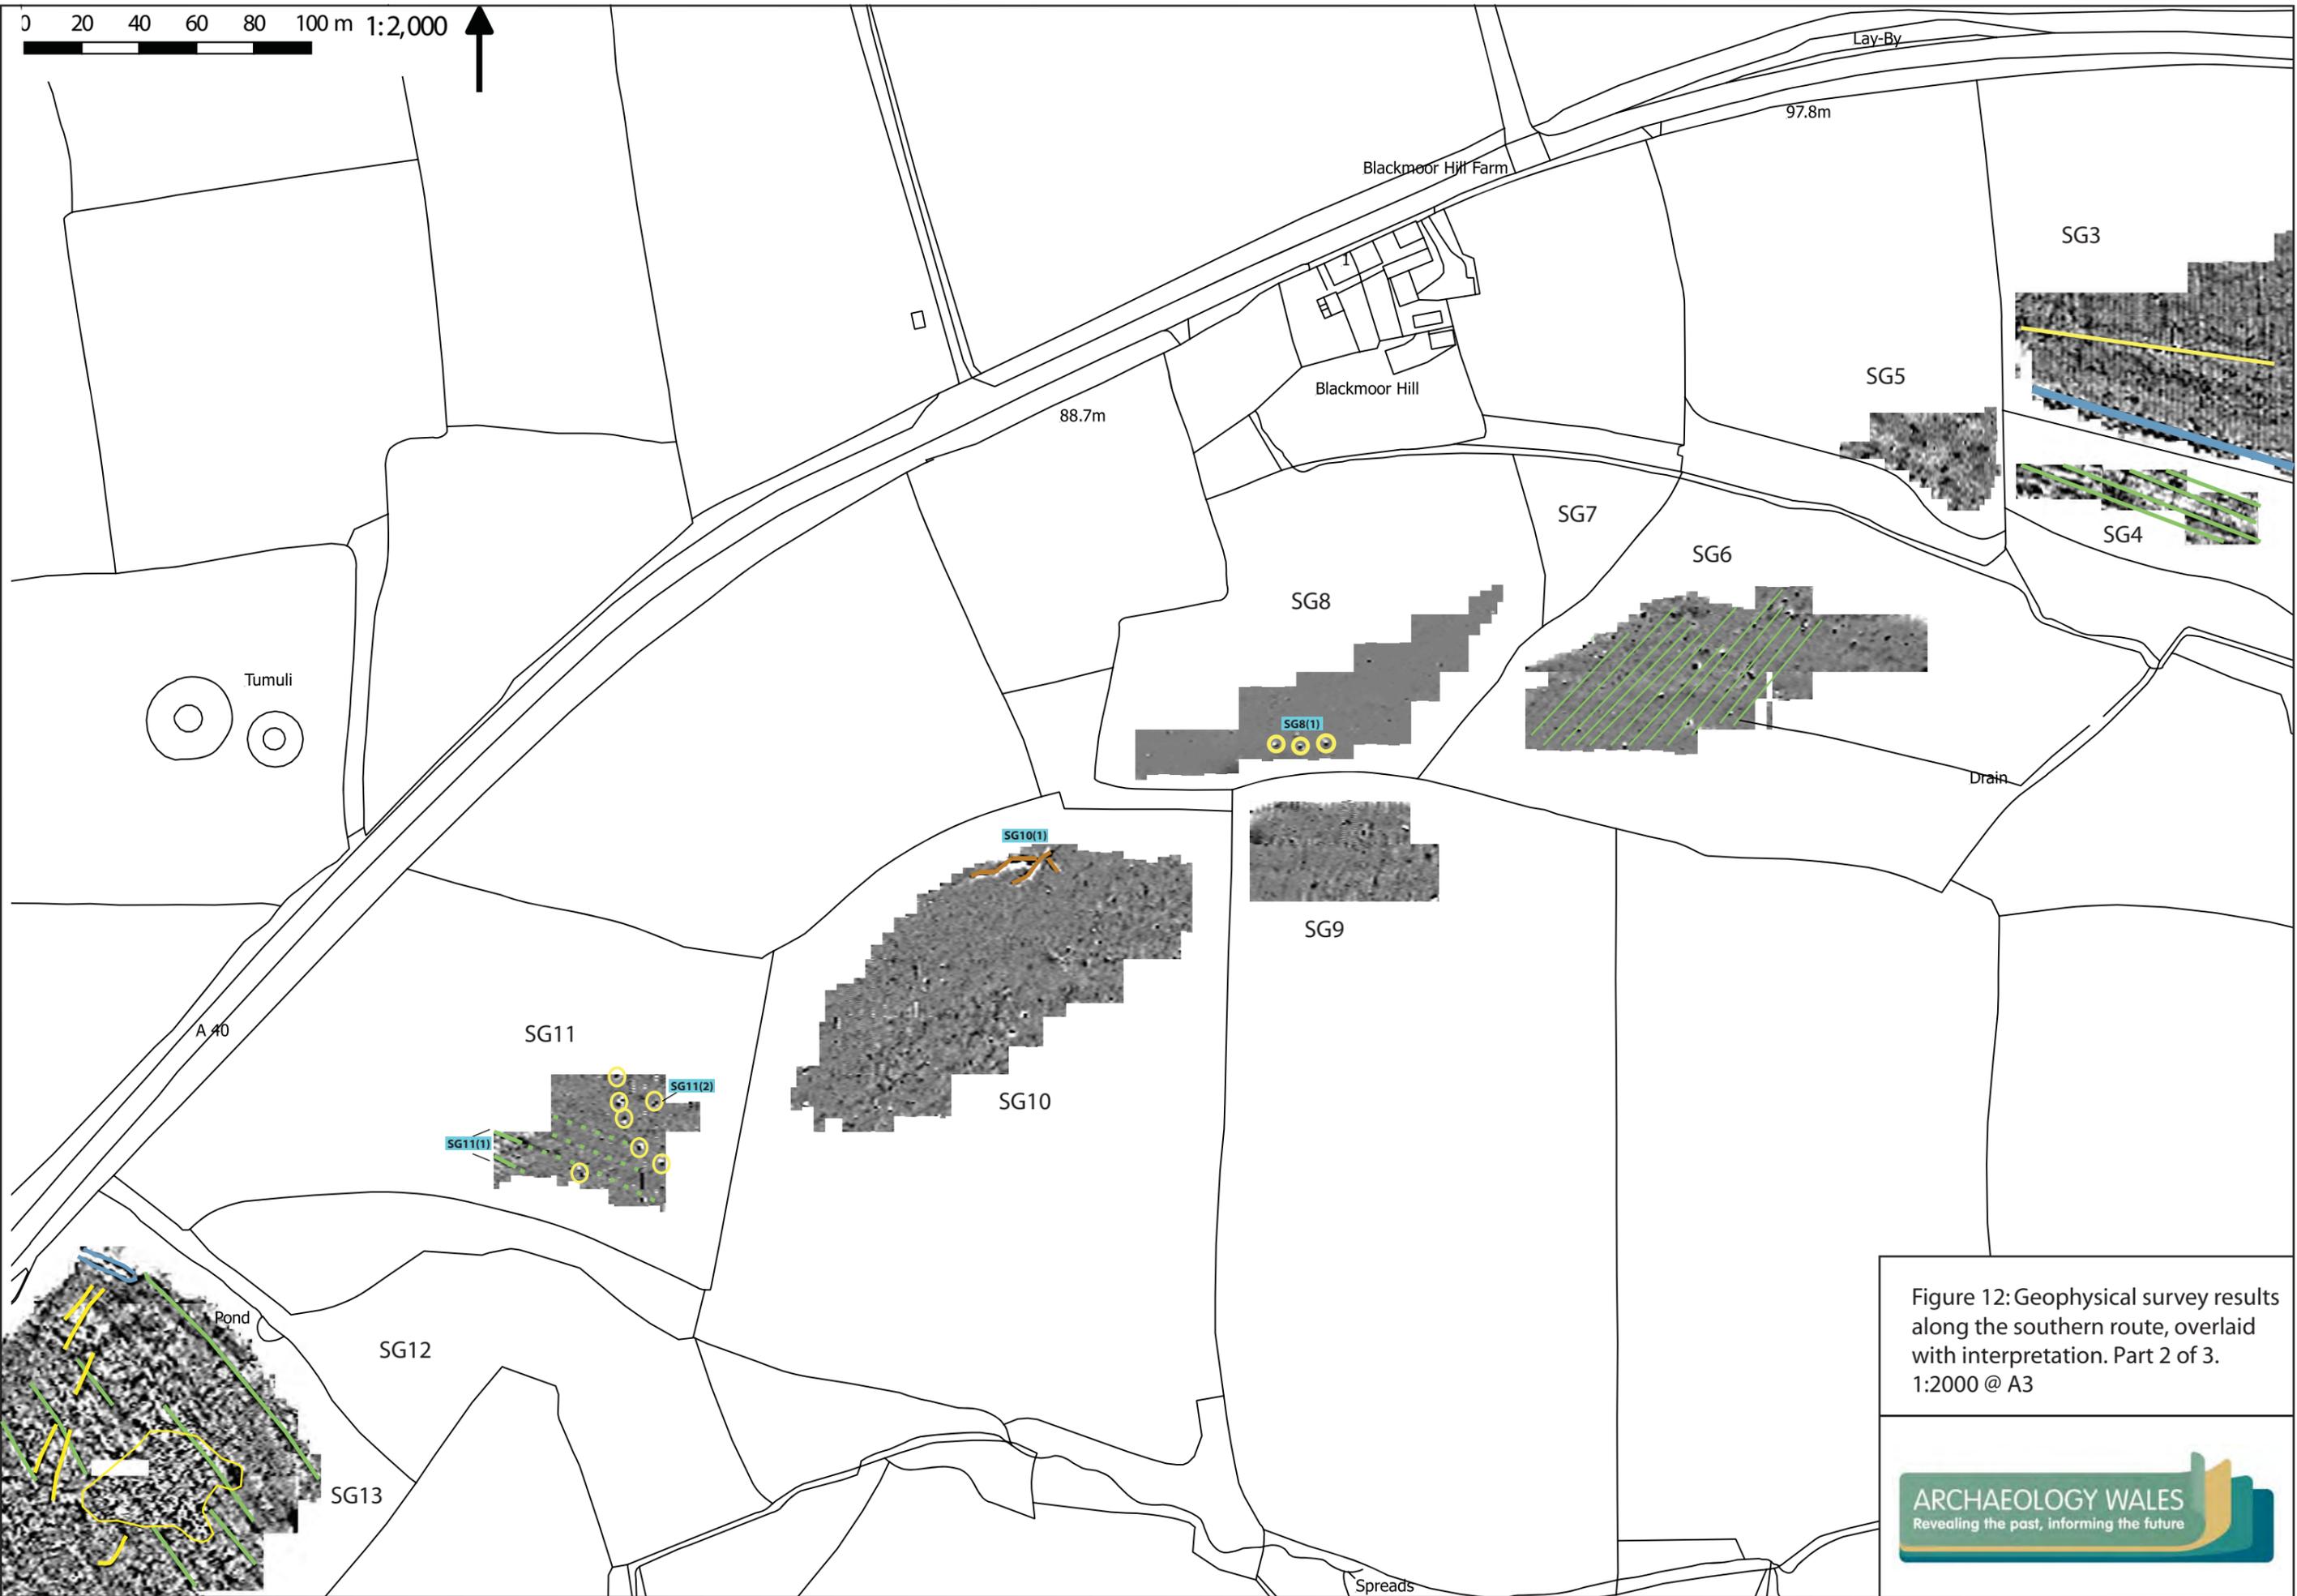
Figure 12: Geophysical survey results along the southern route, overlaid with interpretation. Part 2 of 3. 1:2000 @ A3

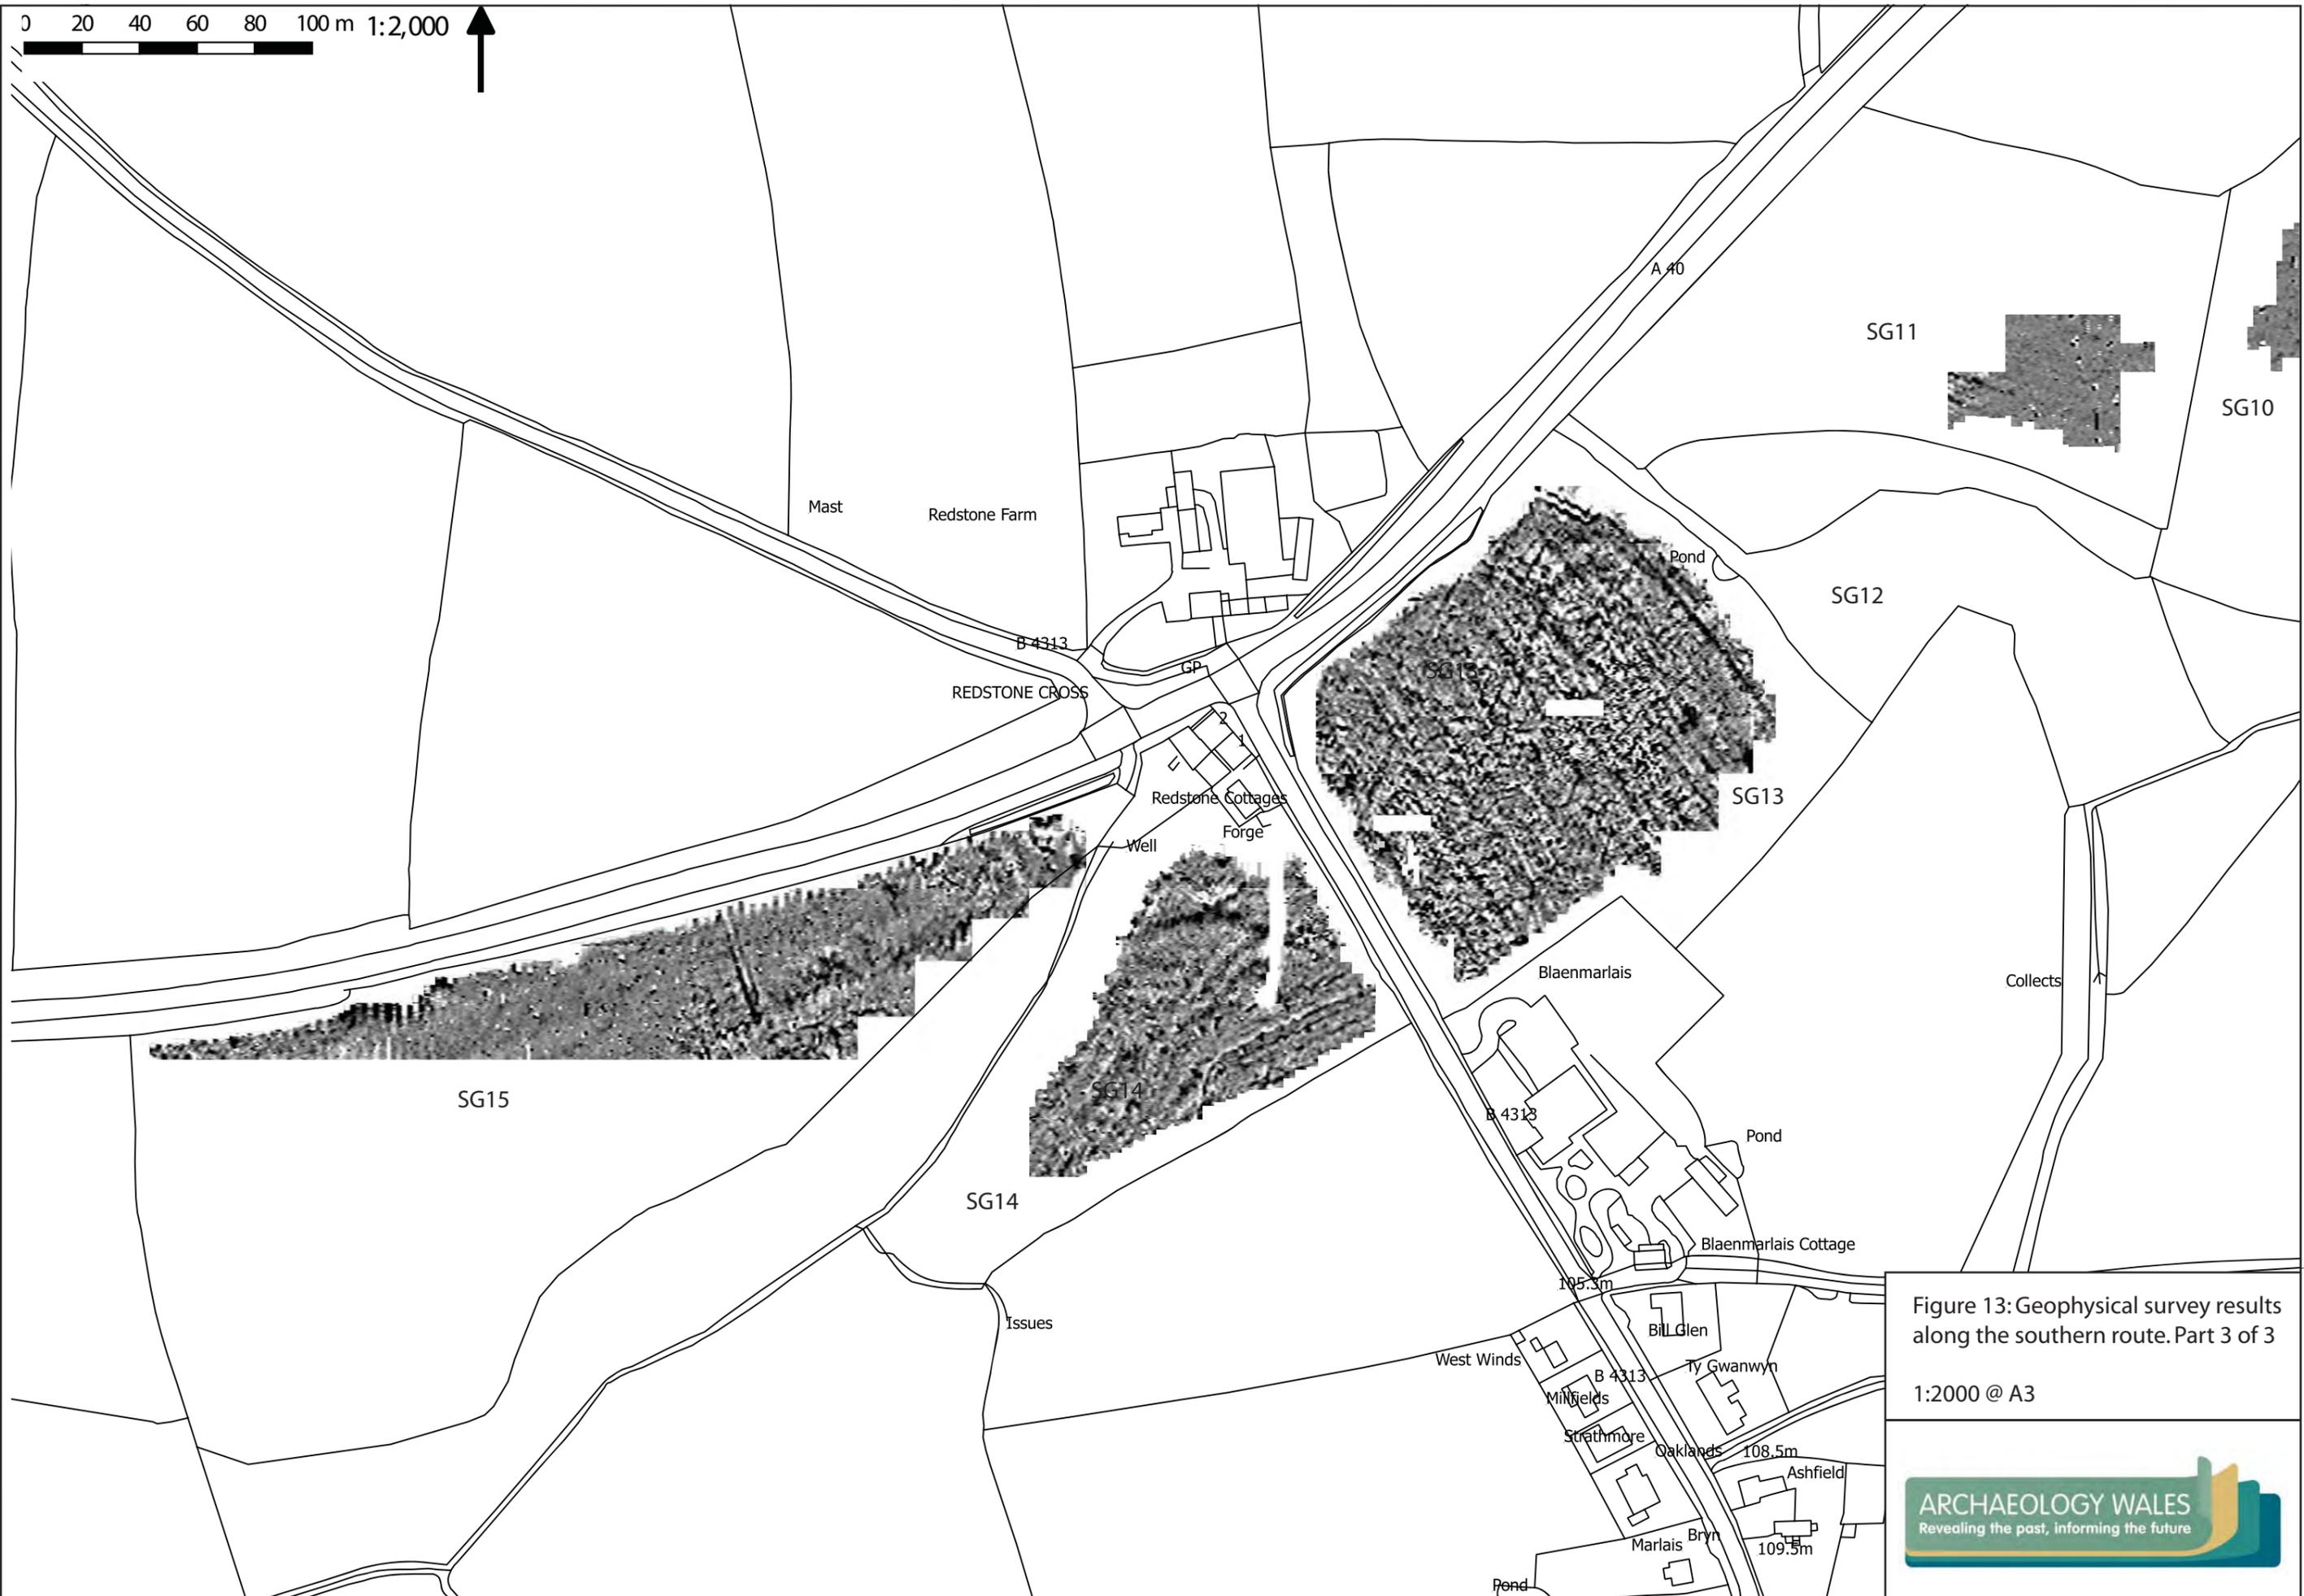
Figure 13: Geophysical survey results along the southern route. Part 3 of 3
1:2000 @ A3
