A40 PENBLEWIN TO REDSTONE CROSS IMPROVEMENTS

ENVIRONMENTAL STATEMENT
VOLUME 3C: TECHNICAL APPENDICES

July 2020

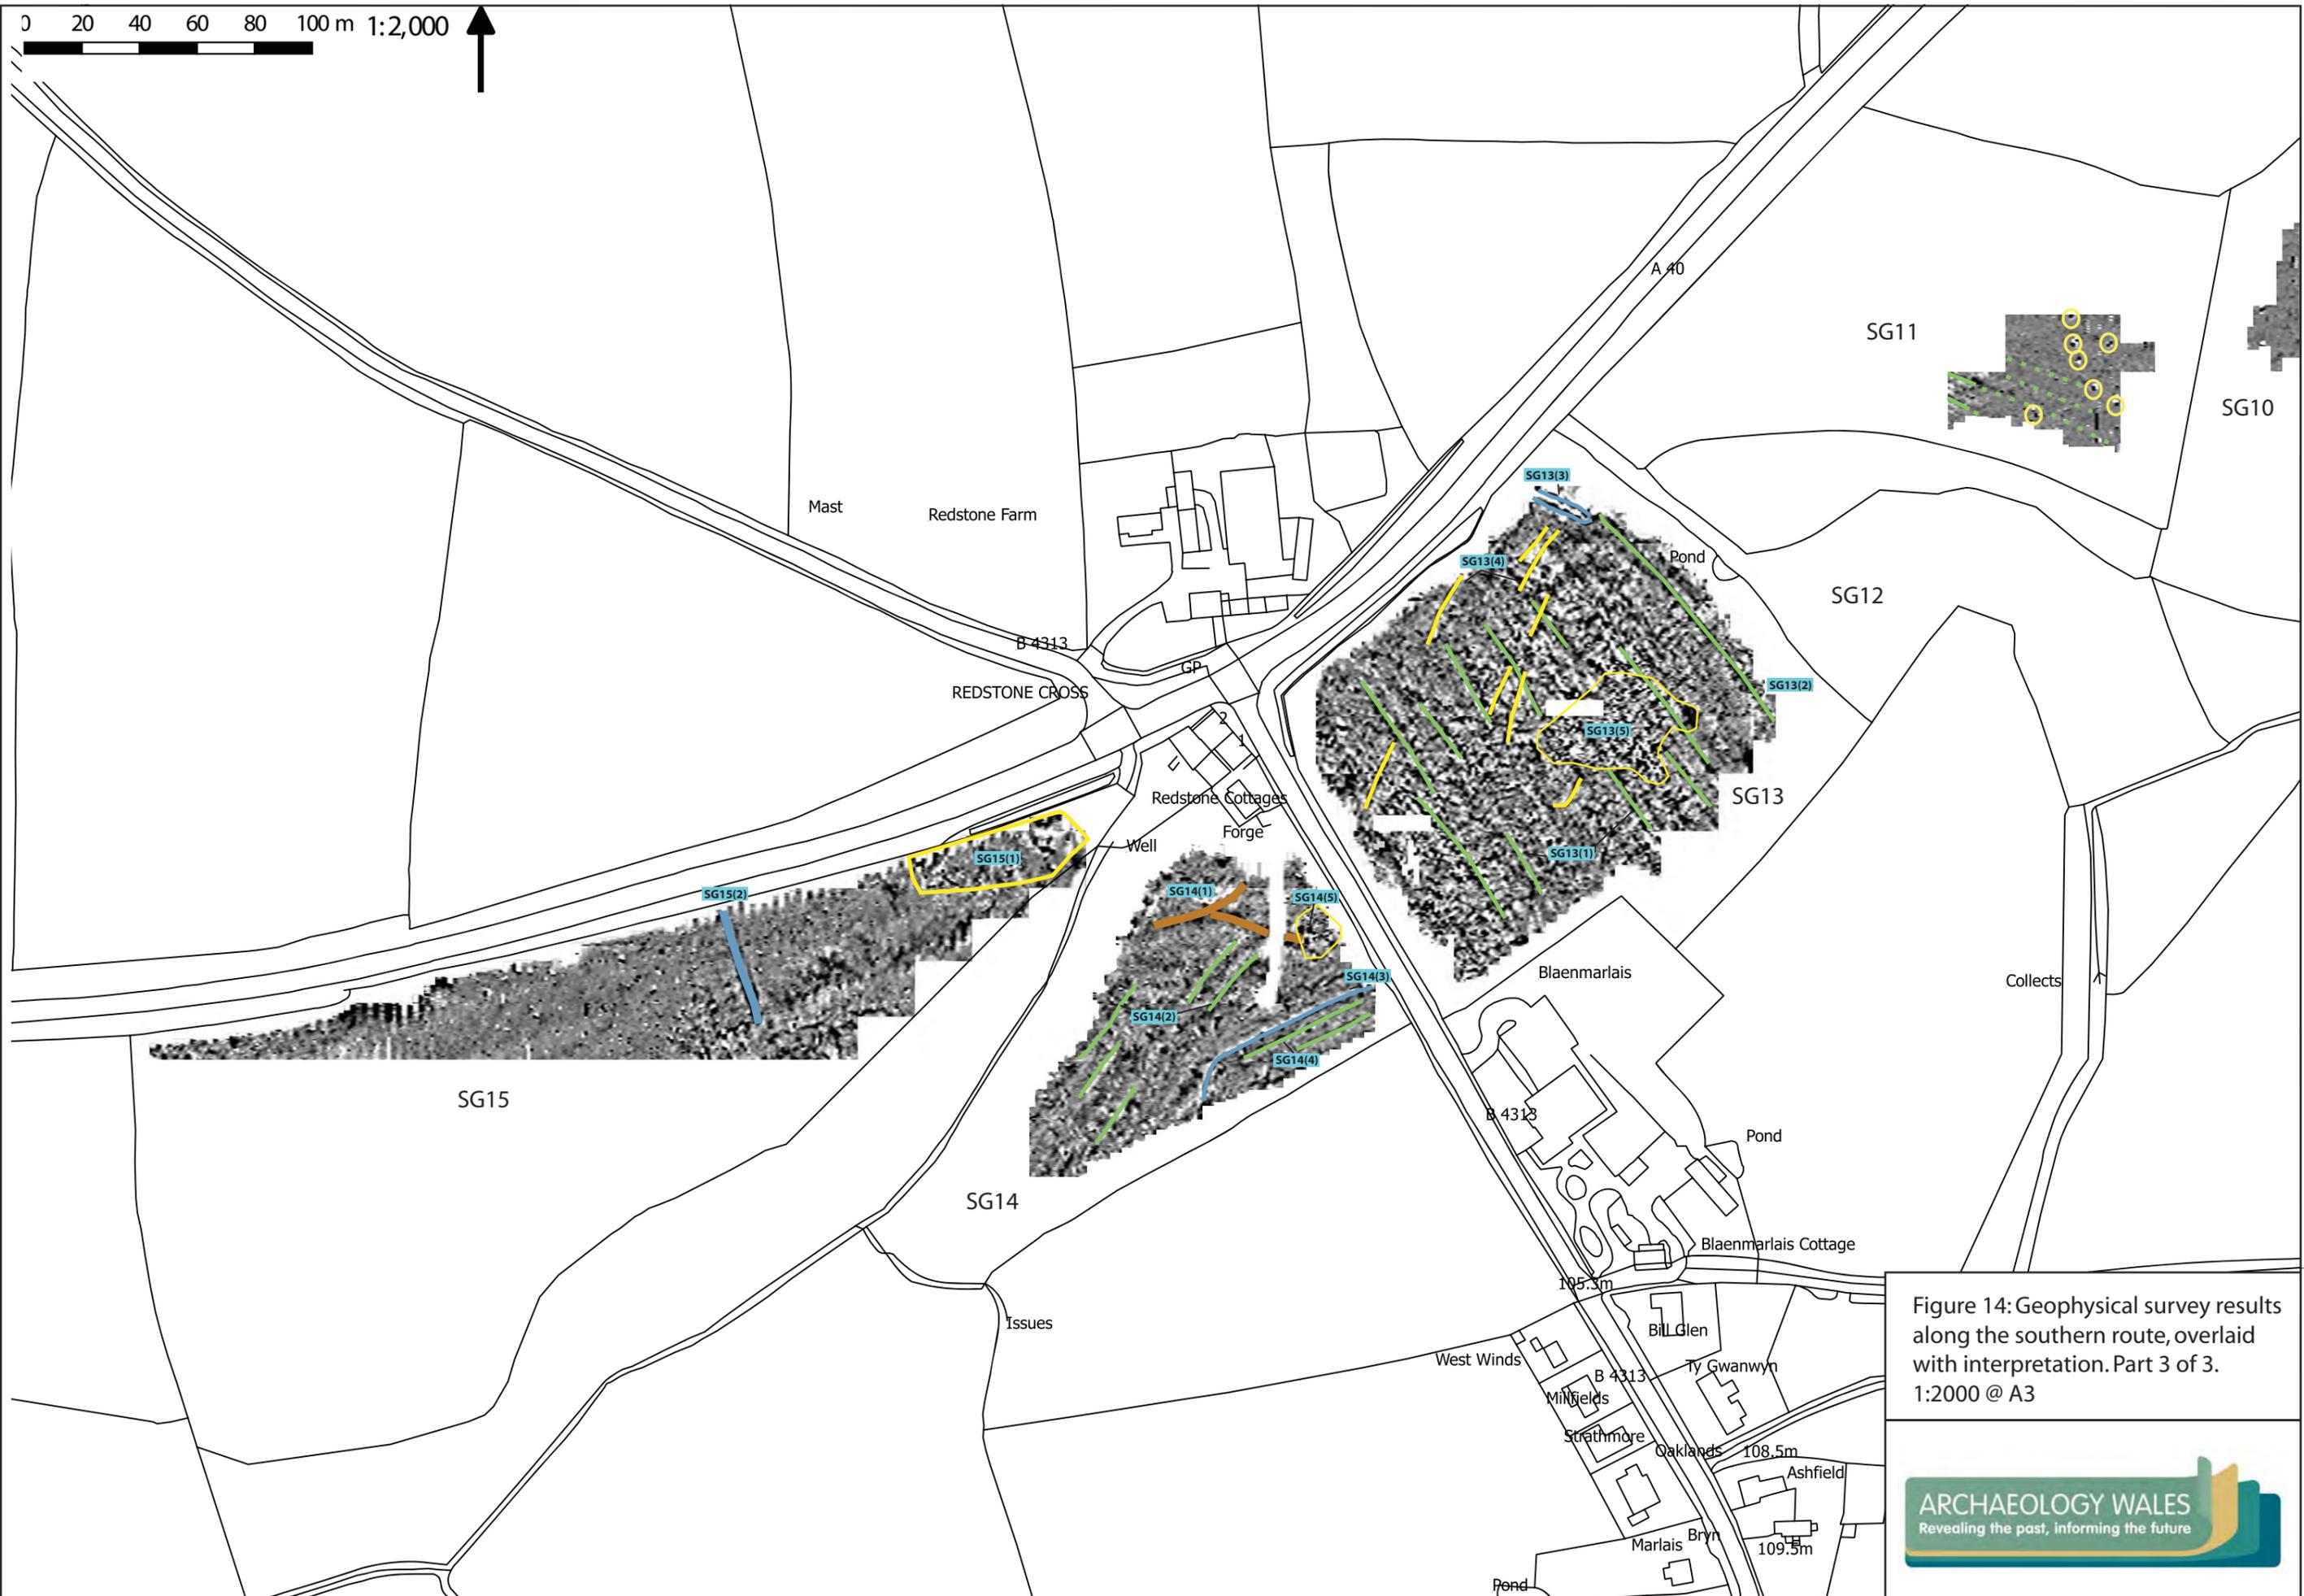
Figure 14: Geophysical survey results along the southern route, overlaid with interpretation. Part 3 of 3. 1:2000 @ A3

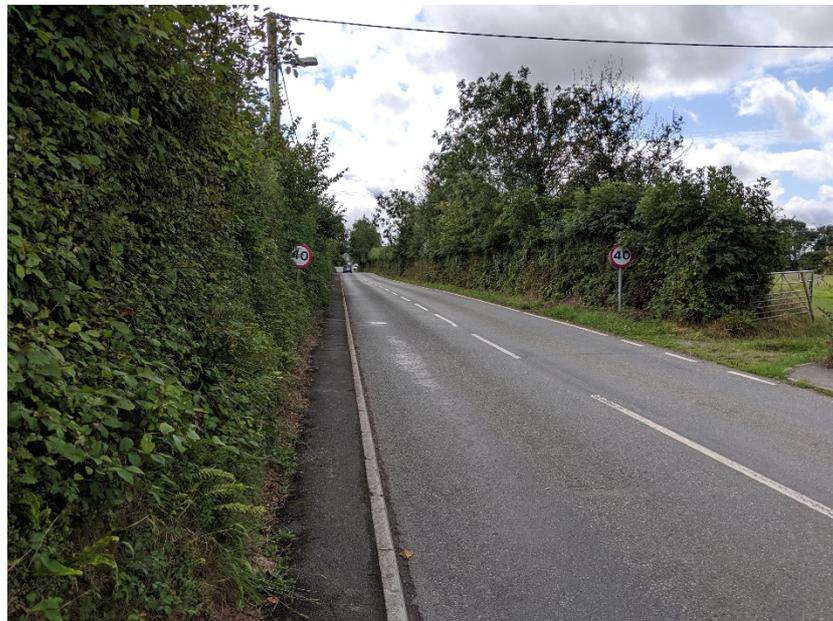
- f) The footway along the B4313 was generally very narrow and overgrown, as shown in Figure 7. The footway width reduced as the distance from Narberth town centre increased. The footway extended to Redstone Cross Junction.

Figure 7: Footway along the B4313 Redstone Road

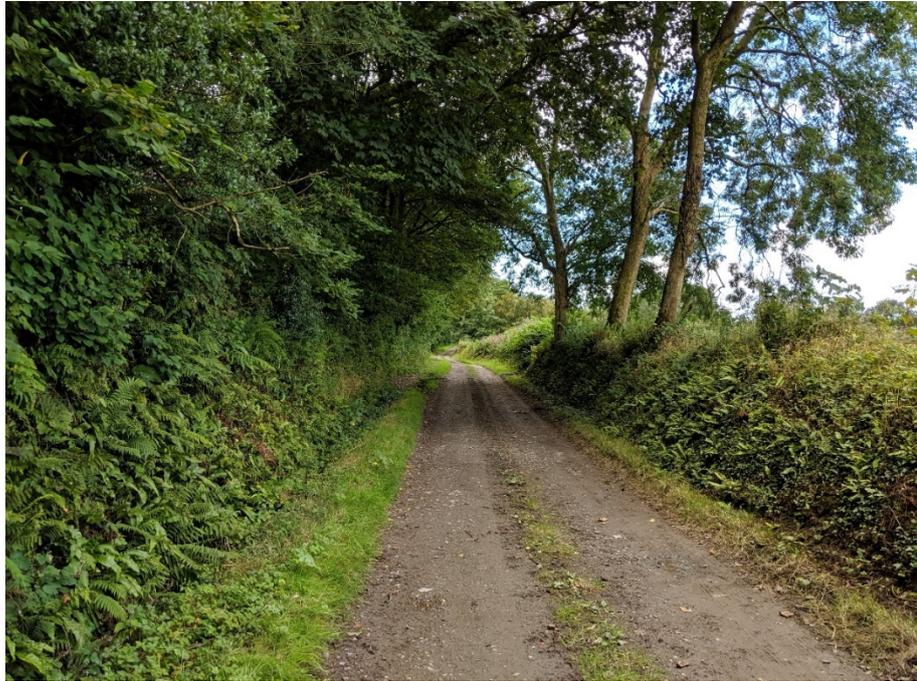
to Blaenffynnonau Farm and was considered suitable for use by pedestrians, horses and mountain bikes, as shown in Figure 8.

Figure 8: Bridleway SP27/2/1 leading to Blaenffynnonau Farm

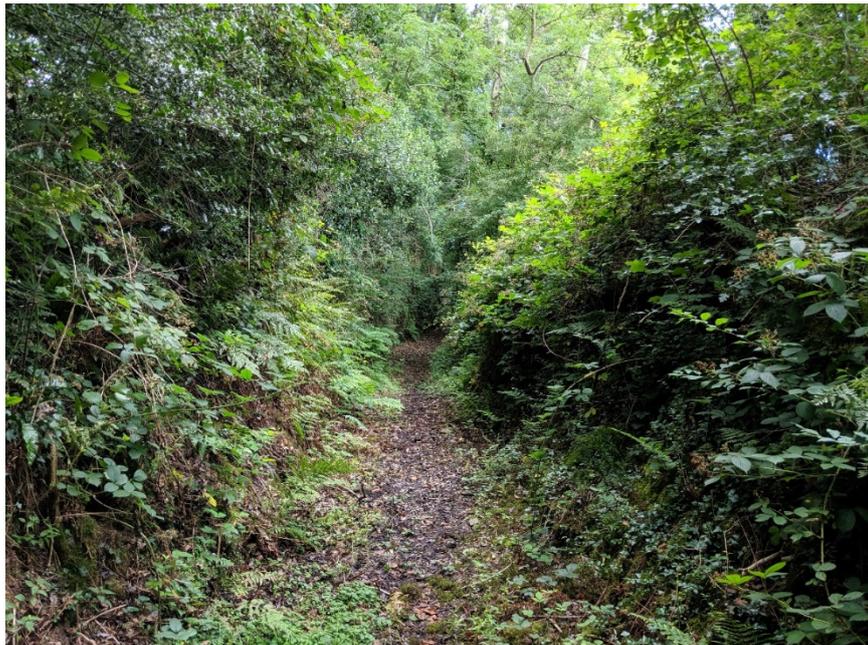
- h) The SP27/2/1 bridleway narrows just east of the Blaenffynnonau Farm. At some sections east of the farm, the bridleway was slightly overgrown, but still in generally good condition (as shown in Figure 9). There was no evidence along the track of recent use by horses, cyclists or pedestrians.

Figure 9: Bridleway SP27/2/1 east of Blaenffynnonau Farm

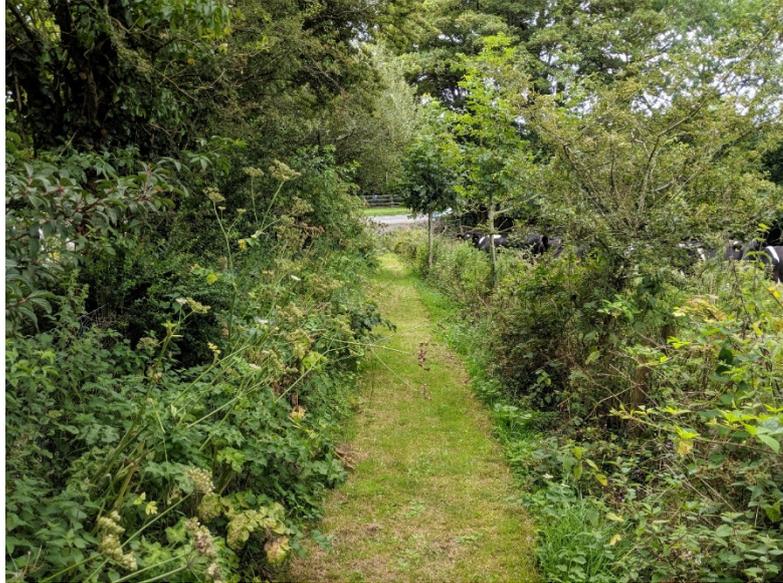
Figure 10: Bridleway SP27/2/1 - grassed path leading to A478

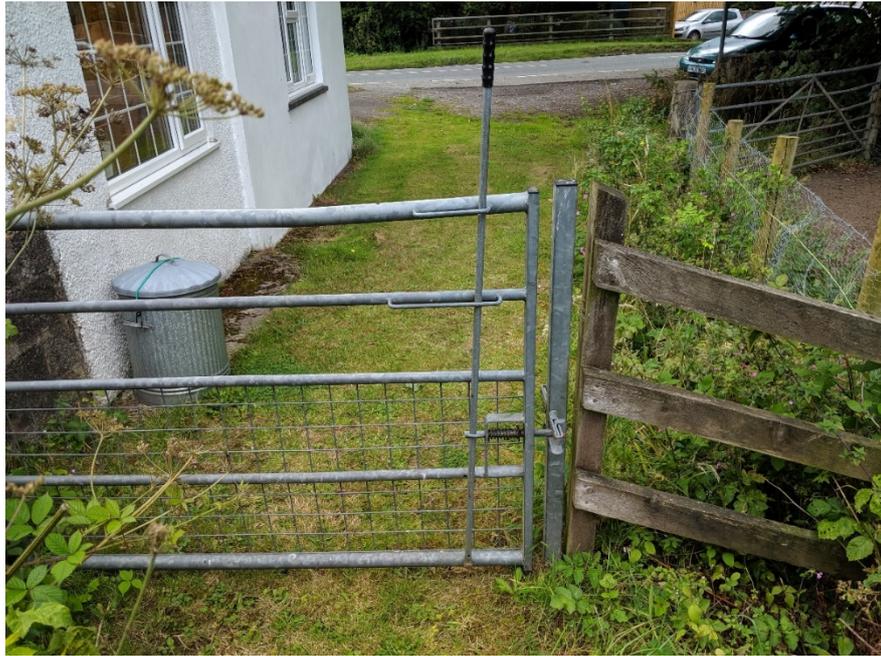
Figure 11: Bridleway SP27/2/1 – gate at eastern end
