M4 Corridor around Newport

Environmental Statement Volume 3: Appendix 10.8 Otter and Water Vole Survey 2014

M4CaN-DJV-EBD-ZG_GEN-AX-EN-0028

Welsh Government M4 Corridor Around Newport Otter and Water Vole Survey 2014

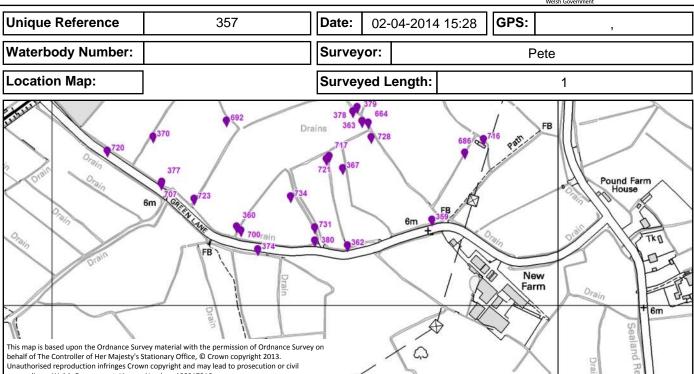
Habitat	Reen
Bank Profile	Steep >45deg
Depth of Water	>2m
Channel Width	5 - 10m
Flow Speed	Slow
Shore Banks	Earth

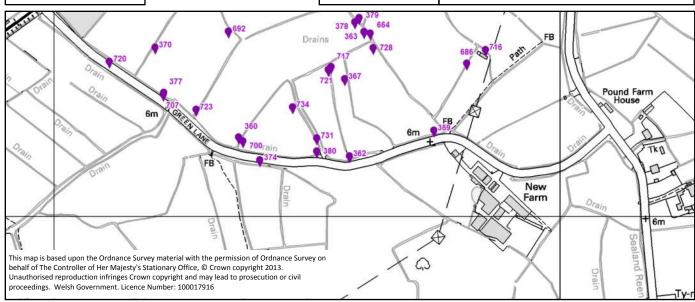
Habitat	River
Bank Profile	Shallow <45deg
Depth of Water	0.5 - 1m
Channel Width	10 - 20m
Flow Speed	Fast
Shore Banks	Boulders

Neighboring Land Use	Urban;
Bank Management	Fenced
Suitability for Otters	High
Otter Signs	Spraints;
Suitability for Watervoles	Low
Watervole Signs

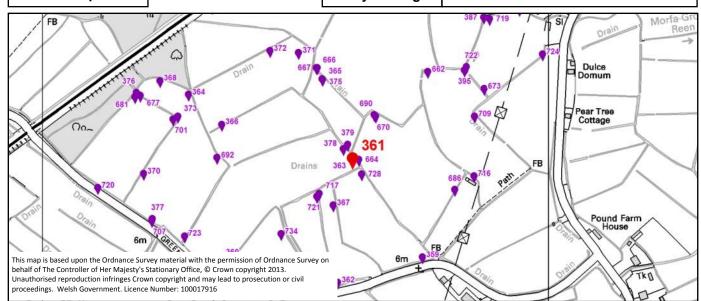
Unique Reference	361	Date: 02-07-2014 13:31		Date: 02-07-2014 13:31		GPS:	51.544757, -3.016413
Waterbody Number:	277	Surveyor:		F	Pip		
Location Map:		Surveyed Length:

Habitat	Ditch			
Bank Profile	Flat <10 degrees			
Depth of Water	<0.5m			
Channel Width	2 - 5m			
Flow Speed	Still			
Shore Banks	Earth

Neighboring Land Use	Livestock grazing;
Bank Management	Unfenced
Suitability for Otters	Negligible
Otter Signs	
Suitability for Watervoles	Negligible
Watervole Signs

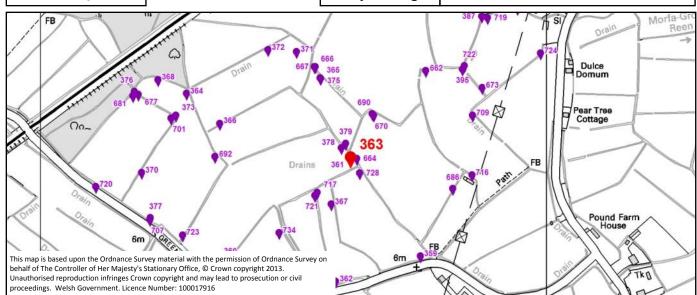
Unique Reference	363	Date:	02-	07-2014 13:55	GPS:	51.544757, -3.016413
Waterbody Number:	866	Survey	or:		F	Pip
Location Map:		Surveyed Length: 60		60

Habitat	
Bank Profile	Flat <10 degrees
Depth of Water	<0.5m
Channel Width	1 - 2m
Flow Speed	Still
Shore Banks	Earth

Neighboring Land Use	Livestock grazing;
Bank Management	Unfenced
Suitability for Otters	Negligible
Otter Signs	
Suitability for Watervoles	Negligible
Watervole Signs

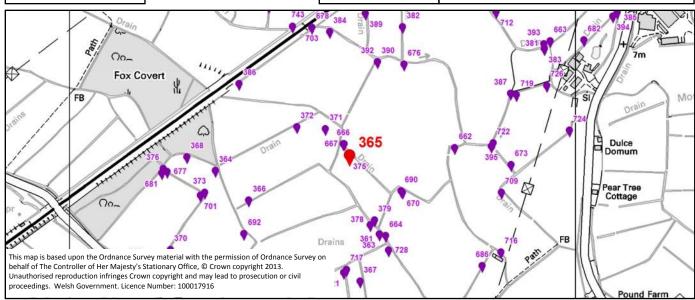
Unique Reference	365	Date:	02-	07-2014 14:12	GPS:	51.546146, -3.017298
Waterbody Number:	272	Surveyor:		F	Pip	
Location Map:		Surveyed Length:

Habitat	Ditch			
Bank Profile	Shallow <45deg			
Depth of Water	<0.5m			
Channel Width	1 - 2m			
Flow Speed	Still			
Shore Banks	Earth

Neighboring Land Use	Livestock grazing;
Bank Management	Unfenced
Suitability for Otters	Negligible
Otter Signs	
Suitability for Watervoles	Negligible
Watervole Signs

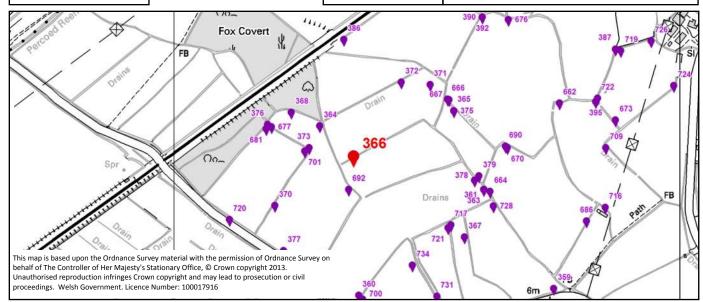
Unique Reference	366	Date:	02-	07-2014 14:45	GPS:	51.54532, -3.020144
Waterbody Number:	269	Survey	or:		F	Pip
Location Map:		Surveyed Length:

Habitat	Ditch			
Bank Profile	Shallow <45deg			
Depth of Water	<0.5m			
Channel Width	1 - 2m			
Flow Speed	Still			
Shore Banks	Earth

Neighboring Land Use	Livestock grazing;
Bank Management	Unfenced
Suitability for Otters	Negligible
Otter Signs	
Suitability for Watervoles	Negligible
Watervole Signs

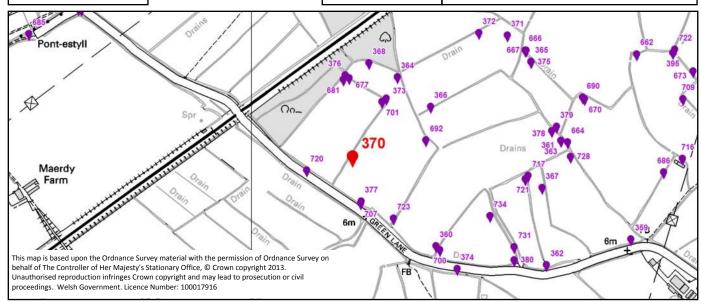
Unique Reference	370	Date:	02-	07-2014 11:16	GPS:	51.544429, -3.022356
Waterbody Number:	293	Surveyor:		I	Pip	
Location Map:		Surveyed Length:			100

Habitat	Ditch			
Bank Profile	Shallow <45deg			
Depth of Water	<0.5m			
Channel Width	1 - 2m			
Flow Speed	Still			
Shore Banks	Earth

Neighboring Land Use	Livestock grazing;
Bank Management	Unfenced
Suitability for Otters	Negligible
Otter Signs	
Suitability for Watervoles	Low
Watervole Signs

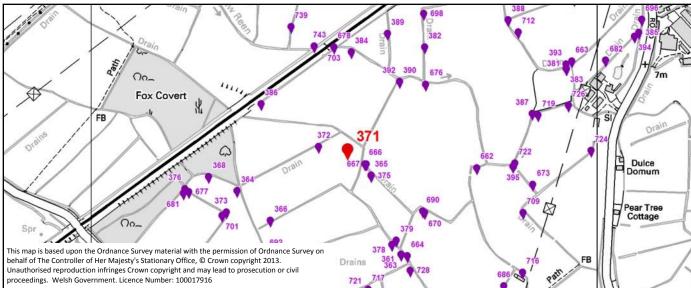
Unique Reference	371	Date:	02-	07-2014 14:50	GPS:	51.546601, -3.017985
Waterbody Number:	267	Surveyor:			Joe	
Location Map:		Surveyed Length:			100

Habitat	Ditch
Bank Profile	Shallow <45deg
Depth of Water	0.5 - 1m
Channel Width	1 - 2m
Flow Speed	Still
Shore Banks	Earth

Neighboring Land Use	Livestock grazing;
Bank Management	Unfenced
Suitability for Otters	Negligible
Otter Signs	
Suitability for Watervoles	Low
Watervole Signs

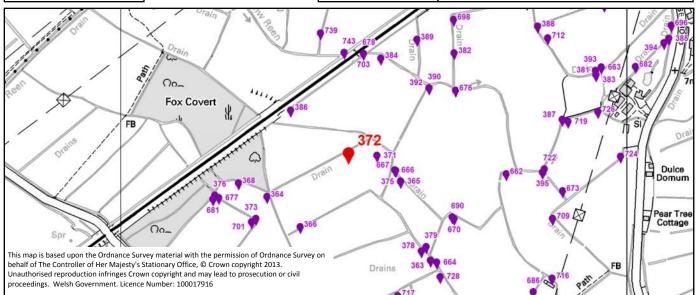
Unique Reference	372	Date: 02-07-2014 14		07-2014 14:51	GPS:	51.546633, -3.018803
Waterbody Number:	268	Surveyor:			Joe	
Location Map:		Surveyed Length:			70

Habitat	Ditch
Bank Profile	Shallow <45deg
Depth of Water	0.5 - 1m
Channel Width	1 - 2m
Flow Speed	Still
Shore Banks	Earth

Neighboring Land Use	Livestock grazing;
Bank Management	Unfenced
Suitability for Otters	Negligible
Otter Signs	
Suitability for Watervoles	Negligible
Watervole Signs

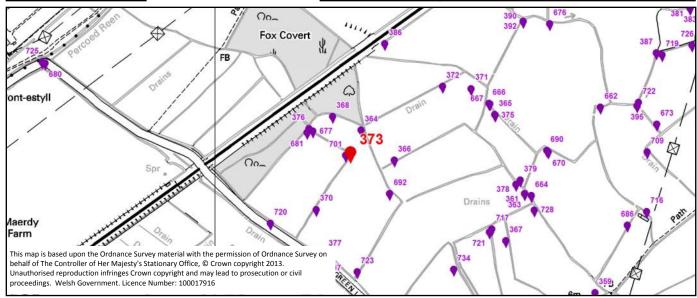
Unique Reference	373	Date: 02-07-2014 11:24		GPS:	51.545453, -3.021404	
Waterbody Number:	294	Surveyor:			Pip	
Location Map:		Surveyed Length:			40

Habitat	Ditch			
Bank Profile	Shallow <45deg			
Depth of Water	<0.5m			
Channel Width	1 - 2m			
Flow Speed	Still			
Shore Banks	Earth

Neighboring Land Use	Livestock grazing;
Bank Management	Unfenced
Suitability for Otters	Negligible
Otter Signs	
Suitability for Watervoles	Low
Watervole Signs

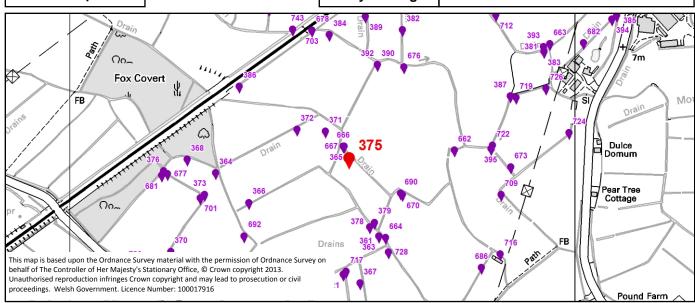
Unique Reference	375	Date:	Date: 02-07-2014 14:13		02-07-2014 14:13 GPS: 51.5461		
Waterbody Number:	271	Surveyor:		Pip			
Location Map:		Surveyed Length:

Habitat	Ditch
Bank Profile	Shallow <45deg
Depth of Water	<0.5m
Channel Width	1 - 2m
Flow Speed	Still
Shore Banks	Earth

Neighboring Land Use	Livestock grazing;
Bank Management	Unfenced
Suitability for Otters	Negligible
Otter Signs	
Suitability for Watervoles	Negligible
Watervole Signs

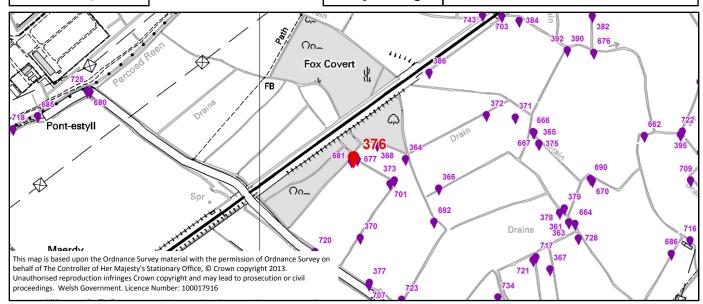
Unique Reference	376	Date:	Date: 02-07-2014 11:33		GPS:	51.545857, -3.022593
Waterbody Number:	287	Surveyor:		Pip		
Location Map:		Surve	Surveyed Length:		ength: 20

Habitat	Ditch				
Bank Profile	Flat <10 degrees				
Depth of Water	<0.5m				
Channel Width	1 - 2m				
Flow Speed	Still				
Shore Banks	Earth

Neighboring Land Use	Livestock grazing;
Bank Management	Unfenced
Suitability for Otters	Negligible
Otter Signs	
Suitability for Watervoles	Low
Watervole Signs

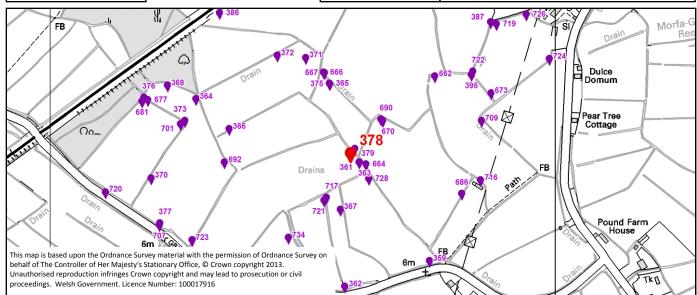
Unique Reference	378	Date: 02-07-2014 14:00		GPS:	51.544921, -3.016677		
Waterbody Number:	270	Surveyor:			Pip		
Location Map:		Surveyed Length:		80

Habitat	Ditch
Bank Profile	Flat <10 degrees
Depth of Water	
Channel Width	1 - 2m
Flow Speed	Still
Shore Banks	Earth

Neighboring Land Use	Livestock grazing;
Neighborning Land OSE	Livestock grazing,
Bank Management	Unfenced
Suitability for Otters	Negligible
Otter Signs	
Suitability for Watervoles	Negligible
Watervole Signs

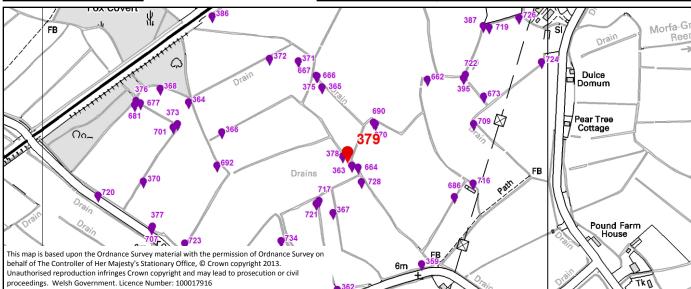
Unique Reference	379	Date: 02-07-2014 14		07-2014 14:05	5 GPS: 51.545, -3.016552		
Waterbody Number:	273	Surveyor:			Pip		
Location Map:		Surveyed Length:		20

Habitat	Ditch
Bank Profile	Shallow <45deg
Depth of Water	<0.5m
Channel Width	1 - 2m
Flow Speed	Still
Shore Banks	Earth

Neighboring Land Use	Livestock grazing;
Bank Management	Unfenced
Suitability for Otters	Negligible
Otter Signs	
Suitability for Watervoles	Negligible
Watervole Signs

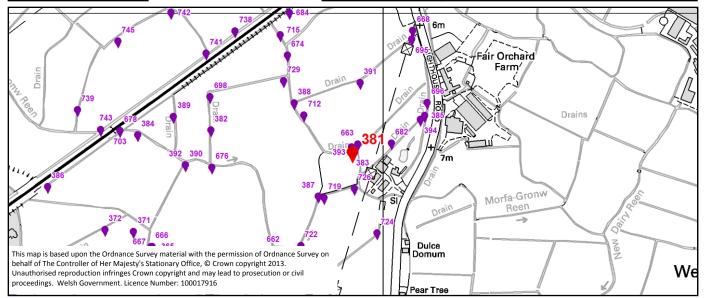
Unique Reference	381	Date: 04-07-2014 12:00		GPS:	51.548071, -3.011774
Waterbody Number:	232	Surveyor:		TS	
Location Map:		Surveyed Length:			100

Habitat	Reen		
Bank Profile			
Depth of Water			
Channel Width	<1m		
Flow Speed	Still		
Shore Banks	Earth

Neighboring Land Use	Arable;
Bank Management	Unfenced
Suitability for Otters	Negligible
Otter Signs	
Suitability for Watervoles	Negligible
Watervole Signs

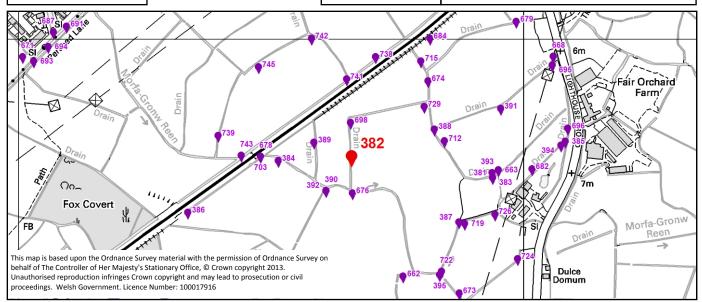
Unique Reference	382	Date:	Date: 04-07-2014 14:49		GPS:	51.548422, -3.015823
Waterbody Number:	257	Surveyor:		TS		
Location Map:		Surve	Surveyed Length:		h: 100

Habitat	Reen			
Bank Profile	Flat <10 degrees			
Depth of Water	<0.5m			
Channel Width	<1m			
Flow Speed	Still			
Shore Banks	Earth

Neighboring Land Use	Arable;
Bank Management	Unfenced
Suitability for Otters	Negligible
Otter Signs	
Suitability for Watervoles	Negligible
Watervole Signs

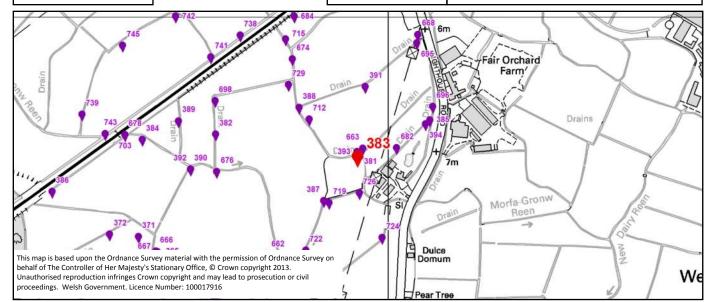
Unique Reference	383	Date: 04-07-2014 11:59		GPS:	51.548074, -3.011779	
Waterbody Number:	248	Surveyor:		TS		
Location Map:		Survey	Surveyed Length:			100

Habitat	Reen			
Bank Profile	Shallow <45deg			
Depth of Water	0.5 - 1m			
Channel Width	<1m			
Flow Speed	Still			
Shore Banks	Earth

Neighboring Land Use	Arable; Scrub;
Bank Management	Unfenced
Suitability for Otters	Negligible
Otter Signs	
Suitability for Watervoles	Low
Watervole Signs

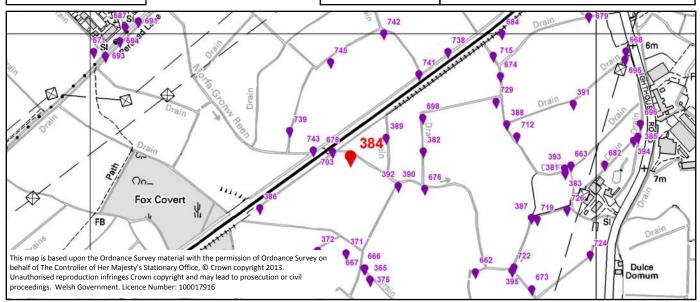
Waterbody Number:
 Surveyor:
 TS

Habitat	Reen			
Bank Profile	Shallow <45deg			
Depth of Water	1 - 2m			
Channel Width	2 - 5m			
Flow Speed	Still			
Shore Banks	Earth

Neighboring Land Use	Arable;
Bank Management	Unfenced
Suitability for Otters	Low
Otter Signs	
Suitability for Watervoles	Medium
Watervole Signs

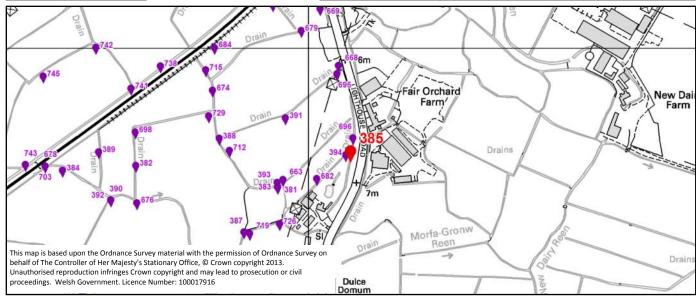
Unique Reference	385	Date:	Date: 04-07-2014 12		GPS:	51.54873, -3.009719
Waterbody Number:	218	Surve	or:	TS		
Location Map:		Survey	Surveyed Length:			500

Habitat	Reen			
Bank Profile	Flat <10 degrees			
Depth of Water	<0.5m			
Channel Width	<1m			
Flow Speed				
Shore Banks

Neighboring Land Use	
Bank Management	
Suitability for Otters	Negligible
Otter Signs	
Suitability for Watervoles	Negligible
Watervole Signs

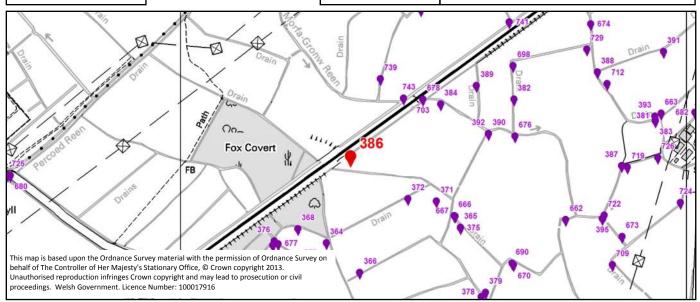
Unique Reference	386	Date:	04-	07-2014 09:25	GPS:	51.547376, -3.02046
Waterbody Number:	112	Survey	Surveyor:		-	TS
Location Map:		Surve	Surveyed Length:			100

Habitat	Reen
Bank Profile	
Depth of Water	
Channel Width	
Flow Speed	
Shore Banks

Neighboring Land Use	Scrub;
Bank Management	
Suitability for Otters	Negligible
Otter Signs	
Suitability for Watervoles	Negligible
Watervole Signs

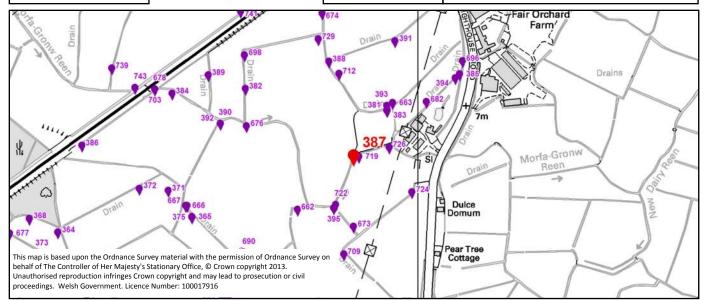
Unique Reference	387	Date:	te: 04-07-2014 11:33		GPS:	51.547274, -3.012723
Waterbody Number:	246	Survey	Surveyor:		TS	
Location Map:		Survey	Surveyed Length:		100

Habitat	Reen
Bank Profile	Shallow <45deg
Depth of Water	1 - 2m
Channel Width	1 - 2m
Flow Speed	Still
Shore Banks	Earth

Neighboring Land Use	Arable;
Bank Management	Unfenced
Suitability for Otters	Negligible
Otter Signs	
Suitability for Watervoles	Low
Watervole Signs

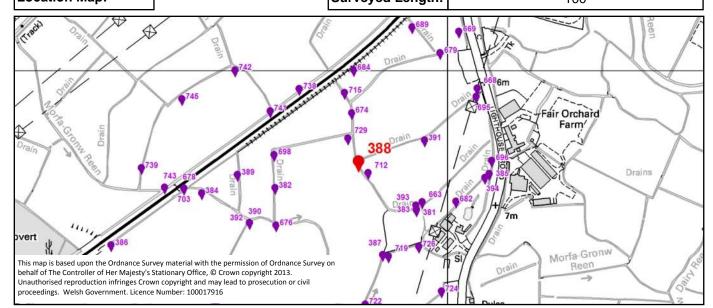
Waterbody Number:
 249
 Surveyor:
 TS

Habitat	Reen		
Bank Profile	Shallow <45deg		
Depth of Water	0.5 - 1m		
Channel Width	1 - 2m		
Flow Speed	Still		
Shore Banks	Earth

Neighboring Land Use	Arable;
Bank Management	Unfenced
Suitability for Otters	Negligible
Otter Signs	
Suitability for Watervoles	Low
Watervole Signs

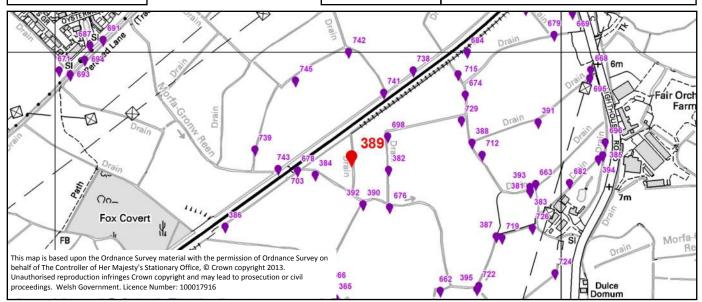
Unique Reference	389	Date:	Date: 04-07-2014 10:22		GPS:	51.548651, -3.016888
Waterbody Number:	259	Surveyor:		TS		
Location Map:		Surve	Surveyed Length:		100

Habitat	Reen		
Bank Profile	Shallow <45deg		
Depth of Water	0.5 - 1m		
Channel Width	1 - 2m		
Flow Speed	Sluggish		
Shore Banks	Silt

Neighboring Land Use	Arable;
Bank Management	Mixture
Suitability for Otters	Low
Otter Signs	
Suitability for Watervoles	Low
Watervole Signs

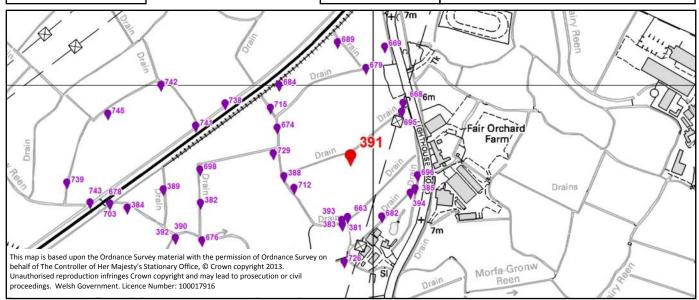
Unique Reference	391	Date:	Date: 04-07-2014 13:14		GPS:	51.549299, -3.011576
Waterbody Number:	231	Surveyor:		TS		
Location Map:		Surve	Surveyed Length:			100

Habitat	Ditch				
Bank Profile	Flat <10 degrees				
Depth of Water	<0.5m				
Channel Width	<1m				
Flow Speed	Still				
Shore Banks

Neighboring Land Use	
Bank Management	Unfenced
Suitability for Otters	Negligible
Otter Signs	
Suitability for Watervoles	Negligible
Watervole Signs

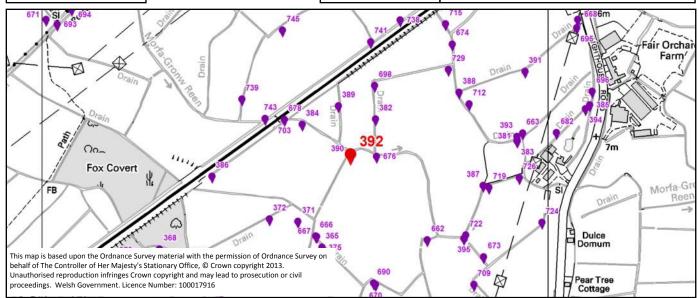
Unique Reference	392	Date: 04-07-2014 10:48		GPS:	51.547802, -3.016526	
Waterbody Number:	266	Surveyor:			TS	
Location Map:		Survey	Surveyed Length:		100

Habitat	Reen			
Bank Profile	Flat <10 degrees			
Depth of Water	<0.5m			
Channel Width	1 - 2m			
Flow Speed	Still			
Shore Banks	Earth

Neighboring Land Use	Arable;				
Bank Management	Unfenced				
Suitability for Otters	Negligible				
Otter Signs					
Suitability for Watervoles	Low				
Watervole Signs

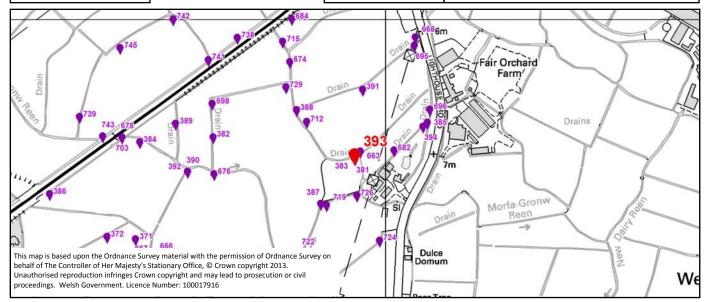
Unique Reference	393	Date: 04-07-2014 11:42		GPS:	51.548153, -3.01179	
Waterbody Number:	247	Surveyor:			TS	
Location Map:		Survey	Surveyed Length:			100

Habitat	Reen		
Bank Profile	Flat <10 degrees		
Depth of Water	0.5 - 1m		
Channel Width	1 - 2m		
Flow Speed	Still		
Shore Banks	Earth

Neighboring Land Use	Arable; Scrub;
Bank Management	Mixture
Suitability for Otters	Negligible
Otter Signs	
Suitability for Watervoles	Low
Watervole Signs

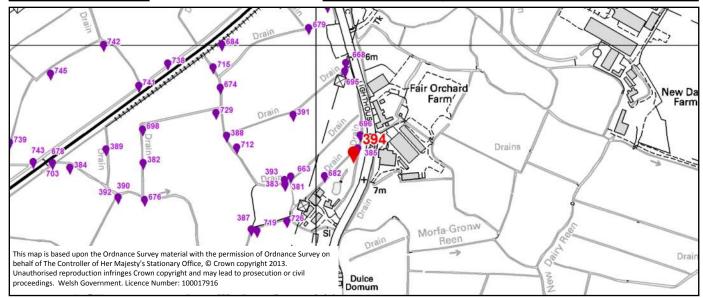
Unique Reference	394	Date:	04-0	7-2014 12:53	GPS:	51.548658, -3.009846
Waterbody Number:	235	Survey	or:		-	TS
Location Map:		Surveyed Length:		enath:		100

Habitat	Reen
Bank Profile	Flat <10 degrees
Depth of Water	<0.5m
Channel Width	1 - 2m
Flow Speed	Still
Shore Banks	Earth

Neighboring Land Use	Arable;
Bank Management	Unfenced
Suitability for Otters	Negligible
Otter Signs	
Suitability for Watervoles	Negligible
Watervole Signs

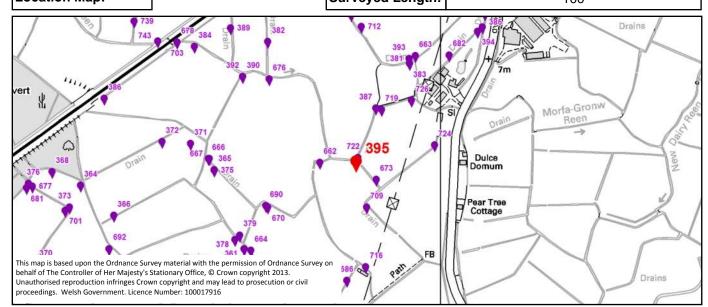
Unique Reference	395	Date:	04-	07-2014 11:18	GPS:	51.546336, -3.013258	
Waterbody Number:	261	Surveyor:			TS		
Location Map:		Surveyed Length:		enath:		100

Habitat	Reen			
Bank Profile	Flat <10 degrees			
Depth of Water	1 - 2m			
Channel Width	1 - 2m			
Flow Speed	Still			
Shore Banks	Earth

Neighboring Land Use	Arable;
Bank Management	Unfenced
Suitability for Otters	Low
Otter Signs	
Suitability for Watervoles	High
Watervole Signs

Phragmites, sweet reed grass, yellow loosestrife, rush, iris

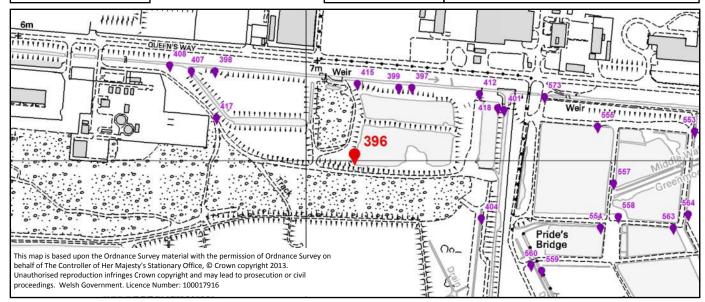
Unique Reference	396	Date:	05-	08-2014 14:22	GPS:	51.569576, -2.89457
Waterbody Number:	1220	Survey	or:		TS MN	A AO TR
Location Map:		Surveyed Length:			100

Habitat	Pond
Bank Profile	Steep >45deg
Depth of Water	<0.5m
Channel Width	>20m
Flow Speed	
Shore Banks	Stones

Neighboring Land Use	Scrub;
Bank Management	Unfenced
Suitability for Otters	Negligible
Otter Signs	
Suitability for Watervoles	Negligible
Watervole Signs

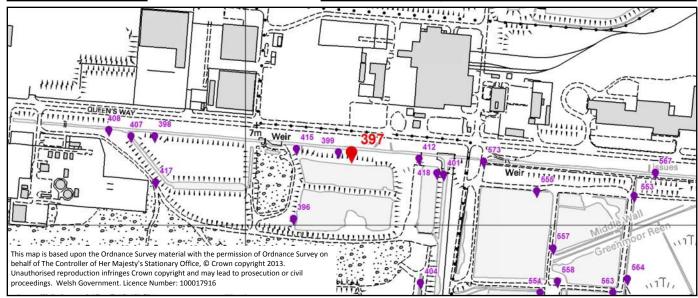
Unique Reference	397	Date:	05-0	08-2014 12:22	GPS:	51.570764, -2.892951
Waterbody Number:	1185	Survey	or:		TS MN	AO TR
Location Map:		Surveyed Length:		enath:		50

Habitat	Reen			
Bank Profile	Steep >45deg			
Depth of Water	1 - 2m			
Channel Width	2 - 5m			
Flow Speed	Sluggish			
Shore Banks	Earth

Neighboring Land Use	Scrub;
Bank Management	Unfenced
Suitability for Otters	Low
Otter Signs	
Suitability for Watervoles	Medium
Watervole Signs	Feeding Stations;

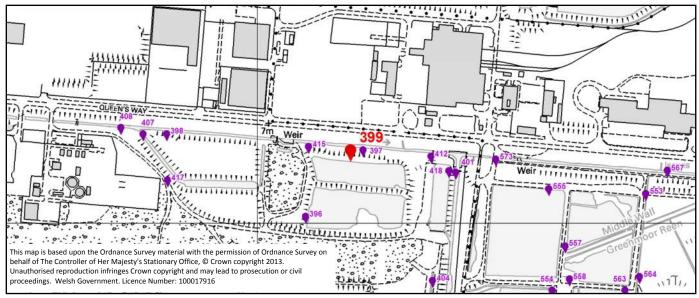
Unique Reference	399	Date:	05-	08-2014 12:17	GPS:	51.570762, -2.893319
Waterbody Number:	1204	Survey	or:		TS MN	// AO TR
Location Map:		Surveyed Length:		enath:		50

Habitat	Reen
Bank Profile	Steep >45deg
Depth of Water	1 - 2m
Channel Width	
Flow Speed	Sluggish
Shore Banks

Neighboring Land Use	
Bank Management	Unfenced
Suitability for Otters	Low
Otter Signs	
Suitability for Watervoles	Medium
Watervole Signs	Feeding Stations;

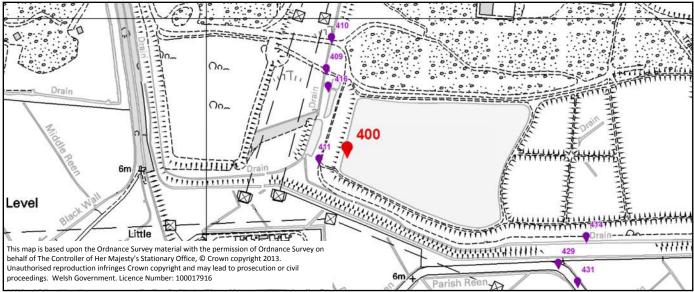
Unique Reference	400	Date:	05-	08-2014 15:26	GPS:	51.567098, -2.90631
Waterbody Number:	790	Surveyor:		TS MN	/I AO TR	
Location Map:		Surveyed Length:

Habitat	Pond
Bank Profile	Steep >45deg
Depth of Water	<0.5m
Channel Width	>20m
Flow Speed	
Shore Banks	Stones

Neighboring Land Use	Scrub;
Bank Management	Unfenced
Suitability for Otters	Negligible
Otter Signs	
Suitability for Watervoles	Negligible
Watervole Signs

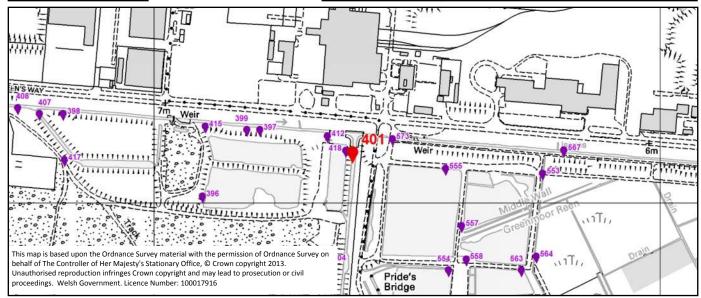
Unique Reference	401	Date: 05-08-2014 12:4		08-2014 12:47	GPS:	51.570391, -2.890309
Waterbody Number:	536	Surveyor:			TS MM AO TR	
Location Map:		Surveyed Length:			50

Habitat	Reen
Bank Profile	Steep >45deg
Depth of Water	1 - 2m
Channel Width	2 - 5m
Flow Speed	Sluggish
Shore Banks

Neighboring Land Use	
Bank Management	Unfenced
Suitability for Otters	Negligible
Otter Signs	
Suitability for Watervoles	Low
Watervole Signs

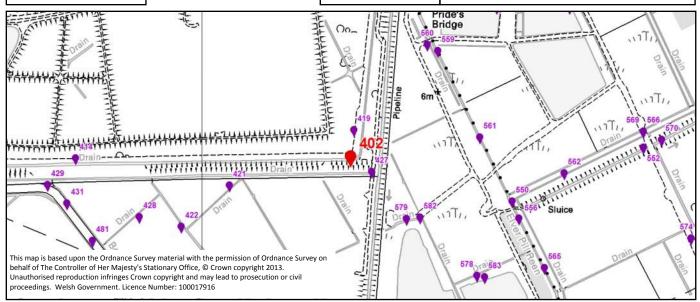
Waterbody Number:
 1257
 Surveyor:
 TS MM AO TR

Habitat	Reen
Bank Profile	Steep >45deg
Depth of Water	0.5 - 1m
Channel Width	2 - 5m
Flow Speed	Still
Shore Banks	Stones

Neighboring Land Use	Scrub;
Bank Management	Unfenced
Suitability for Otters	Negligible
Otter Signs	
Suitability for Watervoles	Negligible
Watervole Signs

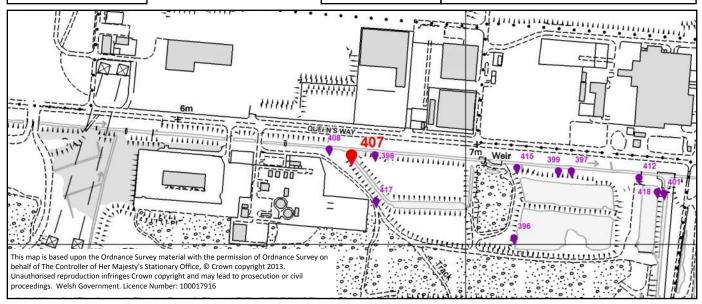
Unique Reference	407	Date:	05-	08-2014 11:11	GPS:	51.571002, -2.899234
Waterbody Number:	1244	Survey	or:		TS	MM
Location Map:		Surve	Surveyed Length:			20

Habitat	Reen
Bank Profile	Steep >45deg
Depth of Water	1 - 2m
Channel Width	2 - 5m
Flow Speed	Still
Shore Banks	Earth

Neighboring Land Use	Scrub;
Bank Management	Unfenced
Suitability for Otters	Low
Otter Signs	
Suitability for Watervoles	Medium
Watervole Signs	Feeding Stations;

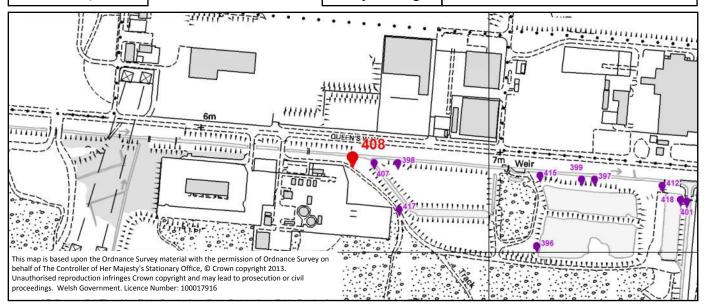
Unique Reference	408	Date:	05-0	08-2014 10:11	GPS:	51.571102, -2.899867
Waterbody Number:	1238	Survey	or:		TS	MM
Location Map:		Surveyed Length:		ength:		50

Habitat	Reen		
Bank Profile	Steep >45deg		
Depth of Water	1 - 2m		
Channel Width	5 - 10m		
Flow Speed	Sluggish		
Shore Banks	Earth

Neighboring Land Use	Scrub;
Bank Management	Unfenced
Suitability for Otters	Low
Otter Signs	
Suitability for Watervoles	Medium
Watervole Signs	Feeding Stations;

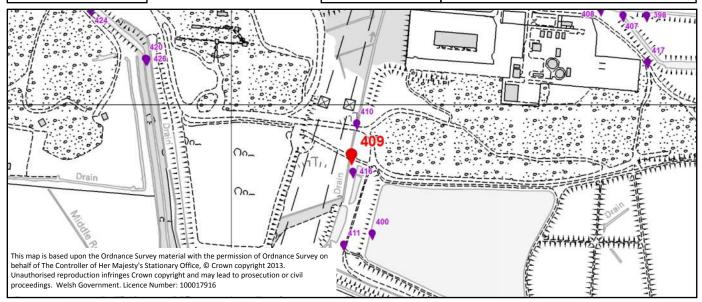
Unique Reference	409	Date:	05-	08-2014 15:51	GPS:	51.568493, -2.906935
Waterbody Number:	1248	Survey	or:		TS MN	A AO TR
Location Map:		Surveyed Length:

Habitat	Reen
Bank Profile	Steep >45deg
Depth of Water	0.5 - 1m
Channel Width	5 - 10m
Flow Speed	Still
Shore Banks	Stones

Neighboring Land Use	Scrub;
Bank Management	Unfenced
Suitability for Otters	Negligible
Otter Signs	
Suitability for Watervoles	Negligible
Watervole Signs

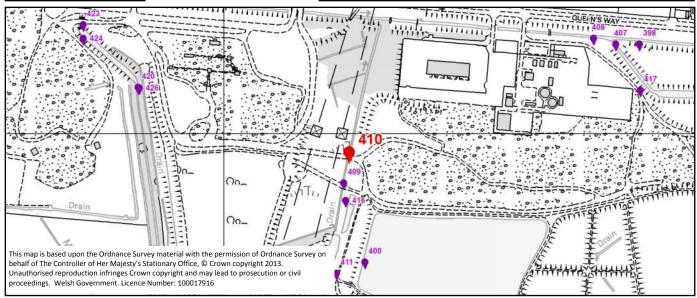
Unique Reference	410	Date:	05-0	08-2014 15:59	GPS:	51.569041, -2.906789
Waterbody Number:	1259	Survey	or:		TS MN	/I AO TR
Location Map:		Surve	Surveyed Length:			100

Habitat	Reen				
Bank Profile	Steep >45deg				
Depth of Water	0.5 - 1m				
Channel Width	2 - 5m				
Flow Speed	Still				
Shore Banks

Neighboring Land Use	
Bank Management	Unfenced
Suitability for Otters	Negligible
Otter Signs	
Suitability for Watervoles	Negligible
Watervole Signs

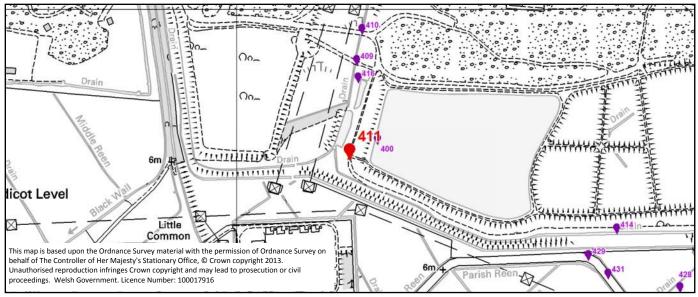
Waterbody Number:
 1121
 Surveyor:
 TS MM AO TR

Habitat	Reen	Neighboring Land Use	
Bank Profile		Bank Management	
Depth of Water		Suitability for Otters	Negligible
Channel Width		Otter Signs	
Flow Speed		Suitability for Watervoles	Negligible
Shore Banks		Watervole Signs

Vegetation Description	Comments:
Phragmites dominated and overgrown	Overgrown, bad water quality, no access

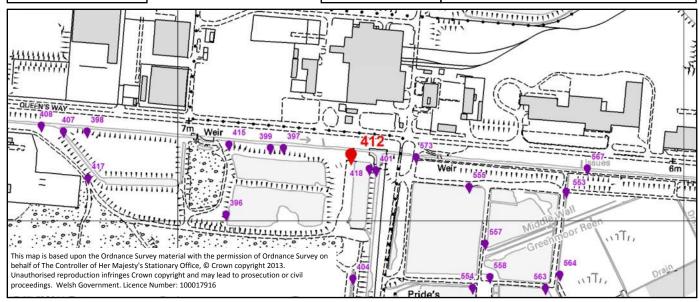
Unique Reference	412	Date:	05-	08-2014 12:38	GPS:	51.570666, -2.891017
Waterbody Number:	1194	Survey	urveyor: TS MM AO TR		M AO TR	
Location Map:		Surve	ed L	ength:

Habitat	Reen
Bank Profile	Steep >45deg
Depth of Water	1 - 2m
Channel Width	2 - 5m
Flow Speed	Sluggish
Shore Banks	Earth

Neighboring Land Use	Scrub;
Bank Management	Unfenced
Suitability for Otters	Low
Otter Signs	
Suitability for Watervoles	Medium
Watervole Signs	Feeding Stations;

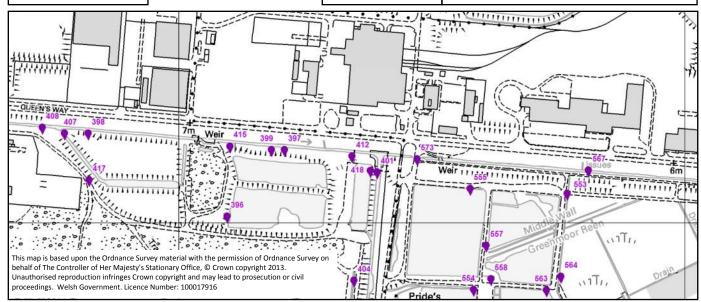
Unique Reference	413	Date: 05-08-2014 14:26		GPS:	,	
Waterbody Number:	1206	Survey	Surveyor:		TS MM AO TR	
Location Map:		Survey	ed L	ength:

Habitat	Pond
Bank Profile	Steep >45deg
Depth of Water	<0.5m
Channel Width	>20m
Flow Speed	
Shore Banks	Stones

Neighboring Land Use	Scrub;
Bank Management	Unfenced
Suitability for Otters	Negligible
Otter Signs	
Suitability for Watervoles	
Watervole Signs

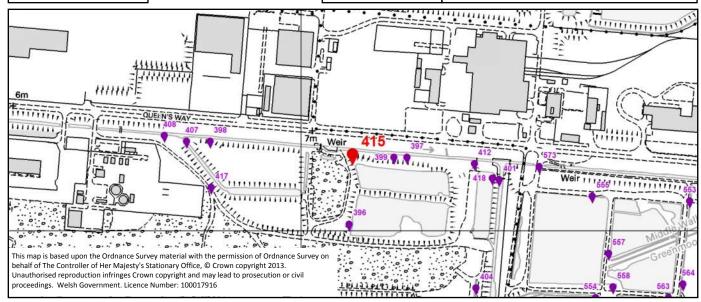
Unique Reference	415	Date:	05-0	08-2014 12:02	GPS:	51.570815, -2.894507
Waterbody Number:	1205	Survey	or:		TS MN	AO TR
Location Map:		Surveyed Length:		enath:		50

Habitat	Reen		
Bank Profile	Steep >45deg		
Depth of Water	1 - 2m		
Channel Width	5 - 10m		
Flow Speed	Sluggish		
Shore Banks	Earth

Neighboring Land Use	Scrub;
Bank Management	
Suitability for Otters	Low
Otter Signs	
Suitability for Watervoles	Medium
Watervole Signs	Feeding Stations;

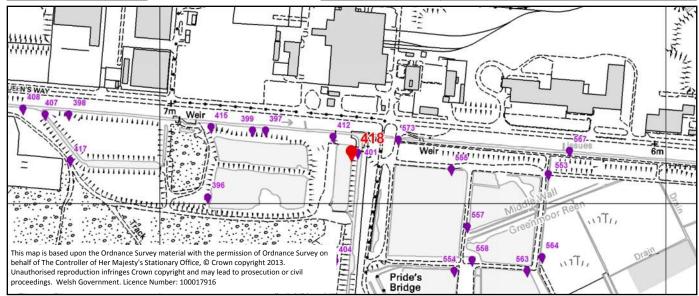
Unique Reference	418	Date:	05-0	08-2014 12:45	GPS:	51.570417, -2.890501
Waterbody Number:	1234	Survey	or:		TS MN	A AO TR
Location Map:		Surveyed Length: 100		100

Habitat	Pond
Bank Profile	Shallow <45deg
Depth of Water	>2m
Channel Width	10 - 20m
Flow Speed	Sluggish
Shore Banks

Neighboring Land Use	
Bank Management	Fenced
Suitability for Otters	Negligible
Otter Signs	
Suitability for Watervoles	Negligible
Watervole Signs

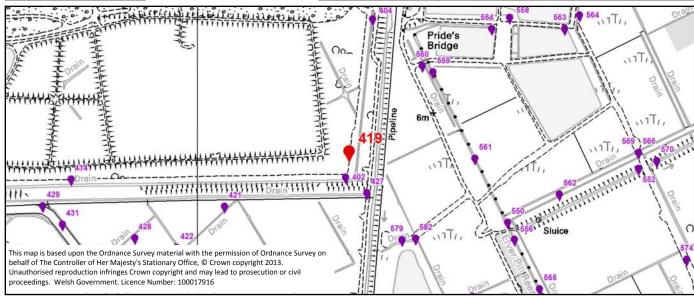
Unique Reference	419	Date:	05-0	08-2014 14:48	GPS:	51.566139, -2.891545
Waterbody Number:	1071	Surveyor:		TS MM AO TR		
Location Map:		Surveyed Length: 10		10

Habitat	Reen
Bank Profile	Shallow <45deg
Depth of Water	<0.5m
Channel Width	5 - 10m
Flow Speed	
Shore Banks	Stones

Neighboring Land Use	Scrub;
Bank Management	Unfenced
Suitability for Otters	Negligible
Otter Signs	
Suitability for Watervoles	Low
Watervole Signs

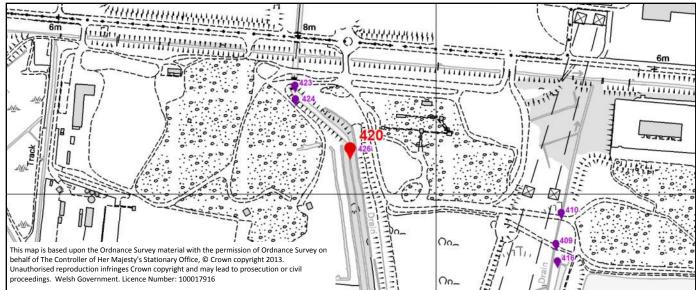
Waterbody Number:
 578
 Surveyor:
 AO MM

Habitat	
Bank Profile	
Depth of Water	
Channel Width	2 - 5m
Flow Speed	Slow
Shore Banks	Earth

2012 111
Neighboring Land Use	Scrub;
Bank Management	
Suitability for Otters	Low
Otter Signs	
Suitability for Watervoles	Medium
Watervole Signs

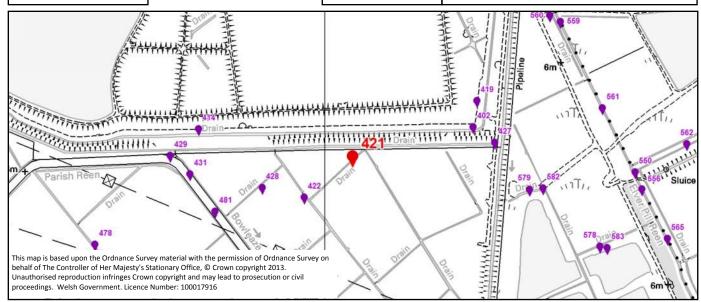
Waterbody Number:
 1082
 Surveyor:
 AO MM

Habitat	Ditch
Bank Profile	Shallow <45deg
Depth of Water	<0.5m
Channel Width	2 - 5m
Flow Speed	Still
Shore Banks	Poached

Neighboring Land Use	
Bank Management	Unfenced
Suitability for Otters	Negligible
Otter Signs	
Suitability for Watervoles	Negligible
Watervole Signs

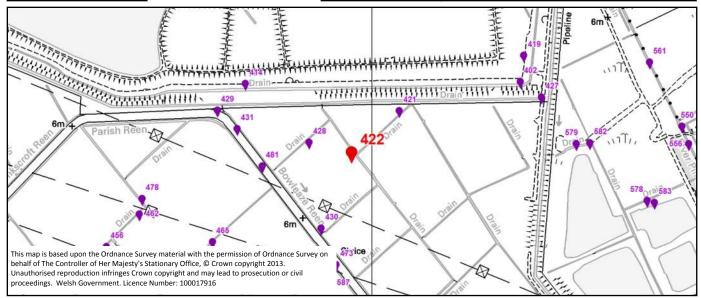
Unique Reference	422	Date:	06-	08-2014 15:21	GPS:	51.564393, -2.89643
Waterbody Number:	1124	Survey	or:		AC	MM
Location Map:		Surveyed Length:

Habitat	Ditch
Bank Profile	
Depth of Water	<0.5m
Channel Width	
Flow Speed	
Shore Banks	Earth

Neighboring Land Use	Livestock grazing;
Bank Management	Unfenced
Suitability for Otters	Negligible
Otter Signs	
Suitability for Watervoles	Negligible
Watervole Signs

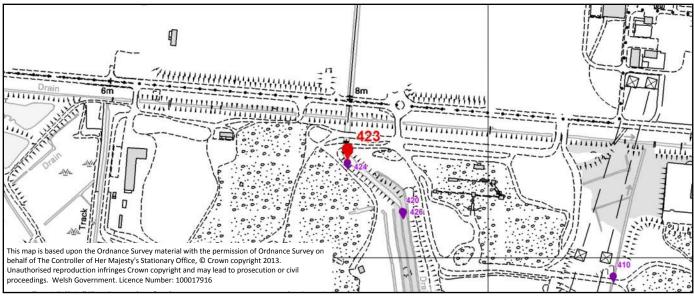
Unique Reference	423	Date:	06-	08-2014 11:45	GPS:	51.571226, -2.91442
Waterbody Number:	1286	Survey	or:		AC) MM
Location Map:		Surveyed Length:			10

Habitat	Reen		
Bank Profile	Steep >45deg		
Depth of Water	>2m		
Channel Width	5 - 10m		
Flow Speed	Still		
Shore Banks	Earth

Neighboring Land Use	Scrub;
Bank Management	Unfenced
Suitability for Otters	Low
Otter Signs	
Suitability for Watervoles	Medium
Watervole Signs

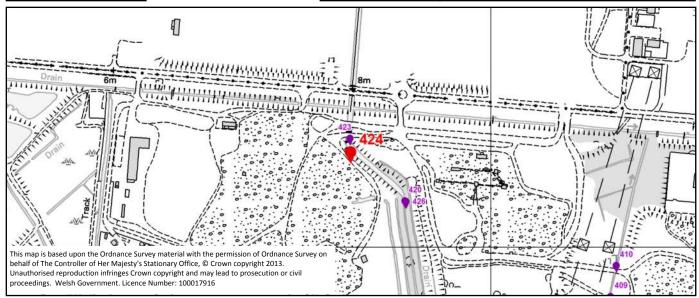
Unique Reference	424	Date:	Date: 06-08-2014 11:48		GPS:	51.570987, -2.914408
Waterbody Number:	1296	Survey	or:		AC) MM
Location Map:		Surveyed Length:		enath:		50

Habitat	Reen		
Bank Profile	Steep >45deg		
Depth of Water	>2m		
Channel Width	5 - 10m		
Flow Speed	Sluggish		
Shore Banks	Earth

Neighboring Land Use	Scrub;
Bank Management	Unfenced
Suitability for Otters	Low
Otter Signs	
Suitability for Watervoles	Medium
Watervole Signs

Kayak survey recommended. Moderate water quality. Waterfowl unidentified sp., seen further along reen. On the unmanaged side of reen (west) difficult to access but surveyed 50m. Surveying along managed/cut side (east) no evidence due to management but cannot discount presence.

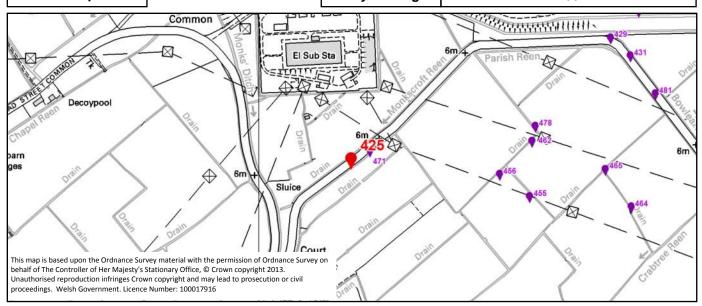
Waterbody Number:
 565
 Surveyor:
 AO MM

Habitat	Reen		
Bank Profile	Steep >45deg		
Depth of Water	1 - 2m		
Channel Width	1 - 2m		
Flow Speed	Still		
Shore Banks	Earth

Neighboring Land Use	Livestock grazing;
Bank Management	Unfenced
Suitability for Otters	Low
Otter Signs	
Suitability for Watervoles	Medium
Watervole Signs

Kayak survey recommended. Feeding station and burrows/holes show evidence for bank vole.

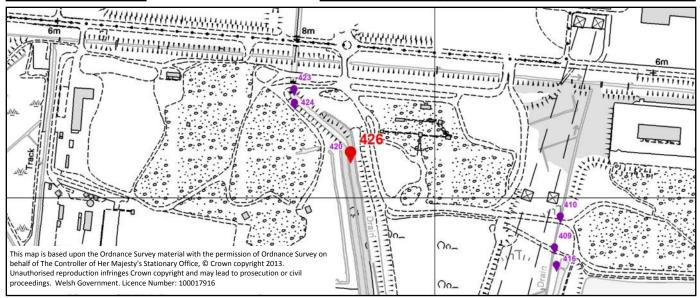
Waterbody Number:
 1299
 Surveyor:
 AO MM

Habitat	Reen
Bank Profile	Steep >45deg
Depth of Water	
Channel Width	2 - 5m
Flow Speed	Still
Shore Banks	Earth

Neighboring Land Use	Scrub;
Bank Management	Unfenced
Suitability for Otters	Negligible
Otter Signs	
Suitability for Watervoles	Negligible
Watervole Signs

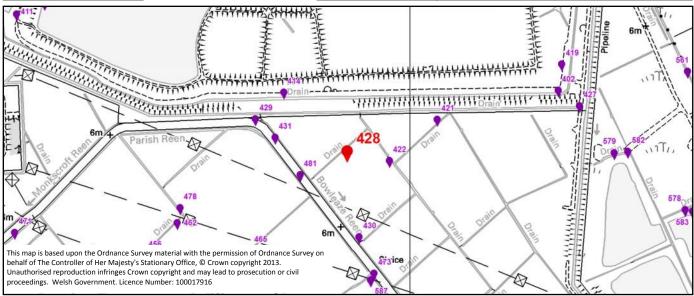
Unique Reference	428	Date:	06-0	08-2014 15:26	GPS:	51.564557, -2.897631	
Waterbody Number:	562	Survey	Surveyor:		AO MM		
Location Map:		Surveyed Length:		ength:		100

Habitat	Ditch
Bank Profile	
Depth of Water	<0.5m
Channel Width	
Flow Speed	Still
Shore Banks	Earth

Neighboring Land Use	Livestock grazing;
Bank Management	Unfenced
Suitability for Otters	Negligible
Otter Signs	
Suitability for Watervoles	Negligible
Watervole Signs

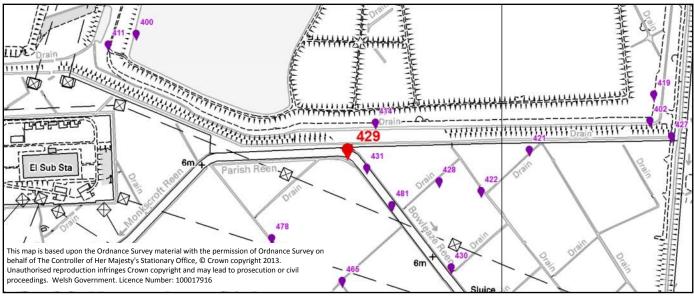
Unique Reference	429	Date: 06-08-2014 14:48		08-2014 14:48	GPS:	51.565102, -2.900259	
Waterbody Number:	1152	Survey	Surveyor:		AO MM		
Location Map:		Surveyed Length:		ength:		250

Habitat	Reen			
Bank Profile				
Depth of Water	1 - 2m			
Channel Width	5 - 10m			
Flow Speed	Still			
Shore Banks	Earth

National Control of the Control of t	I Control and Con
Neighboring Land Use	Livestock grazing;
Bank Management	Unfenced
Suitability for Otters	Negligible
Otter Signs	
Suitability for Watervoles	Negligible
Watervole Signs

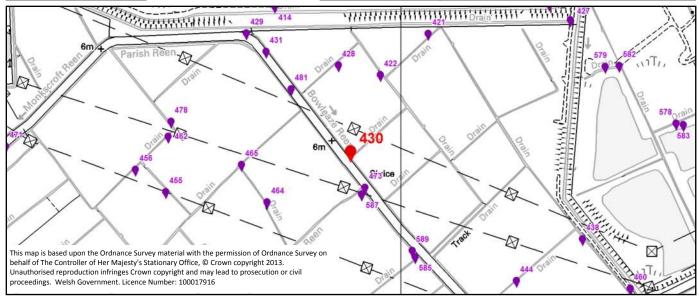
Unique Reference	430	Date:	Date: 06-08-2014 16:09		GPS:	51.56304, -2.897258
Waterbody Number:	588	Survey	Surveyor:		AO MM	
Location Map:		Surveyed Length:			20

Habitat	Ditch
Bank Profile	
Depth of Water	
Channel Width	
Flow Speed	
Shore Banks	Earth

Neighboring Land Use	Livestock grazing;
Bank Management	Unfenced
Suitability for Otters	Negligible
Otter Signs	
Suitability for Watervoles	Negligible
Watervole Signs

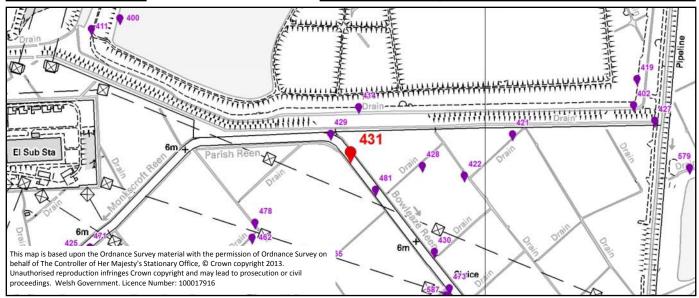
Unique Reference	431	Date:	Date: 06-08-2014 15:37		GPS:	51.564782, -2.899693
Waterbody Number:	560	Surveyor:		AO MM		
Location Map:		Surve	Surveyed Length:			200

Habitat	Reen		
Bank Profile	Steep >45deg		
Depth of Water	1 - 2m		
Channel Width	2 - 5m		
Flow Speed	Still		
Shore Banks	Earth

Neighboring Land Use	Livestock grazing;
Bank Management	Mixture
Suitability for Otters	Low
Otter Signs	
Suitability for Watervoles	Medium
Watervole Signs

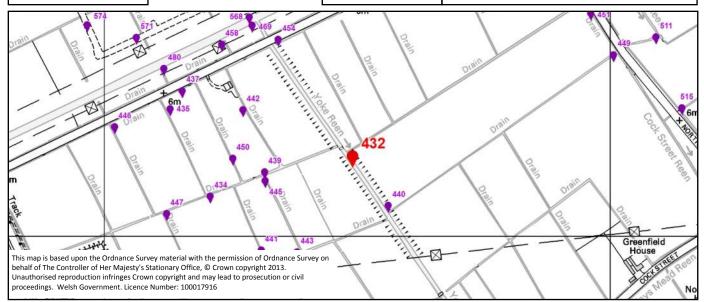
Unique Reference	432	Date: 07-08-2014 16:15		GPS:	51.562037, -2.874296
Waterbody Number:	1148	Surveyor:		TR and AO	
Location Map:		Surveyed Length:			700

Habitat	Reen		
Bank Profile	Flat <10 degrees		
Depth of Water	<0.5m		
Channel Width	2 - 5m		
Flow Speed	Still		
Shore Banks	Earth

Neighboring Land Use	Arable; Livestock grazing;
Bank Management	Unfenced
Suitability for Otters	Low
Otter Signs	
Suitability for Watervoles	Low
Watervole Signs	Feeding Stations;

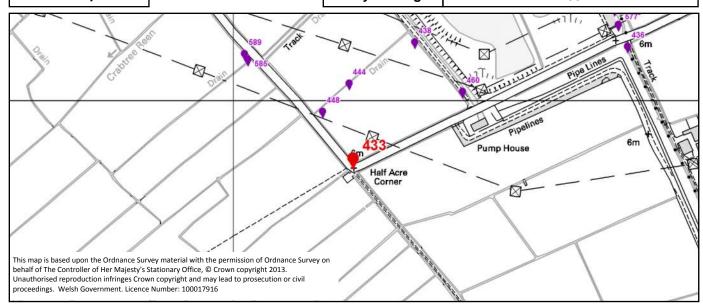
Unique Reference	433	Date: 07-08-2014 10:20		GPS:	51.559473, -2.892327
Waterbody Number:	539	Surveyor:		TR and AO	
Location Map:		Surveyed Length:			100

Habitat	Ditch			
Bank Profile	Flat <10 degrees			
Depth of Water	0.5 - 1m			
Channel Width	5 - 10m			
Flow Speed	Still			
Shore Banks	Earth

Neighboring Land Use	Arable; Livestock grazing;
Bank Management	Unfenced
Suitability for Otters	Low
Otter Signs	
Suitability for Watervoles	Low
Watervole Signs

Found rodent trails

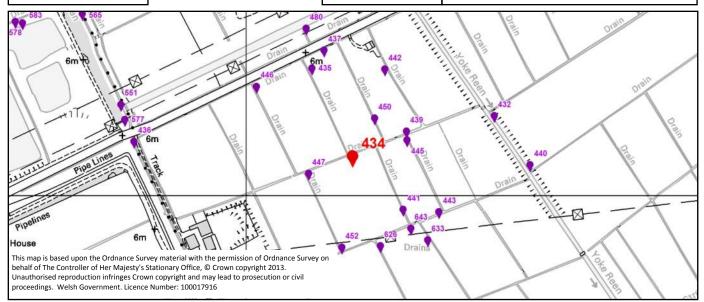
Unique Reference	434	Date: 07-08-2014 14:29		GPS:	51.561292, -2.878327
Waterbody Number:	759	Surveyor:		TR and AO	
Location Map:		Surveyed Length:			60

Habitat	Ditch			
Bank Profile	Flat <10 degrees			
Depth of Water	<0.5m			
Channel Width	1 - 2m			
Flow Speed	Still			
Shore Banks	Earth

Neighboring Land Use	Arable; Livestock grazing;
Bank Management	Mixture
Suitability for Otters	Low
Otter Signs	
Suitability for Watervoles	Low
Watervole Signs

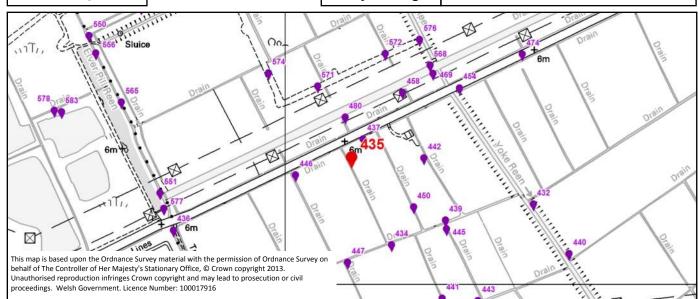
Unique Reference	435	Date: 07-08-2014 14:09		GPS:	51.562833, -2.879499	
Waterbody Number:	594	Survey	Surveyor:		TR and AO	
Location Map:		Surveyed Length:		ength:		150

Habitat	Ditch		
Bank Profile	Flat <10 degrees		
Depth of Water	<0.5m		
Channel Width	<1m		
Flow Speed	Still		
Shore Banks	Earth

Neighboring Land Use	Arable; Livestock grazing;
Bank Management	Fenced
Suitability for Otters	Low
Otter Signs	
Suitability for Watervoles	Low
Watervole Signs

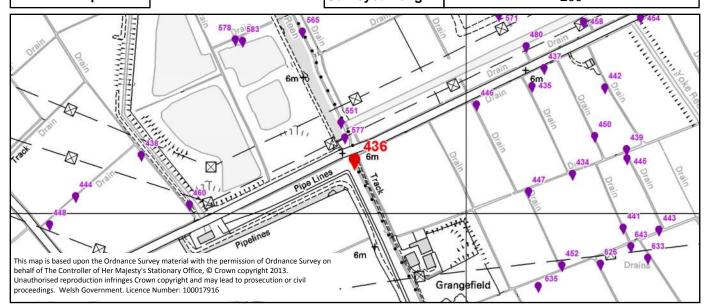
Unique Reference	436	Date: 07-08-2014 10:50		GPS:	51.561505, -2.884547		
Waterbody Number:	1060	Surveyor:			TR and AO		
Location Map:		Surveyed Length:			200

Habitat	Reen		
Bank Profile	Steep >45deg		
Depth of Water	>2m		
Channel Width	2 - 5m		
Flow Speed	Still		
Shore Banks	Earth

Neighboring Land Use	Arable; Livestock grazing;
Bank Management	Unfenced
Suitability for Otters	Low
Otter Signs	
Suitability for Watervoles	Medium
Watervole Signs

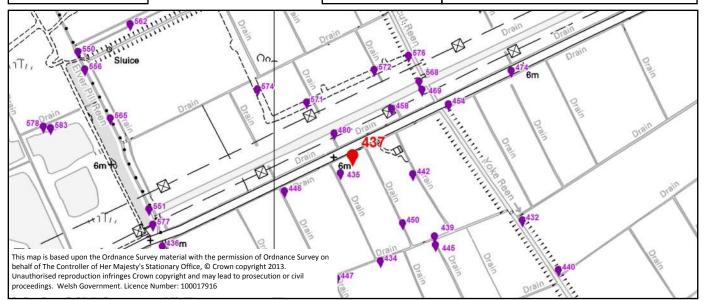
Unique Reference	437	Date: 07-08-2014 14:04		GPS:	51.563153, -2.879163	
Waterbody Number:	595	Survey	or:		TR a	ind AO
Location Map:		Surveyed Length:			60

Habitat	Ditch			
Bank Profile	Flat <10 degrees			
Depth of Water	<0.5m			
Channel Width	1 - 2m			
Flow Speed	Still			
Shore Banks	Earth

Neighboring Land Use	Arable; Livestock grazing;
Bank Management	Unfenced
Suitability for Otters	Low
Otter Signs	
Suitability for Watervoles	Low
Watervole Signs

Phragmites, ash, goat willow, bramble, crack willow, bramble

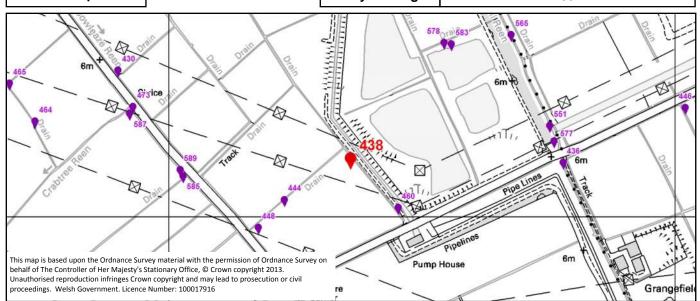
Unique Reference	438	Date:	Date: 07-08-2014 09:53		GPS:	51.561537, -2.890614
Waterbody Number:	537	Surveyor:			TR a	nd AO
Location Map:		Surveyed Length:		ength:		60

Habitat	Ditch
Bank Profile	Shallow <45deg
Depth of Water	<0.5m
Channel Width	1 - 2m
Flow Speed	Still
Shore Banks	Earth

Neighboring Land Use	Arable; Livestock grazing;
Bank Management	Unfenced
Suitability for Otters	Low
Otter Signs	
Suitability for Watervoles	Low
Watervole Signs

Crack willow, blackthorn,hawthorn,bramble,rosebay willow herb,phragmites

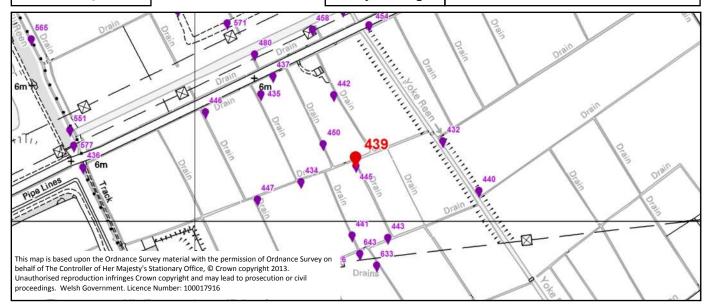
Unique Reference	439	Date: 07-08-2014 11:40		GPS:	51.561739, -2.876791	
Waterbody Number:	1134	Survey	Surveyor:		TR a	ind AO
Location Map:		Surveyed Length:		ength:		60

Habitat	Reen
Bank Profile	Shallow <45deg
Depth of Water	<0.5m
Channel Width	1 - 2m
Flow Speed	Still
Shore Banks	Earth

Neighboring Land Use	Arable; Livestock grazing;
Bank Management	Unfenced
Suitability for Otters	Low
Otter Signs	
Suitability for Watervoles	Low
Watervole Signs

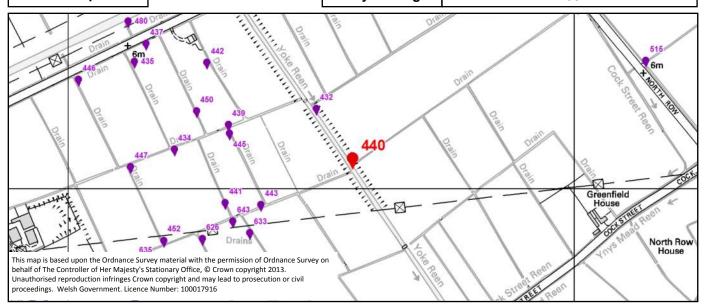
Unique Reference	440	Date:	Date: 07-08-2014 16:02		GPS:	51.561172, -2.873253
Waterbody Number:	1186	Survey	Surveyor:		TR a	ind AO
Location Map:		Surveyed Length:		ngth:		200

Habitat	Reen
Bank Profile	Steep >45deg
Depth of Water	1 - 2m
Channel Width	5 - 10m
Flow Speed	Still
Shore Banks	Earth

Neighboring Land Use	Arable; Livestock grazing;
Bank Management	Unfenced
Suitability for Otters	Low
Otter Signs	
Suitability for Watervoles	Low
Watervole Signs

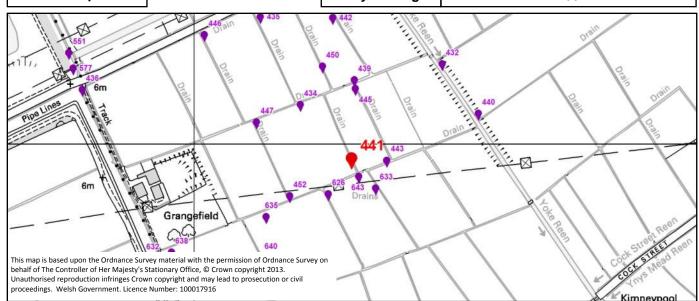
Unique Reference	441	Date:	Date: 07-08-2014 12:03		GPS:	51.560357, -2.876855	
Waterbody Number:	1156	Survey	Surveyor:		TR and AO		
Location Map:		Survey	Surveyed Length:			100

Habitat	Ditch				
Bank Profile	Flat <10 degrees				
Depth of Water	<0.5m				
Channel Width	1 - 2m				
Flow Speed	Still				
Shore Banks	Earth

Neighboring Land Use	Arable; Livestock grazing;
Bank Management	Unfenced
Suitability for Otters	Low
Otter Signs	
Suitability for Watervoles	Low
Watervole Signs

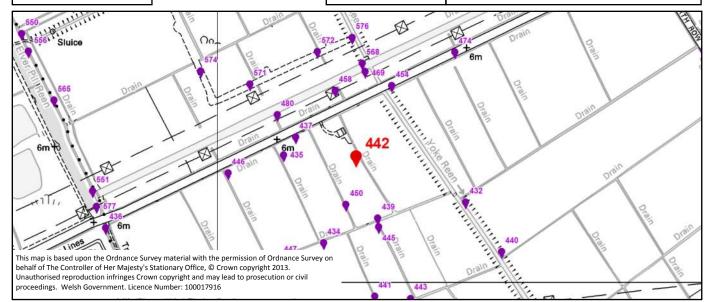
Unique Reference	442	Date:	Date: 07-08-2014 11:27		GPS:	51.56283, -2.877428	
Waterbody Number:	601	Surveyor:			TR and AO		
Location Map:		Surveyed Length:			100

Habitat	Ditch
Bank Profile	Flat <10 degrees
Depth of Water	1 - 2m
Channel Width	1 - 2m
Flow Speed	Still
Shore Banks

Neighboring Land Use	
Bank Management	Fenced
Suitability for Otters	Low
Otter Signs	
Suitability for Watervoles	Low
Watervole Signs

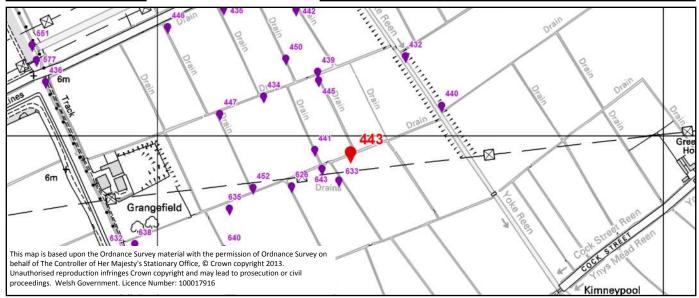
Unique Reference	443	Date:	Date: 07-08-2014 11:58		GPS:	51.560326, -2.875837
Waterbody Number:	1146	Survey	Surveyor:		TR and AO	
Location Map:		Surve	Surveyed Length:			20

Habitat	Ditch					
Bank Profile	Flat <10 degrees					
Depth of Water	<0.5m					
Channel Width	1 - 2m					
Flow Speed	Still					
Shore Banks	Earth

Neighboring Land Use	Arable; Livestock grazing;
Neighborning Land OSE	Alabie, Livestock grazing,
Bank Management	Unfenced
Suitability for Otters	Low
Otter Signs	
Suitability for Watervoles	Low
Watervole Signs

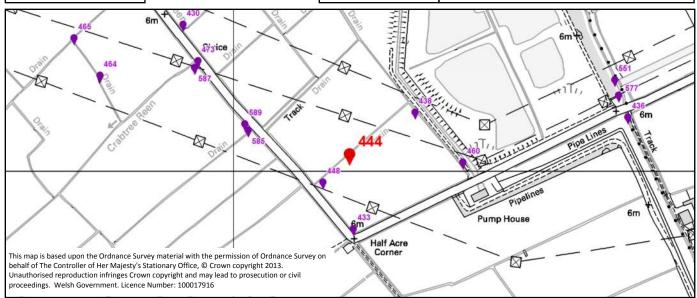
Unique Reference	444	Date: 07-08-2014 10:02		GPS:	51.56079, -2.892476	
Waterbody Number:	548	Survey	Surveyor:		TR and AO	
Location Map:		Surveyed Length:			100

Habitat	Ditch					
Bank Profile	Flat <10 degrees					
Depth of Water	<0.5m					
Channel Width	1 - 2m					
Flow Speed	Still					
Shore Banks	Earth

Neighboring Land Use	Arable; Livestock grazing;
Bank Management	Unfenced
Suitability for Otters	Low
Otter Signs	
Suitability for Watervoles	Low
Watervole Signs
