M4 Corridor around Newport

Environmental Statement Volume 3: Appendix 10.8 Otter and Water Vole Survey 2014

M4CaN-DJV-EBD-ZG_GEN-AX-EN-0028

Welsh Government M4 Corridor Around Newport Otter and Water Vole Survey 2014

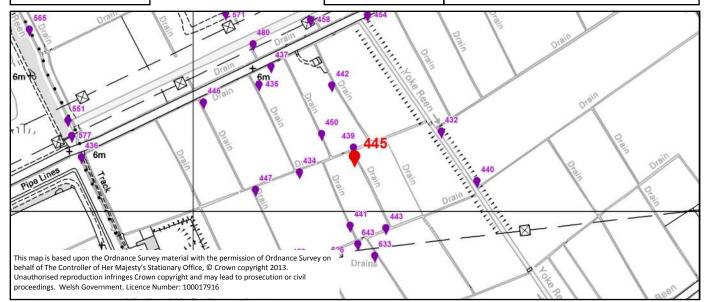
Unique Reference	445	Date: 07-08-2014 11:47		GPS:	51.561584, -2.876766	
Waterbody Number:	1050	Survey	Surveyor:		TR and AO	
Location Map:		Surveyed Length:			100

Habitat	Ditch					
Bank Profile	Flat <10 degrees					
Depth of Water	<0.5m					
Channel Width	2 - 5m					
Flow Speed	Still					
Shore Banks	Earth

Neighboring Land Use	Arable; Livestock grazing;
Bank Management	Unfenced
Suitability for Otters	Low
Otter Signs	
Suitability for Watervoles	Low
Watervole Signs

Hawthorn,phragmites,bramble, blackthorn,crack willow,oak

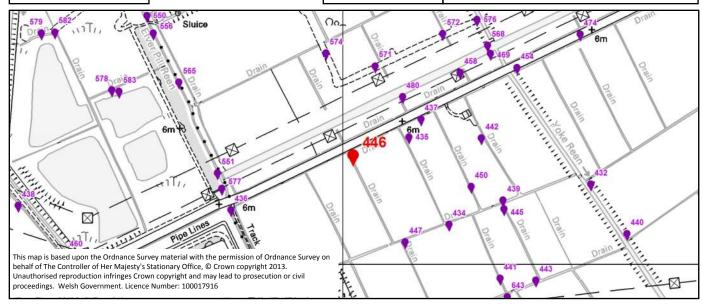
Unique Reference	446	Date: 07-08-2014 15:12		GPS:	51.562501, -2.881077	
Waterbody Number:	593	Survey	Surveyor:		TR and AO	
Location Map:		Surveyed Length:			150

Habitat	Ditch			
Bank Profile	Shallow <45deg			
Depth of Water	0.5 - 1m			
Channel Width	2 - 5m			
Flow Speed	Still			
Shore Banks

Neighboring Land Use	
Bank Management	Unfenced
Suitability for Otters	Low
Otter Signs	
Suitability for Watervoles	Low
Watervole Signs

Lamena , bull rush,brambles,mature oak tree, wild rose,goat willow, crack willow,phragmites

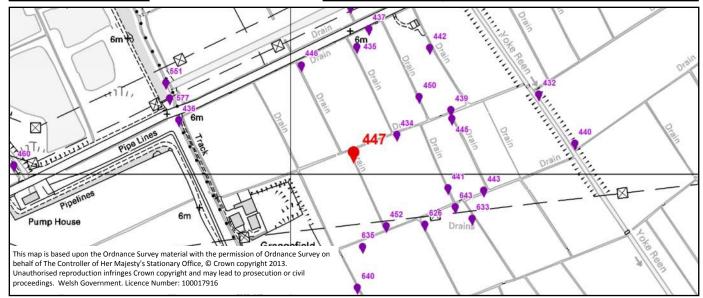
Unique Reference	447	Date:	07-0	08-2014 14:38	GPS:	51.560974, -2.879565
Waterbody Number:	1155	Survey	or:		TR a	ind AO
Location Map:		Surveyed Length:		ength:		150

Habitat	Ditch
Bank Profile	Flat <10 degrees
Depth of Water	<0.5m
Channel Width	1 - 2m
Flow Speed	Still
Shore Banks	Earth

Neighboring Land Use	Arable; Livestock grazing;
Bank Management	Fenced
Suitability for Otters	Low
Otter Signs	
Suitability for Watervoles	Low
Watervole Signs

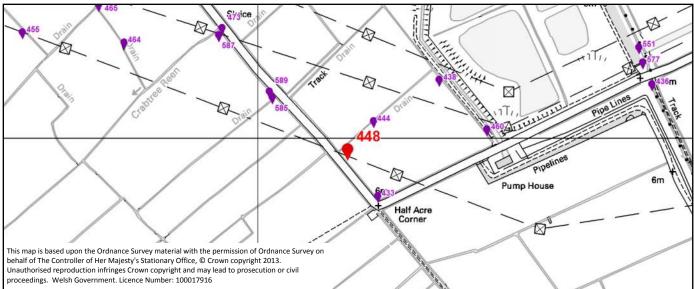
Unique Reference	448	Date:	07-	08-2014 10:10	GPS:	51.560289, -2.893212
Waterbody Number:	544	Survey	or:		TR a	nd AO
Location Map:		Surveyed Length:		ength:		100

Habitat	Ditch			
Bank Profile	Flat <10 degrees			
Depth of Water	<0.5m			
Channel Width	1 - 2m			
Flow Speed	Still			
Shore Banks	Earth

Neighboring Land Use	Arable; Livestock grazing;
Bank Management	Unfenced
Suitability for Otters	Low
Otter Signs	
Suitability for Watervoles	Low
Watervole Signs

Vegetation Description	Comments:
Crack willow, hawthorn, wild rose, bramble, Phragmites, ash	Dry ditch,

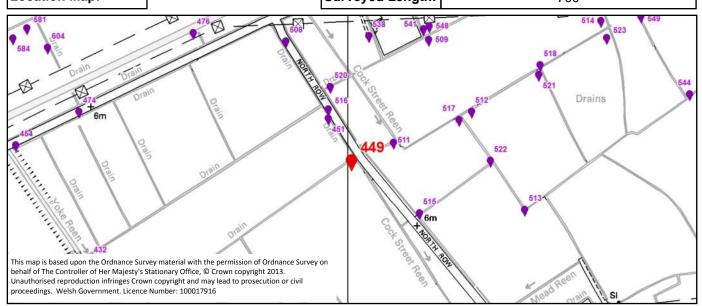
Unique Reference	449	Date:	Date: 07-08-2014 15:47		GPS:	51.563879, -2.866879
Waterbody Number:	614	Surve	Surveyor:		TR a	and AO
Location Man		Surveyed Length:		ength:		700

Habitat	Ditch		
Bank Profile	Flat <10 degrees		
Depth of Water	<0.5m		
Channel Width	2 - 5m		
Flow Speed	Still		
Shore Banks	Earth

Neighboring Land Use	Arable; Livestock grazing;
Bank Management	Unfenced
Suitability for Otters	Low
Otter Signs	
Suitability for Watervoles	Low
Watervole Signs

Hawthorn, blackthorn, nettle, dock, phragmites, lamena, bramble, crack willow, hazel

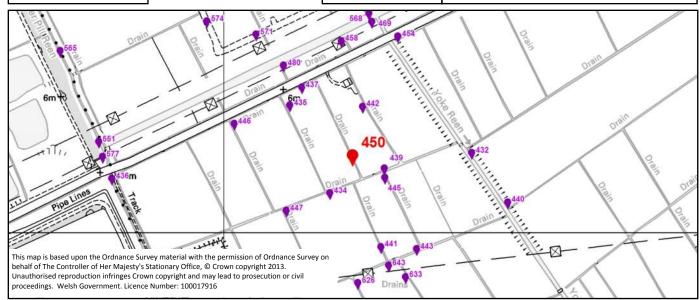
Unique Reference	450	Date:	Date: 07-08-2014 12:17		GPS:	51.561967, -2.877704
Waterbody Number:	598	Survey	ırveyor:		TR a	and AO
Location Map:		Surveyed Length:			100

Habitat	Ditch			
Bank Profile	Flat <10 degrees			
Depth of Water	<0.5m			
Channel Width	<1m			
Flow Speed	Still			
Shore Banks	Earth

Neighboring Land Use	Arable; Livestock grazing;
Neighborning Land OSE	Alabie, Livestock grazing,
Bank Management	Unfenced
Suitability for Otters	Low
Otter Signs	
Suitability for Watervoles	Low
Watervole Signs

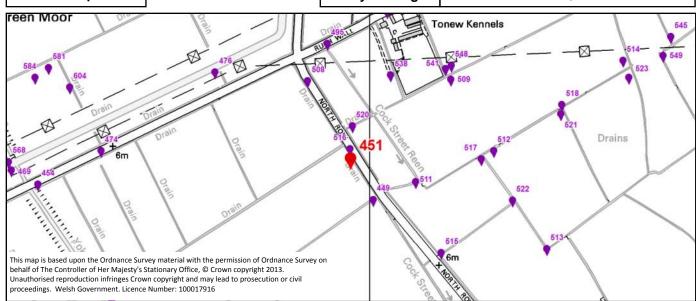
Unique Reference	451	Date:	Date: 07-08-2014 15:42		GPS:	51.564607, -2.867547
Waterbody Number:	611	Survey	Surveyor:		TR and AO	
Location Map:		Surveyed Length:		ength:		70

Habitat	Reen			
Bank Profile	Shallow <45deg			
Depth of Water	<0.5m			
Channel Width	2 - 5m			
Flow Speed				
Shore Banks	Earth

Neighboring Land Use	Arable; Livestock grazing;
Bank Management	Unfenced
Suitability for Otters	Negligible
Otter Signs	
Suitability for Watervoles	Negligible
Watervole Signs

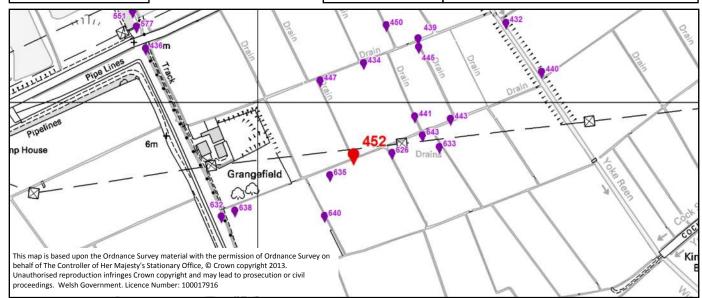
Unique Reference	452	Date:	Date: 07-08-2014 14:47		GPS:	51.559679, -2.878598
Waterbody Number:	1051	Survey	Surveyor:		TR and AO	
Location Map:		Surveyed Length:			60

Habitat	Ditch			
Bank Profile	Flat <10 degrees			
Depth of Water	0.5 - 1m			
Channel Width	2 - 5m			
Flow Speed	Still			
Shore Banks	Earth

Neighboring Land Use	Arable; Livestock grazing;
Bank Management	Mixture
Suitability for Otters	Low
Otter Signs	
Suitability for Watervoles	Low
Watervole Signs

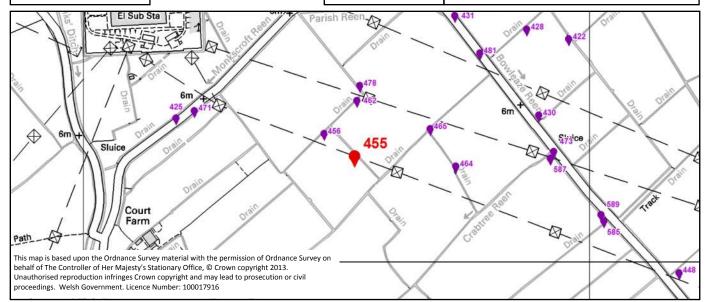
Unique Reference	455	Date:	06-	08-2014 16:05	GPS:	51.56228, -2.902507
Waterbody Number:	1080	Survey	or:		-	TS
Location Map:		Surveyed Length:

Habitat	Reen				
Bank Profile	Flat <10 degrees				
Depth of Water	<0.5m				
Channel Width	1 - 2m				
Flow Speed	Still				
Shore Banks	Earth

Neighboring Land Use	Livestock grazing;
Bank Management	Mixture
Suitability for Otters	Negligible
Otter Signs	
Suitability for Watervoles	Negligible
Watervole Signs

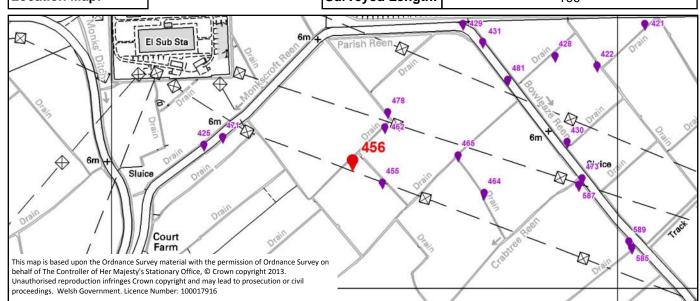
Unique Reference	456	Date:	06-	08-2014 16:10	GPS:	51.562666, -2.903373
Waterbody Number:	1078	Survey	or:	TS		
Location Map:		Survey	Surveyed Length:			100

Habitat	Reen			
Bank Profile	Shallow <45deg			
Depth of Water	0.5 - 1m			
Channel Width	1 - 2m			
Flow Speed	Still			
Shore Banks	Earth

Neighboring Land Use	Livestock grazing;
Bank Management	Mixture
Suitability for Otters	Negligible
Otter Signs	
Suitability for Watervoles	Low
Watervole Signs

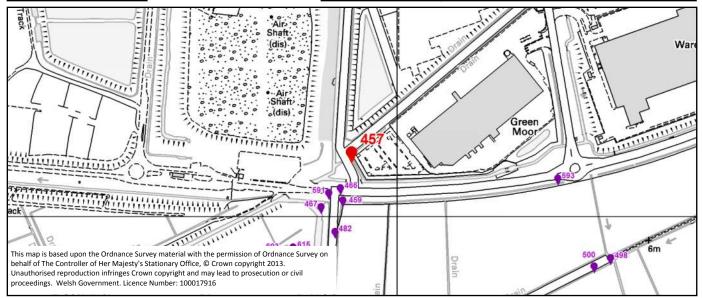
Unique Reference	457	Date:	07-	08-2014 16:36	GPS:	51.570796, -2.868419
Waterbody Number:	651	Survey	or:		TS	MM
Location Map:		Surveyed Length:

Habitat	Reen
Bank Profile	Shallow <45deg
Depth of Water	1 - 2m
Channel Width	1 - 2m
Flow Speed	Still
Shore Banks	Earth

Neighboring Land Use	Urban;
Bank Management	
Suitability for Otters	Negligible
Otter Signs	
Suitability for Watervoles	Negligible
Watervole Signs

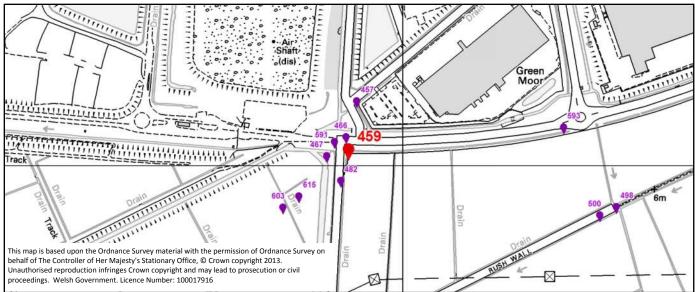
Unique Reference	459	Date:	07-	08-2014 16:44	GPS:	51.569947, -2.86865
Waterbody Number:	676	Survey	or:	TS		
Location Map:		Surveyed Length:		enath:		100

Habitat	Reen		
Bank Profile	Steep >45deg		
Depth of Water	1 - 2m		
Channel Width	2 - 5m		
Flow Speed			
Shore Banks	Earth

Neighboring Land Use	Scrub;
Bank Management	Unfenced
Suitability for Otters	Negligible
Otter Signs	
Suitability for Watervoles	Negligible
Watervole Signs

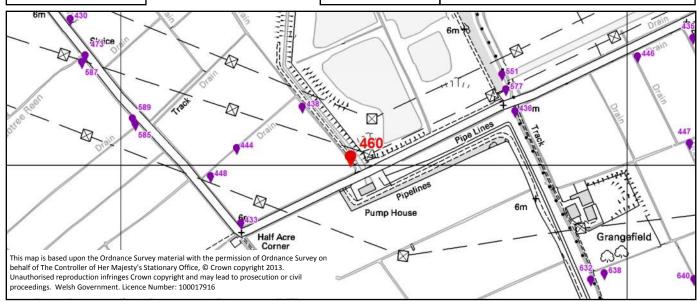
Unique Reference	460	Date:	06-	08-2014 10:58	GPS:	51.560672, -2.889232	
Waterbody Number:	536	Survey	Surveyor:		TS		
Location Map:		Surveyed Length:				1000

Habitat	Dyke
Bank Profile	Steep >45deg
Depth of Water	>2m
Channel Width	2 - 5m
Flow Speed	Sluggish
Shore Banks	Stones

Neighboring Land Use	Scrub;
Bank Management	Unfenced
Suitability for Otters	Negligible
Otter Signs	
Suitability for Watervoles	Low
Watervole Signs

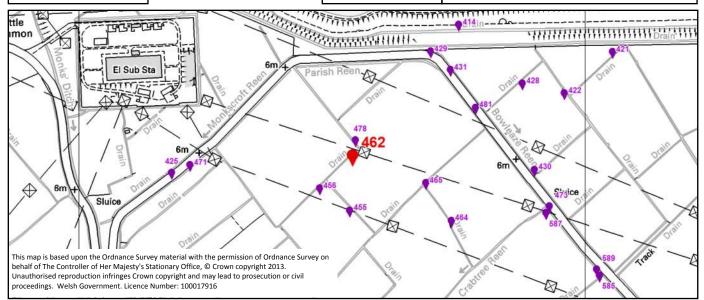
Unique Reference	462	Date:	Date: 06-08-2014 16:30		GPS:	51.563254, -2.902456
Waterbody Number:	1077	Surveyor:		TS		
Location Map:		Survey	Surveyed Length: 50		50

Habitat	Reen			
Bank Profile	Shallow <45deg			
Depth of Water	0.5 - 1m			
Channel Width	1 - 2m			
Flow Speed	Still			
Shore Banks	Earth

Neighboring Land Use	Livestock grazing;
Bank Management	Mixture
Suitability for Otters	Negligible
Otter Signs	
Suitability for Watervoles	Negligible
Watervole Signs

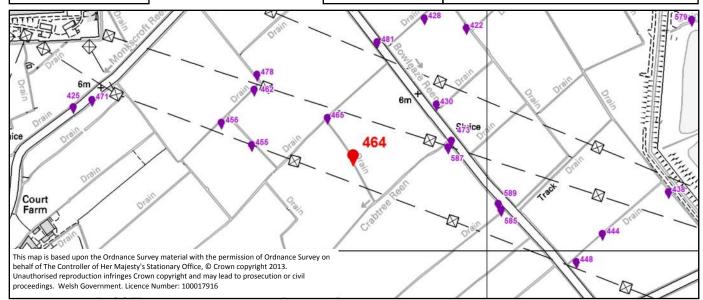
Unique Reference	464	Date:	Date: 06-08-2014 15:41		GPS:	51.562123, -2.899608
Waterbody Number:		Surveyor:		-	ΓS	
Location Map:		Survey	Surveyed Length:		50

Habitat	Reen			
Bank Profile	Shallow <45deg			
Depth of Water	<0.5m			
Channel Width	1 - 2m			
Flow Speed	Still			
Shore Banks	Earth

Neighboring Land Use	Livestock grazing;
Bank Management	Mixture
Suitability for Otters	Negligible
Otter Signs	
Suitability for Watervoles	Negligible
Watervole Signs

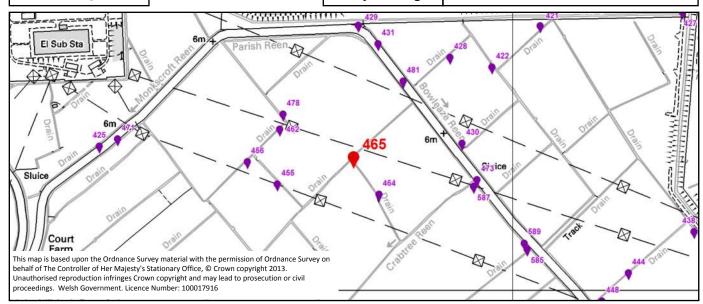
Unique Reference	465	Date:	Date: 06-08-2014 15:51		GPS:	51.562779, -2.900356
Waterbody Number:	561	Surveyor:		TS		
Location Map:		Surve	ed L	enath:	100

Habitat	Reen				
Bank Profile	Shallow <45deg				
Depth of Water	0.5 - 1m				
Channel Width	1 - 2m				
Flow Speed					
Shore Banks	Earth

Neighboring Land Use	Livestock grazing;
Bank Management	Mixture
Suitability for Otters	Negligible
Otter Signs	
Suitability for Watervoles	Low
Watervole Signs

Heavily vegetated by duck weed, encroached by scrub and sedges. Some purple loosestrife and sweet reed grass present

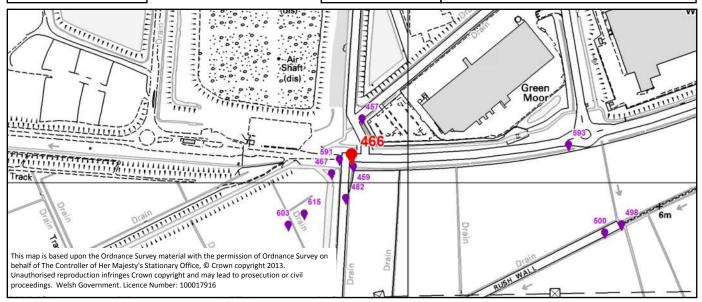
Unique Reference	466	Date:	07-	08-2014 16:00	GPS:	51.570161, -2.868715
Waterbody Number:	1343	Surve	yor: TS MM			
Location Map:		Surveyed Length:

Habitat	Reen		
Bank Profile	Steep >45deg		
Depth of Water	1 - 2m		
Channel Width	2 - 5m		
Flow Speed	Sluggish		
Shore Banks	Earth

Neighboring Land Use	Urban;
Bank Management	Mixture
Suitability for Otters	Low
Otter Signs	
Suitability for Watervoles	Low
Watervole Signs

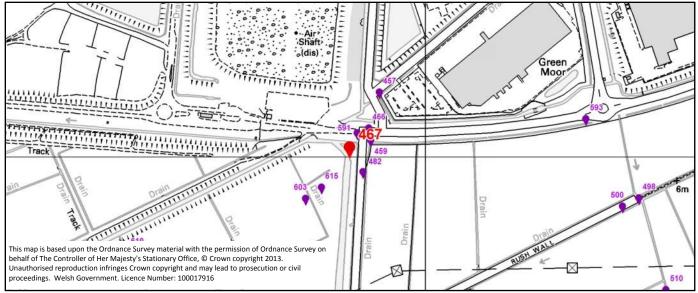
Waterbody Number:
 678
 Surveyor:
 TS MM

Habitat	Reen		
Bank Profile	Steep >45deg		
Depth of Water	1 - 2m		
Channel Width	2 - 5m		
Flow Speed	Still		
Shore Banks	Earth

Neighboring Land Use	Livestock grazing; Scrub;
Bank Management	
Suitability for Otters	
Otter Signs	
Suitability for Watervoles	
Watervole Signs

Duckweed dominated, some Phragmites emerging in water body and on fringes. Bank side veg: bull rush, nUrtica, marsh thistle an bramble scrub. Trees: goat willow, crack willow, hawthorn

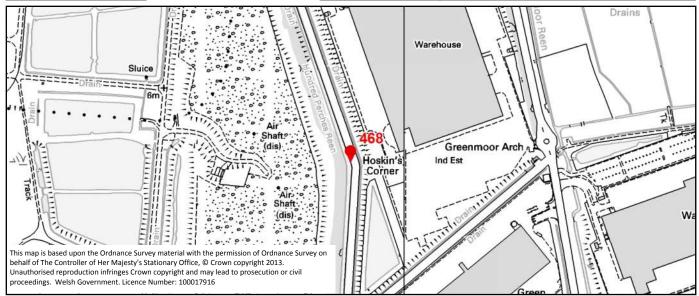
Unique Reference	468	Date:	07-	08-2014 16:17	GPS:	51.573828, -2.868702
Waterbody Number:	1348	Survey	or:		TS	MM
Location Map:		Surveyed Length:

Habitat	Reen		
Bank Profile	Steep >45deg		
Depth of Water	0.5 - 1m		
Channel Width	2 - 5m		
Flow Speed	Still		
Shore Banks	Earth

Neighboring Land Use	Scrub;
Bank Management	Unfenced
Suitability for Otters	Negligible
Otter Signs	
Suitability for Watervoles	Negligible
Watervole Signs

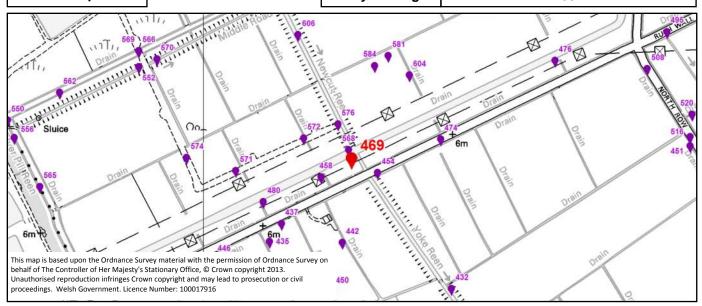
Unique Reference	469	Date:	Date: 07-08-2014 12:23		GPS:	51.564325, -2.877198
Waterbody Number:	1350	Survey	Surveyor:		TS	SMM
Location Map:		Surveyed Length:			50

Habitat	Reen		
Bank Profile	Shallow <45deg		
Depth of Water	>2m		
Channel Width	2 - 5m		
Flow Speed	Still		
Shore Banks	Earth

Neighboring Land Use	Livestock grazing; Scrub;
Bank Management	Unfenced
Suitability for Otters	Low
Otter Signs	
Suitability for Watervoles	Medium
Watervole Signs	Feeding Stations;

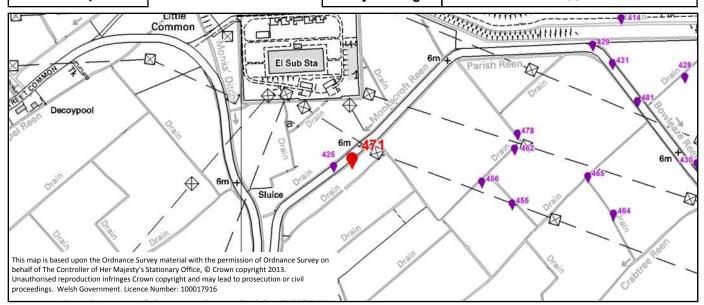
Unique Reference	471	Date: 06-08-2014 14:24		GPS:	51.563046, -2.907077	
Waterbody Number:	566	Surveyor:			TS	
Location Map:		Surveyed Length:		enath:		100

Habitat	Reen			
Bank Profile	Steep >45deg			
Depth of Water	1 - 2m			
Channel Width	1 - 2m			
Flow Speed	Still			
Shore Banks	Earth

Neighboring Land Use	Livestock grazing;
Bank Management	Unfenced
Suitability for Otters	Negligible
Otter Signs	
Suitability for Watervoles	Low
Watervole Signs	Feeding Stations;

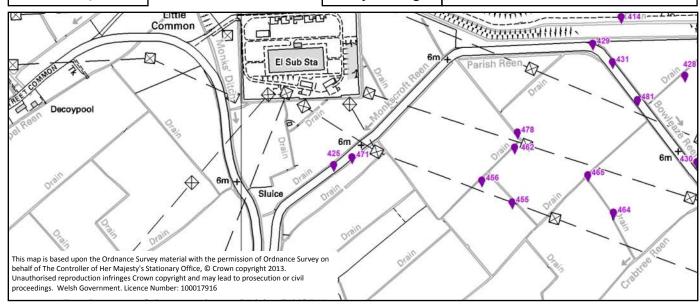
Waterbody Number:
 1068
 Surveyor:
 TS MM

Habitat	Reen		
Bank Profile	Shallow <45deg		
Depth of Water	>2m		
Channel Width	5 - 10m		
Flow Speed	Still		
Shore Banks	Earth

Neighboring Land Use	Livestock grazing; Scrub;
Bank Management	Unfenced
Suitability for Otters	Low
Otter Signs	
Suitability for Watervoles	Medium
Watervole Signs	Latrines;

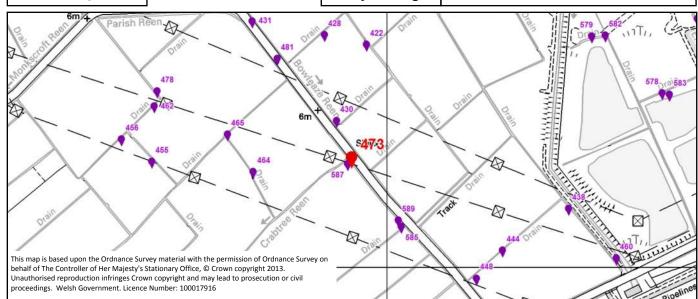
Unique Reference	473	Date: 06-08-2014 15:25		GPS:	51.5624, -2.89682
Waterbody Number:	555	Surveyor:		•	TS
Location Map:		Surveyed Length:			0

Habitat	Reen		
Bank Profile	Steep >45deg		
Depth of Water	1 - 2m		
Channel Width	2 - 5m		
Flow Speed	Still		
Shore Banks	Earth

Neighboring Land Use	Arable;
Bank Management	Mixture
Suitability for Otters	Negligible
Otter Signs	
Suitability for Watervoles	Negligible
Watervole Signs

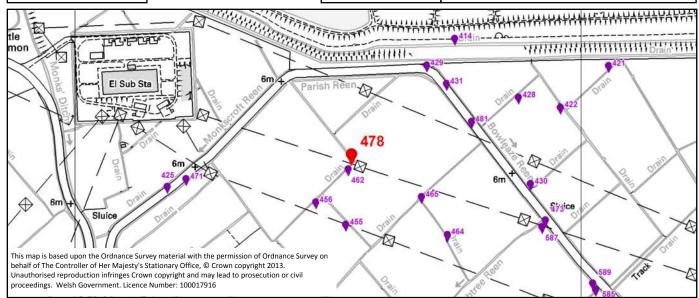
Unique Reference	478	Date: 06-08-2014 16:24		GPS:	51.563521, -2.902378
Waterbody Number:	567	Surveyor:		TS	
Location Map:		Surveyed Length:			50

Habitat	Reen
Bank Profile	Shallow <45deg
Depth of Water	0.5 - 1m
Channel Width	1 - 2m
Flow Speed	Still
Shore Banks

Neighboring Land Use	
Bank Management	Mixture
Suitability for Otters	Negligible
Otter Signs	
Suitability for Watervoles	Negligible
Watervole Signs

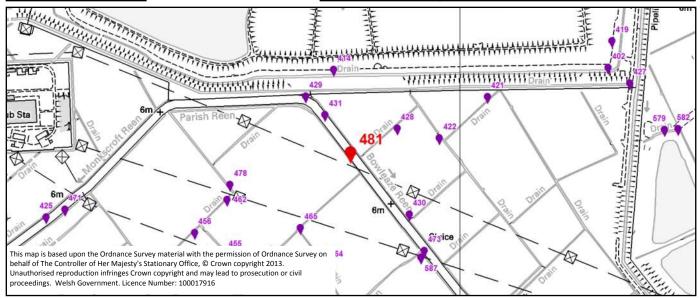
Unique Reference	481	Date:	Date: 06-08-2014 15:06		GPS:	51.564124, -2.898964
Waterbody Number:	559	Survey	Surveyor:		TS	
Location Map:		Survey	Surveyed Length:		50

Habitat	Reen					
Bank Profile	Shallow <45deg					
Depth of Water	0.5 - 1m					
Channel Width	1 - 2m					
Flow Speed	Still					
Shore Banks	Earth

Neighboring Land Use	Livestock grazing;
Bank Management	Unfenced
Suitability for Otters	Low
Otter Signs	
Suitability for Watervoles	Medium
Watervole Signs	Feeding Stations;

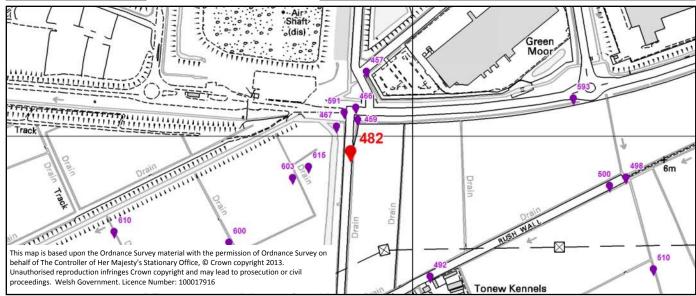
Unique Reference	482	Date:	ate: 07-08-2014 16:52		GPS:	51.569391, -2.868859	
Waterbody Number:	583	Surveyor:			TS		
Location Map:		Survey	Surveyed Length:		100

Habitat	Ditch				
Bank Profile	Steep >45deg				
Depth of Water	1 - 2m				
Channel Width	2 - 5m				
Flow Speed	Still				
Shore Banks	Earth

Neighboring Land Use	Scrub;
Bank Management	Unfenced
Suitability for Otters	Negligible
Otter Signs	
Suitability for Watervoles	Negligible
Watervole Signs

Duckweed dominates surface of water body. Overgrown surrounding vegetation: hawthorn, crack willow, bramble, great willow herb, hedge bind weed, bittersweet nightshade.

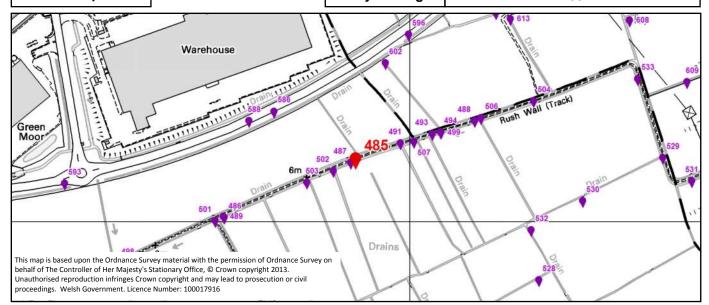
Unique Reference	485	Date:	12-08-2014 16:01		GPS:	51.570883, -2.854241	
Waterbody Number:	787	Surveyor:			TS/FG		
Location Map:		Survey	Surveyed Length:		100

Habitat	Reen				
Bank Profile	Steep >45deg				
Depth of Water	1 - 2m				
Channel Width	2 - 5m				
Flow Speed	Still				
Shore Banks	Earth

Neighboring Land Use	Livestock grazing;
Bank Management	Unfenced
Suitability for Otters	Negligible
Otter Signs	
Suitability for Watervoles	Low
Watervole Signs

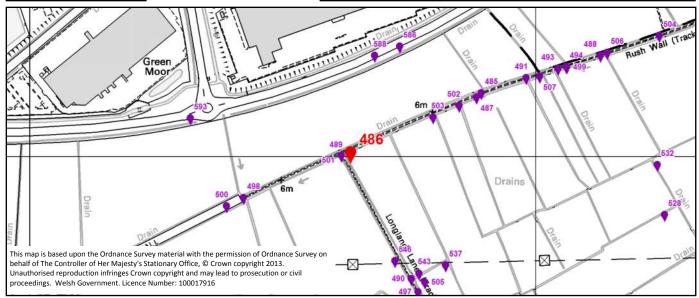
Unique Reference	486	Date:	Date: 12-08-2014 14:04		GPS:	51.569811, -2.857953	
Waterbody Number:	631	Surveyor:			TS/FG		
Location Map:		Survey	Surveyed Length:		Surveyed Length: 100		100

Habitat	Reen
Bank Profile	Steep >45deg
Depth of Water	1 - 2m
Channel Width	2 - 5m
Flow Speed	Still
Shore Banks	Earth

Neighboring Land Use	Livestock grazing;
Bank Management	Unfenced
Suitability for Otters	Negligible
Otter Signs	
Suitability for Watervoles	Low
Watervole Signs	Lawns;

Potential mink tar spots. Mink/rat presence. possible water vole burrow. animal heard. (likely brown rat as no feeding station found on bank). Bank could not be checked due to cattle in field.

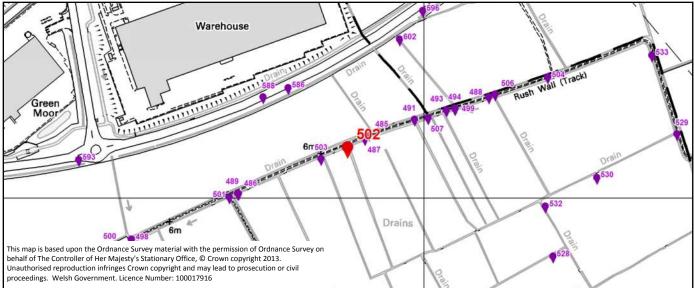
Unique Reference	502	Date:	12-	08-2014 14:29	GPS:	51.570656, -2.854869	
Waterbody Number:	976	Surveyor:		TS/FG			
Location Map:		Surveyed Length:

Vegetation Description	Comments:					
	Unsuitable. Densely vegetated. Heavily shaded. Low water quality. Heavy duckweed cover.

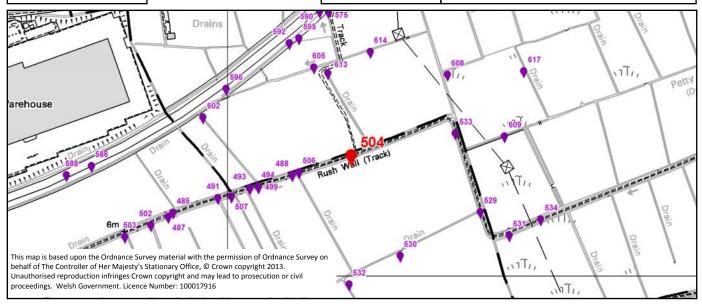
Unique Reference	504	Date:	Date: 12-08-2014 15:24		GPS:	51.571933, -2.849177	
Waterbody Number:	962	Surveyor:		TS/FG			
Location Map:		Survey	Surveyed Length:		Surveyed Length: 50		50

Habitat	Reen
Bank Profile	Steep >45deg
Depth of Water	1 - 2m
Channel Width	2 - 5m
Flow Speed	Still
Shore Banks

Neighboring Land Use	
Bank Management	Unfenced
Suitability for Otters	Negligible
Otter Signs	
Suitability for Watervoles	Low
Watervole Signs

Quite recent mink spraint. No small mammal bones found in spraint.

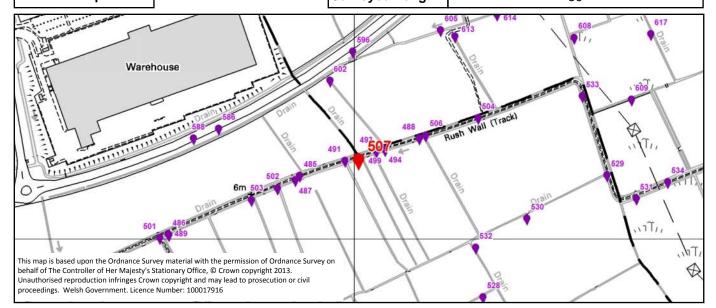
Unique Reference	507	Date:	Date: 12-08-2014 15:42		GPS:	51.571183, -2.85258
Waterbody Number:	888	Survey	Surveyor:		TS/FG	
Location Map:		Surve	Surveyed Length:		th: 50

Habitat	Reen			
Bank Profile	Steep >45deg			
Depth of Water	1 - 2m			
Channel Width	2 - 5m			
Flow Speed	Still			
Shore Banks	Earth

Neighboring Land Use	Livestock grazing;
Bank Management	Unfenced
Suitability for Otters	Negligible
Otter Signs	
Suitability for Watervoles	Low
Watervole Signs

Feeding stations found in 2 separate locations. Bank vole droppings found.

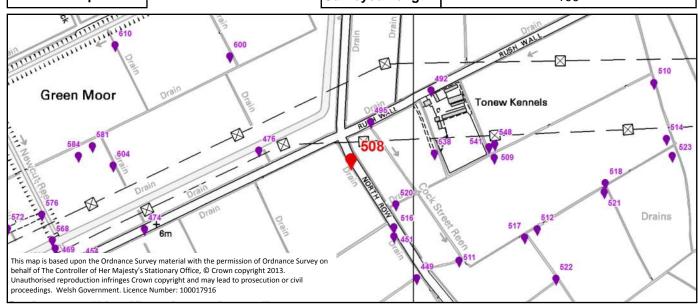
Unique Reference	508	Date:	Date: 12-08-2014 10:42		GPS:	51.565961, -2.868788
Waterbody Number:	612	Survey	Surveyor:		Ao SC	
Location Map:		Surve	Surveyed Length:		h: 100

Habitat	Reen			
Bank Profile	Shallow <45deg			
Depth of Water	<0.5m			
Channel Width	1 - 2m			
Flow Speed	Still			
Shore Banks	Earth

Neighboring Land Use	Livestock grazing;
Bank Management	Unfenced
Suitability for Otters	Negligible
Otter Signs	
Suitability for Watervoles	Low
Watervole Signs	Pathways; Feeding Stations;

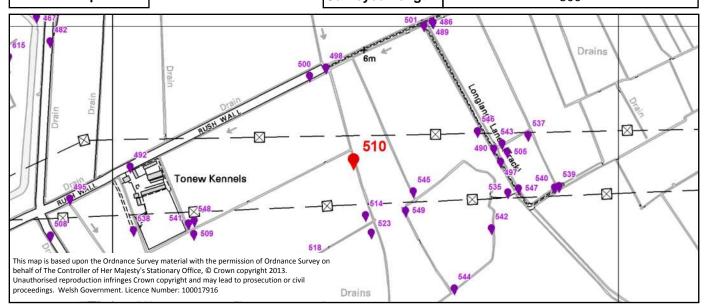
Unique Reference	510	Date:	12-08-2014 16:14		GPS:	51.567374, -2.860181	
Waterbody Number:	981	Surveyor:			AO & SC		
Location Map:		Survey	Surveyed Length:		300

Habitat	Ditch				
Bank Profile	Shallow <45deg				
Depth of Water	1 - 2m				
Channel Width	5 - 10m				
Flow Speed	Still				
Shore Banks	Earth

Neighboring Land Use	Arable;
Bank Management	Mixture
Suitability for Otters	Negligible
Otter Signs	
Suitability for Watervoles	Low
Watervole Signs	Pathways; Feeding Stations;

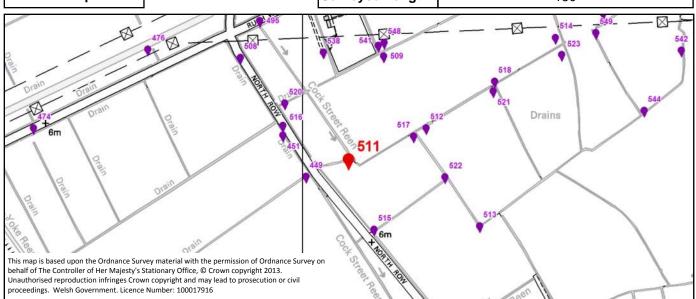
Unique Reference	511	Date:	12-0	08-2014 12:15	GPS:	51.564197, -2.865679
Waterbody Number:	618	Survey	Surveyor:		AO	& SC
Location Map:		Surve	ed Le	enath:		150

Habitat	Reen				
Bank Profile	Steep >45deg				
Depth of Water	>2m				
Channel Width	2 - 5m				
Flow Speed	Still				
Shore Banks	Earth

Neighboring Land Use	Livestock grazing;
Bank Management	Unfenced
Suitability for Otters	Low
Otter Signs	
Suitability for Watervoles	Medium
Watervole Signs

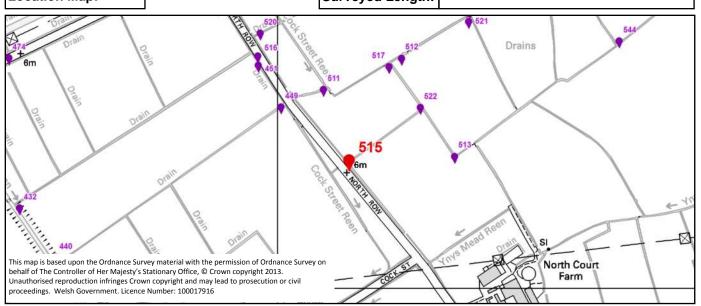
Unique Reference	515	Date:	e: 12-08-2014 11:29		GPS:	51.562957, -2.864918
Waterbody Number:	901	Survey	or:	or: Ao SC		
Location Map:		Surveyed Length:

Habitat	Reen
Bank Profile	Steep >45deg
Depth of Water	1 - 2m
Channel Width	2 - 5m
Flow Speed	Still
Shore Banks	Earth

Neighboring Land Use	Livestock grazing;
Bank Management	Unfenced
Suitability for Otters	
Otter Signs	
Suitability for Watervoles	
Watervole Signs	Feeding Stations;

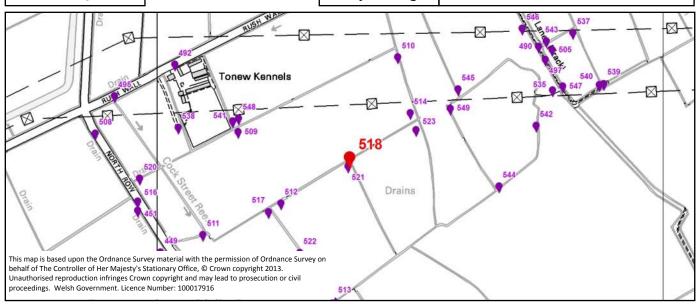
Unique Reference	518	Date:	: 12-08-2014 15:17		GPS:	51.565595, -2.861534
Waterbody Number:	899	Survey	Surveyor:		AO & SC	
Location Map:		Survey	Surveyed Length:			100

Neighboring Land Use	Livestock grazing;
Bank Management	Mixture
Suitability for Otters	Negligible
Otter Signs	
Suitability for Watervoles	Low
Watervole Signs	Feeding Stations;

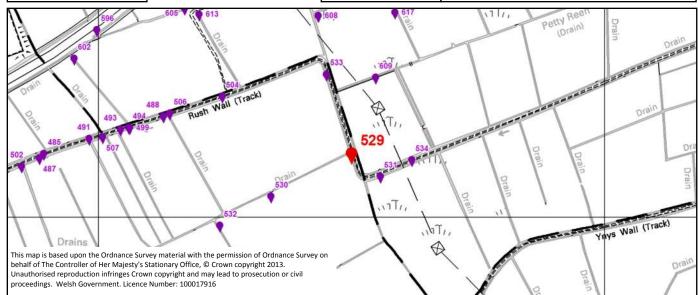
Unique Reference	529	Date:	13-	08-2014 12:09	GPS:	51.570955, -2.84548
Waterbody Number:	877	Survey	or:		-	rs
Location Map:		Survey	ed L	enath:		50

Habitat	Reen			
Bank Profile	Shallow <45deg			
Depth of Water	0.5 - 1m			
Channel Width	2 - 5m			
Flow Speed	Sluggish			
Shore Banks	Earth

Neighboring Land Use	Livestock grazing;
Bank Management	Unfenced
Suitability for Otters	Negligible
Otter Signs	
Suitability for Watervoles	Medium
Watervole Signs

Vegetation Description	Comments:
Sweet reed grass, dense reed bed, common reed	Medium suitability for water vole but likely small to extinct due to mink population as little signs were found

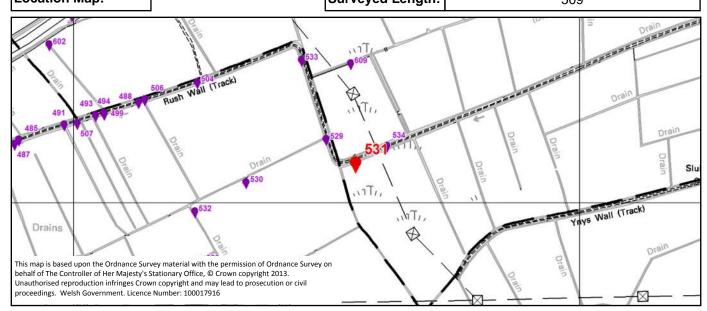
Unique Reference	531	Date:	te: 13-08-2014 11:40		GPS:	51.570548, -2.844646
Waterbody Number:	880	Survey	Surveyor:		TS	
Location Map:		Survey	Surveyed Length:		509

Neighboring Land Use	Livestock grazing;				
Bank Management	Mixture				
Suitability for Otters	Negligible				
Otter Signs					
Suitability for Watervoles	Low				
Watervole Signs	Feeding Stations;

Ma made feeding platform with half eaten platform. No latrine found. Mink raft

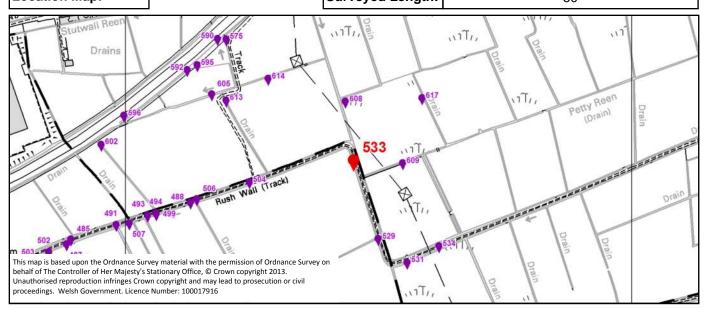
Unique Reference	533	Date:	13-08-2014 10:50		GPS:	51.572342, -2.846219	
Waterbody Number:	950	Survey	Surveyor:		TS		
Location Map:	_	Survey	Surveyed Length:		50

Neighboring Land Use	Livestock grazing;
Bank Management	Mixture
Suitability for Otters	Negligible
Otter Signs	
Suitability for Watervoles	Medium
Watervole Signs	Feeding Stations;

Possible feeding stations but no latrines found. Man made feeding raft found, no evidence on top. Numerous trails through duckweed

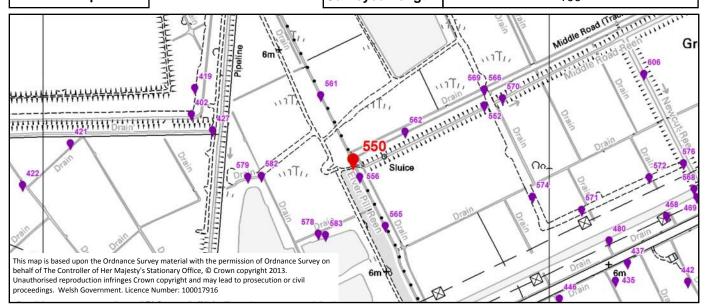
Unique Reference	550	Date:	15-0	08-2014 10:39	GPS:	51.564916, -2.887009
Waterbody Number:	1211	Survey	or:		TS	5 MM
Location Map:		Surve	ed Le	enath:		100

Neighboring Land Use	Scrub;
Bank Management	Unfenced
Suitability for Otters	Low
Otter Signs	
Suitability for Watervoles	Medium
Watervole Signs	Latrines;

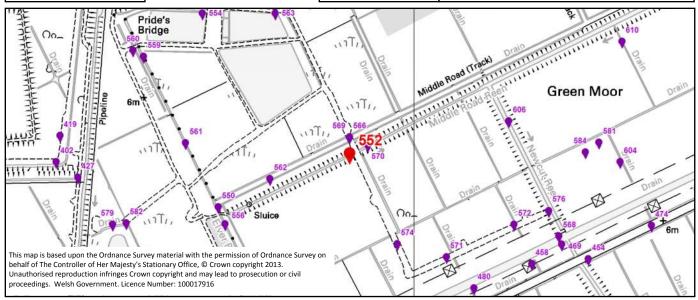
Waterbody Number:
 1129
 Surveyor:
 TS MM

Neighboring Land Use	Scrub;
Bank Management	Unfenced
Suitability for Otters	Medium
Otter Signs	Spraints;
Suitability for Watervoles	Medium
Watervole Signs	Latrines; Burrows;

Boat survey recommended. Potential burrow, no latrines on north and south. Northern bank recently managed. Watervole burrow with latrine found on South bank. Four Otter spraints, two recent found at sluice gate. Evidence of fish ones and moorhen chick feathers. Good water quality with fish fry

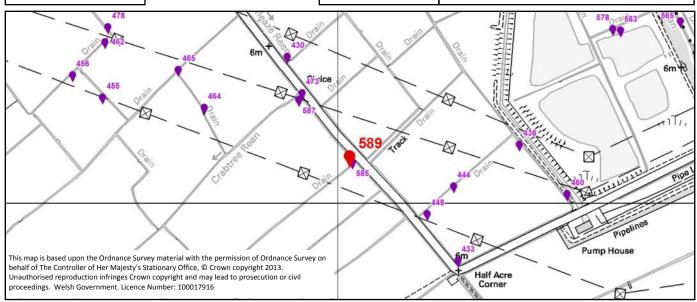
Unique Reference	589	Date:	Date: 20-08-2014 11:18		GPS:	51.561295, -2.895458
Waterbody Number:	555	Survey	or:	Tar, AO,MM		
Location Map:		Survey	Surveyed Length:			100

Habitat	Reen			
Bank Profile	Shallow <45deg			
Depth of Water	>2m			
Channel Width	2 - 5m			
Flow Speed	Still			
Shore Banks	Man-made

Noighboring Land Hoo	Livesteek grazing
Neighboring Land Use	Livestock grazing;
Bank Management	Unfenced
Suitability for Otters	Low
Otter Signs	
Suitability for Watervoles	Medium
Watervole Signs

Old Feeding station found, hedge on other side with hawthorn and blackthorn

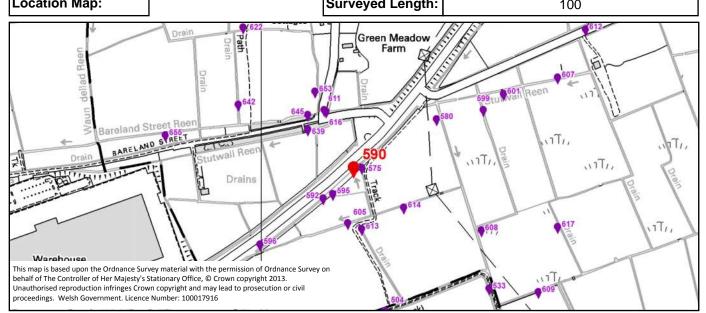
Unique Reference	590	Date:	21-	08-2014 10:15	GPS:	51.57446, -2.850129
Waterbody Number:		Surveyor:			AO, RE	
Location Map:		Surveyed Length:		100

Habitat	Ditch
Bank Profile	Steep >45deg
Depth of Water	<0.5m
Channel Width	2 - 5m
Flow Speed	Still
Shore Banks	Man-made

Neighboring Land Use	Livestock grazing; Urban;
Bank Management	Fenced
Suitability for Otters	Low
Otter Signs	
Suitability for Watervoles	Medium
Watervole Signs	Pathways; Feeding Stations;

Feeding remains found on bank.

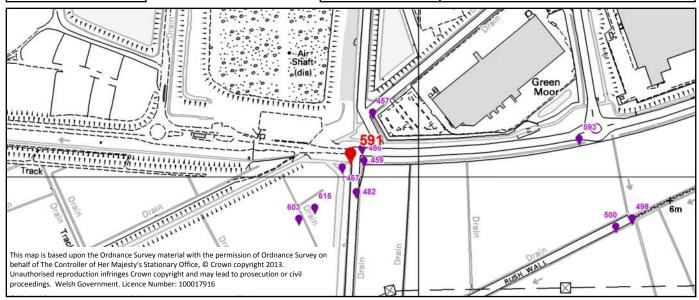
Unique Reference	591	Date:	Date: 21-08-2014 16:08		GPS:	51.570073, -2.869044	
Waterbody Number:	678	Survey	Surveyor:		AO & RE		
Location Map:		Surve	Surveyed Length:		·	100

Habitat	Reen			
Bank Profile	Steep >45deg			
Depth of Water	>2m			
Channel Width	10 - 20m			
Flow Speed	Still			
Shore Banks	Man-made

Neighboring Land Use	Livestock grazing; Broadleaf woodland;
Bank Management	Mixture
Suitability for Otters	Low
Otter Signs	
Suitability for Watervoles	Low
Watervole Signs

Lemna, sweet reed grass in ditch. Vegetation on bank is overgrown, hawthorn, bramble, crack willow, ivy blanketing the ground flora, ash. Phragmites on reen edge. Buddleja.

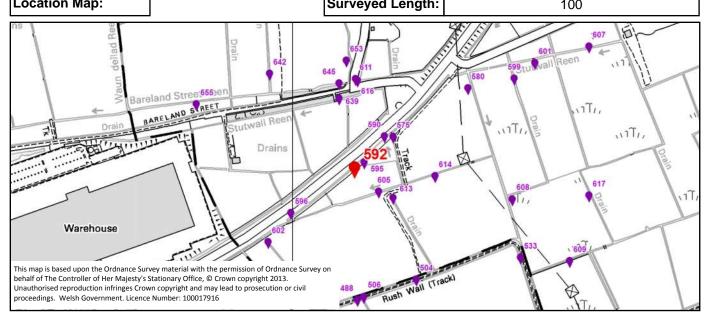
Unique Reference	592	Date:	21-08	3-2014 11:36	GPS:	51.573903, -2.85098	
Waterbody Number:		Survey	Surveyor:		AO, RE		
Location Man:		Surveyed Length:		ogth:		100

Habitat	
Bank Profile	Steep >45deg
Depth of Water	0.5 - 1m
Channel Width	2 - 5m
Flow Speed	Still
Shore Banks	Man-made

Neighboring Land Use	Broadleaf woodland; Urban;
Bank Management	Fenced
Suitability for Otters	Negligible
Otter Signs	
Suitability for Watervoles	Low
Watervole Signs

Oak, hawthorn, goat willow, alder, crack willow. Ivy smothering the bank, nettles, bramble. Hart's tongue fern.

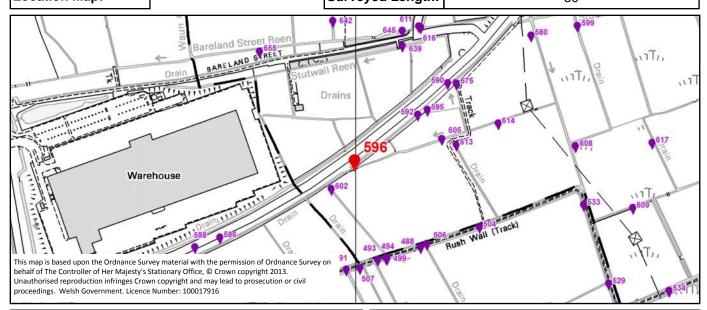
Unique Reference	596	Date:	Date: 21-08-2014 12:12		GPS:	51.573082, -2.852768
Waterbody Number:	843	Survey	urveyor:		AO & RE	
Location Man		Surveyed Length:		nath:		50

Habitat	Ditch			
Bank Profile	Steep >45deg			
Depth of Water	>2m			
Channel Width	5 - 10m			
Flow Speed	Still			
Shore Banks	Earth

Neighboring Land Use	Arable; Broadleaf woodland; Urban;
Bank Management	Mixture
Suitability for Otters	Low
Otter Signs	
Suitability for Watervoles	Low
Watervole Signs

Goat willow, crack willow, hawthorn, ash. Lemna (duckweed) smothering the ditch in some areas. Nettles and bramble on bank. Some areas of the ditch are shallow (less than 5 metres) other lengths are over 2metres deep.

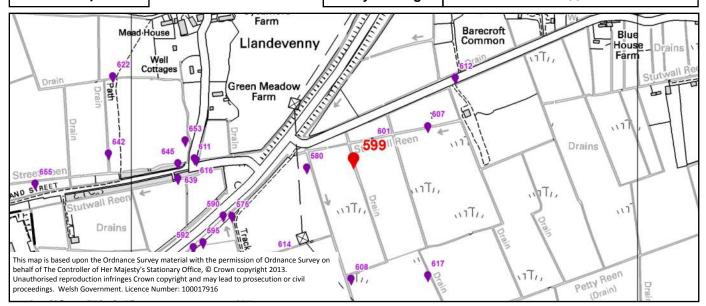
Unique Reference	599	Date:	26-0	8-2014 11:50	GPS:	51.5755, -2.846445
Waterbody Number:	670	Survey	or:		IB, R	P & AO
Location Map:		Surveyed Length:			200

Habitat	Ditch		
Bank Profile	Shallow <45deg		
Depth of Water	1 - 2m		
Channel Width	>20m		
Flow Speed	Still		
Shore Banks	Earth

Neighboring Land Use	Livestock grazing; Broadleaf woodland;
Bank Management	Mixture
Suitability for Otters	Low
Otter Signs	
Suitability for Watervoles	Low
Watervole Signs

Sweet reed grass, bullrush in the ditch. Vegetation on bank side mainly inaccessible due to brambles, crack willow, grey willow, oak tree, goat willow.

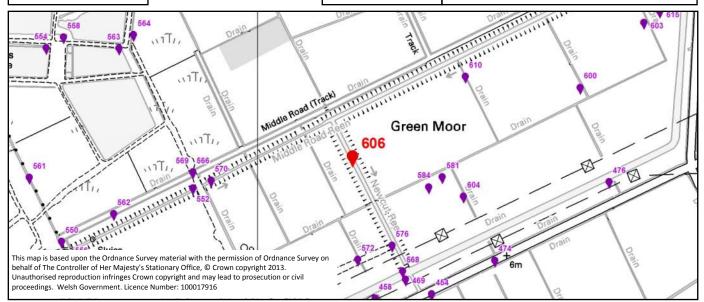
Unique Reference	606	Date: 27-08-2014 14:37		GPS:	51.56649, -2.878754	
Waterbody Number:	603	Surveyor:			In/am	
Location Map:		Surveyed Length:			100

Habitat	Reen			
Bank Profile	Steep >45deg			
Depth of Water	>2m			
Channel Width	5 - 10m			
Flow Speed	Still			
Shore Banks	Earth

Neighboring Land Use	Livestock grazing; Scrub;
Bank Management	Unfenced
Suitability for Otters	Low
Otter Signs	
Suitability for Watervoles	Medium
Watervole Signs

Bank submerged due to recent flooding. Full length of reen walked and surveyed where possible. Further survey recommended when water level has dropped.

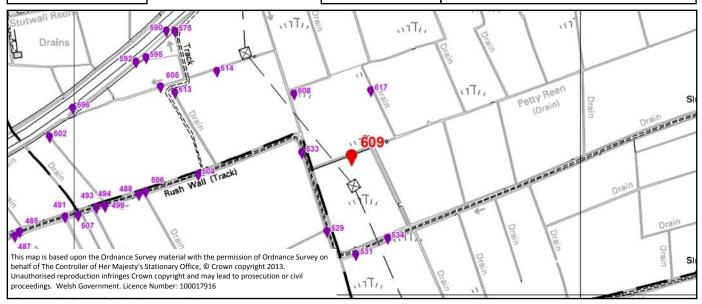
Unique Reference	609	Date:	Date: 26-08-2014 13:17		GPS:	51.572297, -2.844813
Waterbody Number:	915	Survey	Surveyor:		AO, IB, RP	
Location Map:		Surveyed Length:		ength:		100

Habitat	Reen			
Bank Profile	Shallow <45deg			
Depth of Water	>2m			
Channel Width	5 - 10m			
Flow Speed	Still			
Shore Banks	Earth

Neighboring Land Use	Livestock grazing;			
Bank Management	Unfenced			
Suitability for Otters	Low			
Otter Signs				
Suitability for Watervoles	Medium			
Watervole Signs	Latrines; Pathways; Feeding Stations;

Lemons, sweet reed grass in the reen. Bank side vegetation grey willow, crack willow, goat willow, hawthorn, bramble. Marginal veg - good foraging habitat for bats. Inaccessible to survey some areas of ditch due to dense vegan.

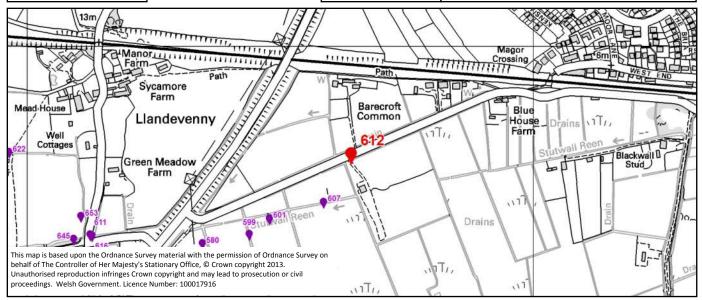
Unique Reference	612	Date: 26-08-2014 15:05		GPS:	51.576944, -2.843559	
Waterbody Number:	666	Surveyor:		AO, IB, RP		
Location Map:		Survey	Surveyed Length:		100

Habitat	Ditch			
Bank Profile	Shallow <45deg			
Depth of Water	1 - 2m			
Channel Width	2 - 5m			
Flow Speed	Still			
Shore Banks	Earth

Neighboring Land Use	Urban; Park/garden;
Bank Management	Unfenced
Suitability for Otters	Low
Otter Signs	
Suitability for Watervoles	Low
Watervole Signs

Nettle, bramble, nightshade understory. Goat willow, popular, hawthorn, crack willow, bulrush. Water quality low, fly tipping in and adjacent to ditch.

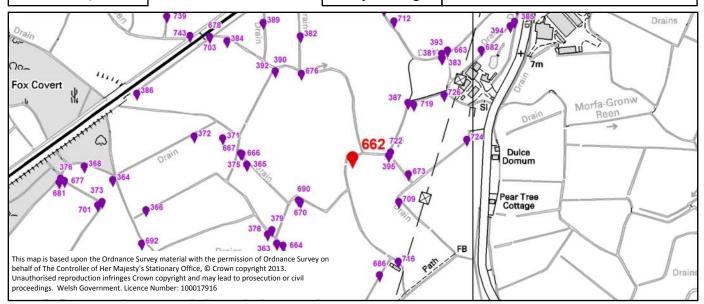
Unique Reference	662	Date:	Date: 10-09-2014 15:41		GPS:	51.546303, -3.014294	
Waterbody Number:	262	Surveyor:			Rp/am		
Location Map:		Surveyed Length:		100

Habitat	Ditch
Bank Profile	Shallow <45deg
Depth of Water	1 - 2m
Channel Width	2 - 5m
Flow Speed	Still
Shore Banks	Earth

Neighboring Land Use	Livestock grazing;
Bank Management	Mixture
Suitability for Otters	Low
Otter Signs	
Suitability for Watervoles	Low
Watervole Signs

Bank vole feeding and droppings found

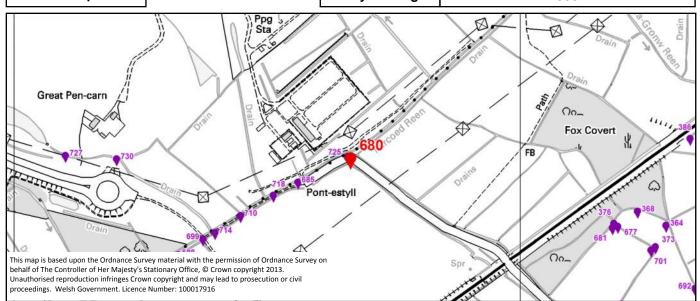
Waterbody Number:
 812
 Surveyor:
 Rp/am

Habitat	Reen
Bank Profile	Steep >45deg
Depth of Water	>2m
Channel Width	2 - 5m
Flow Speed	Still
Shore Banks	Earth

Neighboring Land Use	Scrub;
Bank Management	Unfenced
Suitability for Otters	Low
Otter Signs	
Suitability for Watervoles	Medium
Watervole Signs

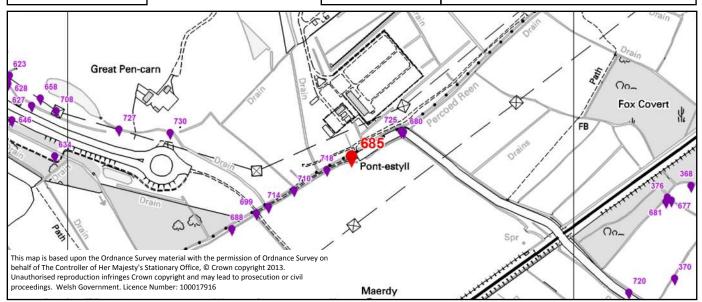
Waterbody Number:
 Surveyor:
 Rp/am

Habitat	Reen			
Bank Profile	Steep >45deg			
Depth of Water	>2m			
Channel Width	2 - 5m			
Flow Speed	Still			
Shore Banks	Earth

Neighboring Land Use	Scrub;
Bank Management	Unfenced
Suitability for Otters	Low
Otter Signs	
Suitability for Watervoles	Medium
Watervole Signs

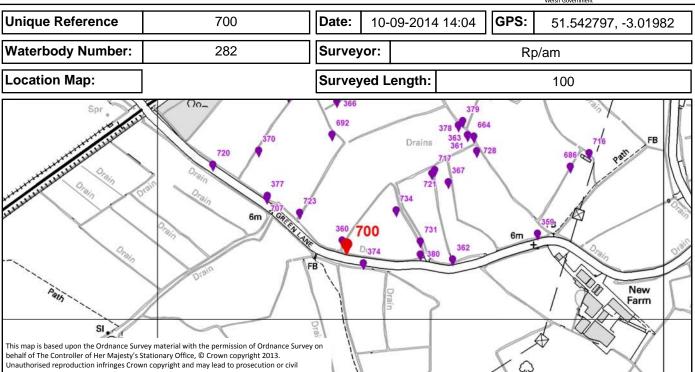
Old otter spraint found under bridge. Bank vole. Difficult to access.

Habitat	Ditch
Bank Profile	Flat <10 degrees
Depth of Water	0.5 - 1m
Channel Width	2 - 5m
Flow Speed	Still
Shore Banks	Poached

Neighboring Land Use	Livestock grazing;
Bank Management	Unfenced
Suitability for Otters	Low
Otter Signs	
Suitability for Watervoles	Low
Watervole Signs

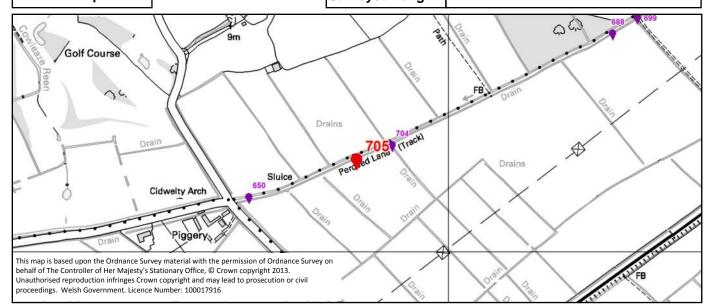
Habitat	Reen
Bank Profile	Vertical/undercut
Depth of Water	>2m
Channel Width	2 - 5m
Flow Speed	Still
Shore Banks	Earth

Neighboring Land Use	Livestock grazing;
Bank Management	Mixture
Suitability for Otters	Low
Otter Signs	
Suitability for Watervoles	Medium
Watervole Signs	Latrines; Burrows; Feeding Stations;

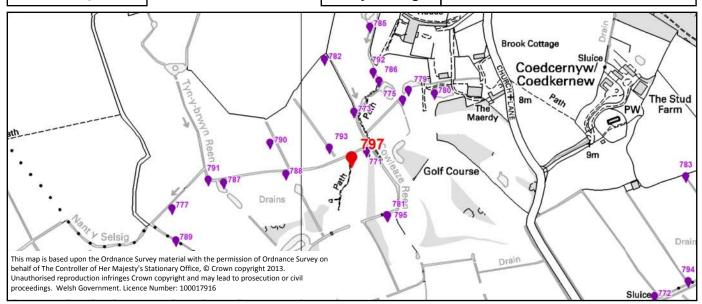
Waterbody Number:
 Surveyor:
 Joe

Habitat	Reen			
Bank Profile	Steep >45deg			
Depth of Water	>2m			
Channel Width	2 - 5m			
Flow Speed	Still			
Shore Banks	Earth

Neighboring Land Use	Livestock grazing; Park/garden;
Bank Management	Mixture
Suitability for Otters	Medium
Otter Signs	
Suitability for Watervoles	Medium
Watervole Signs

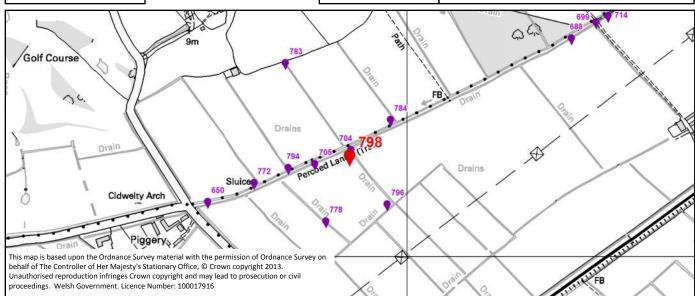
Unique Reference	798	Date:	16-0	9-2014 12:40	GPS:	51.543068, -3.041271
Waterbody Number:		Surveyor:			Zw/am	
Location Map:		Surveyed Length:		ength:		100

Habitat	Ditch			
Bank Profile	Shallow <45deg			
Depth of Water	<0.5m			
Channel Width	1 - 2m			
Flow Speed	Still			
Shore Banks	Earth

Neighboring Land Use	Livestock grazing;
Bank Management	Fenced
Suitability for Otters	Low
Otter Signs	
Suitability for Watervoles	Medium
Watervole Signs
